CRASH COMMENT

JANUARY FEBRUARY MARCH 1950

ISSUED BY
ACCIDENT INVESTIGATION BRANCH
R.C.A.F. HEADQUARTERS OTTAWA ONT

ACCIDENT RESUMÉ

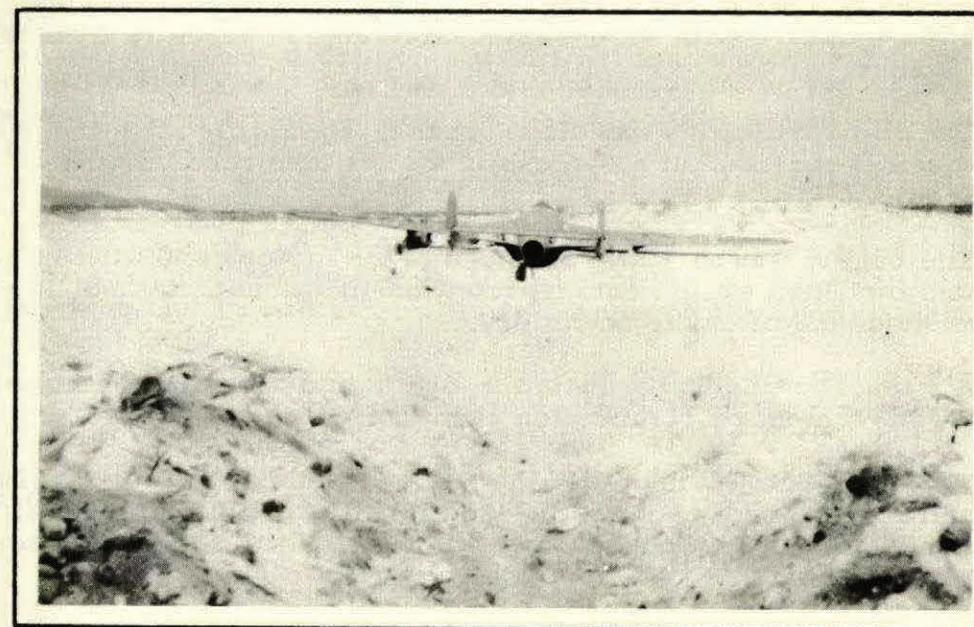
* NO. 1 -- TAKE/OFF DIFFICULTY

The above Vampire, during take-off, exhibited a tendency to roll to the left immediately on becoming airborne. The pilot re-applied the wheels to the runway, increased speed and resumed normal take-off procedure. When airborne the aircraft again began a roll to the left. Thereupon the pilot closed the high pressure cock and landed straight ahead wheels down. The aircraft ran off the end of the runway into deep snow.

Damage was estimated at ten thousand dollars.

The cause of the accident was not definitely proven. However, small patches of ice, which could have had an effect on the aerodynamic qualities of the aircraft, were found on the upper surface of the port wing. The evidence suggested that the pilot caused the aircraft to leave the runway at too low an airspeed and that the peculiar behaviour of the wing was due to a succession of stalls.

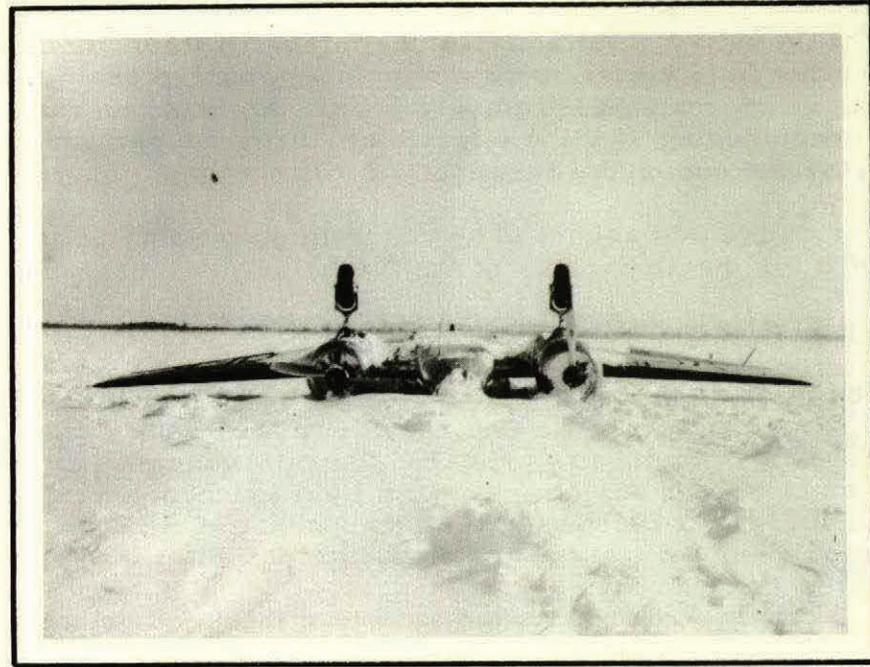
* NO. 6 -- QUESTIONABLE JUDGEMENT

Pilot error, which accounts for over 65% of our accidents, was responsible for the Expeditor's unceremonious position as pictured above. Luckily no one was injured.

The captain, an experienced instrument pilot, attempted a combination visual (head out window) and instrument take-off in moderate snow conditions. He failed to maintain directional control and allowed the aircraft to run off the edge of the runway into snow in which it subsequently overturned.

It is interesting to note that, according to the weather sequences, six minutes before the attempted take-off of the Expeditor the visibility was below the limits laid down for that particular airport. Although the visibility may have momentarily increased, to at or above limits, the pilot's judgement in commencing a take-off in such conditions is certainly open to censure. His method was equally questionable.

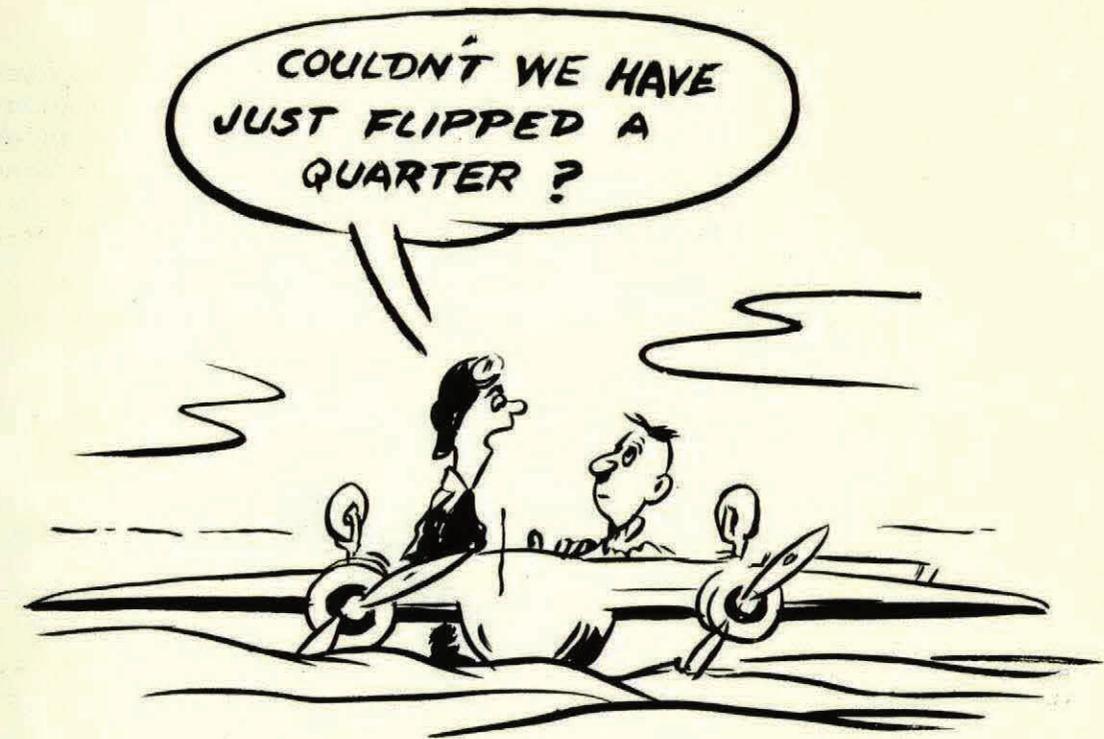
* NO. 7 -- CROSS-WIND LANDING

The Expeditor in this instance came to rest in almost the iden-

tical position of the one in the preceding case.

The captain was landing in a severe cross-wind and failed to keep the aircraft straight. This resulted in the Expeditor running off the runway into deep snow and overturning. Again fortunately, no one was injured.

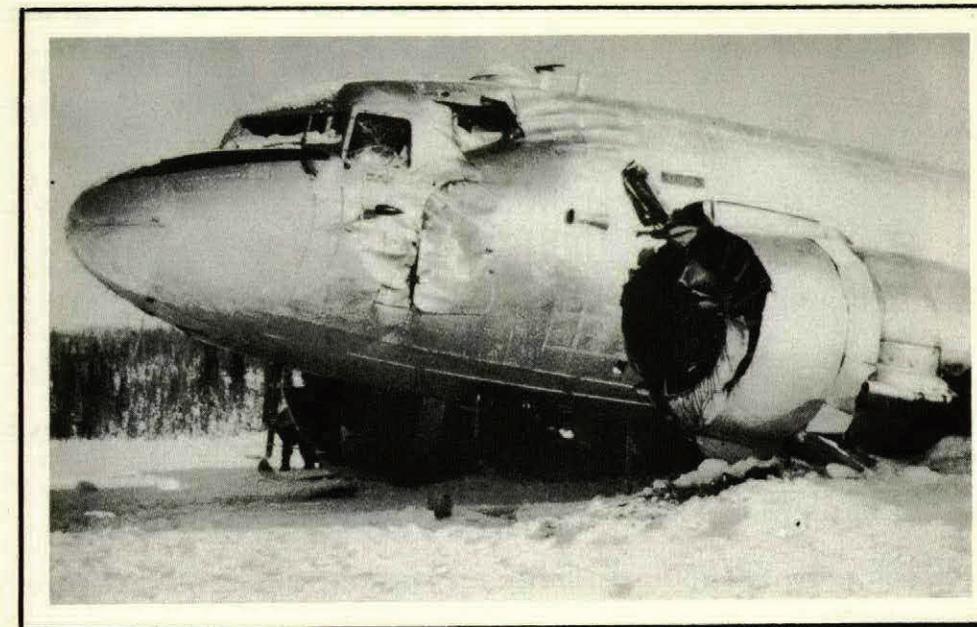
* NO. 16 -- SKI FLYING - CHECK OUTS ARE IMPORTANT.

The captain of the Dakota commenced what was intended to be a normal ski take-off from a lake covered with twelve to fourteen inches of snow.

As the aircraft gathered speed the main skis left the snow surface first, leaving the tail ski still on the surface of the lake. At this point, according to the captain, the control column came fully back and the aircraft shot into the air. The captain then called on the co-pilot for assistance. The co-pilot helped to push the control column forward and cranked on nose heavy trim while the captain reduced power "to prevent a full loop." The speed at take-off was between 50-60 knots and according to the navigator fell off to zero prior to impact.

The aircraft after becoming airborne travelled a distance of 250 yds. and then completely stalled. On impact the skis and wheels were driven up into the wheel wells and both propellers and reduction gear housings parted company with the aircraft. Extensive damage was

also done to the fuselage and mainplanes.

An examination of the aircraft failed to show any indication of ice on the control surfaces or on the underside of the fuselage. Further investigation disclosed no evidence to indicate structural failure or non-removal of control locks.

The reason for the accident was assessed as "error in judgment on the part of the pilot." Contributing factors were:

- (a) The pilot had not received sufficient dual instruction to make him proficient on ski equipped aircraft.
- (b) The pilot had no previous experience on loose snow.
- (c) The pilot did not utilize all the room available for take-off.
- (d) The aircraft was taken off in a three point attitude at or near the point of stall.
- (e) Improper use of elevator trim during take-off.

As the accompanying photograph would indicate the aircraft has joined the "write-off fraternity" and come summer will make like a submarine.

This accident happened to an experienced wheel Dakota pilot and the obvious lesson to be learned is that personnel converting from wheel to ski equipped aircraft must be thoroughly indoctrinated by fully competent check-out pilots. It would also perhaps be quite appropriate to mention here that ski aircraft cannot be trimmed off a loose snow surface in the same manner as a wheel aircraft can be trimmed off a runway.

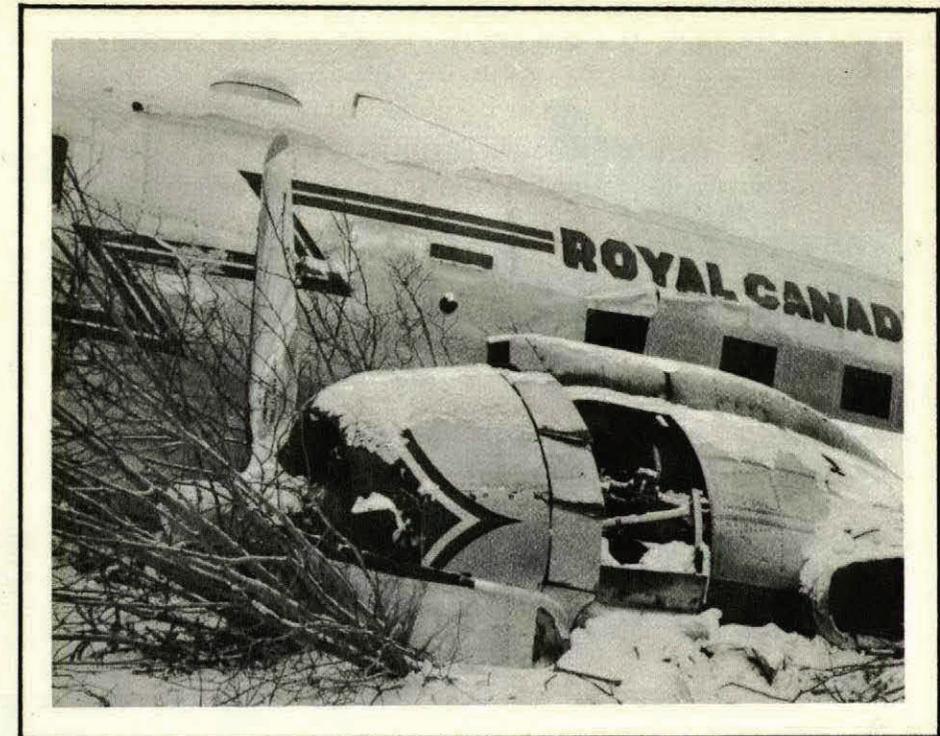
* NO. 17 -- CROSS CHECKING IS VITAL

It would appear, from viewing the pictures in this issue of Crash Comment, that Dakotas have a peculiar habit of coming to rest the hard way. However such is not quite the case and in this instance poor airmanship was a vital factor in bringing the aircraft's life to an abrupt end. Briefly, here is what happened:

Shortly after take-off the captain noticed the stbd. oil pressure gauge needle fluctuate between 40-100 lbs. and finally settle on 40 lbs. The stbd. oil and cylinder head temperatures remained within normal operating limits. As oil venting from the stbd. engine had been noted during previous flights of this aircraft, the captain assumed that venting was again occurring and discontinued the climb. As the wind at ground level was light the pilots decided to land in the opposite direction to their take-off. A 180° turn was executed, wheels lowered, three-quarters flap set and a descent of 1000 feet per minute was initiated. A fairly heavy snow shower was in progress and an early morning glare hampered visibility.

Subsequent inspection of the stbd. motor and its accessories showed no lack of oil and there were no signs of oil on the external surface of the aircraft. However a stoppage was found in the autosyn oil pressure transmitter line. This stoppage was considered responsible for the oil pressure gauge reading inaccurately.

- (a) The Captain feathered the stbd. engine without closely checking his oil and cylinder head temperatures.
- (b) Incorrect overshoot procedure was used.
- (c) Incorrect emergency method was used for raising the u/c.
- (d) The Captain failed to check the load sheet.
- (e) The aircraft was overloaded some 390 pounds.
- (f) The Captain was not aware of proper operating oil temperatures.
- (g) Incorrect rudder trim was applied.

The reason why the Dakota would not maintain height on one engine was never definitely ascertained. However the Court of Inquiry reported a very low standard of airmanship on the part of the pilots.

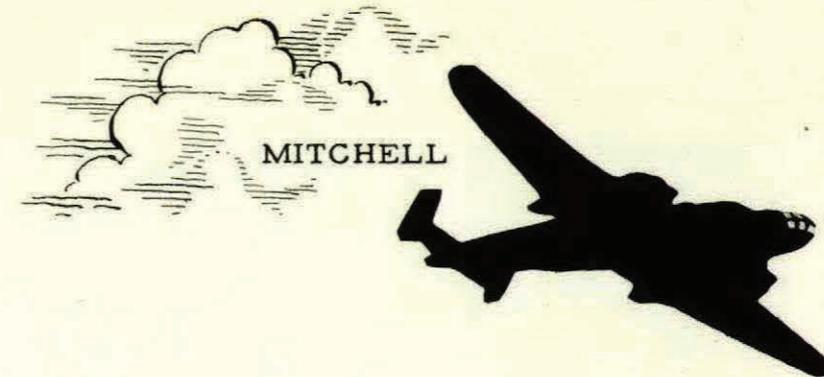
* NO. 18 -- NOSE WHEEL LOCK

During take-off run a severe vibration developed. The pilot closed the throttles and cut the switches. A visual check of the nose wheel assembly revealed that the tow pin cap was unscrewed and that the nose wheel was at an angle of approximately 60°.

Further examination revealed structural damage to the airframe of so serious a nature as to result in a "B" category assessment. This damage had been caused by vibration which developed because the towing pin in the nose oleo leg was not engaged, as a result of which the nose wheel was free to castor during the attempted take-off.

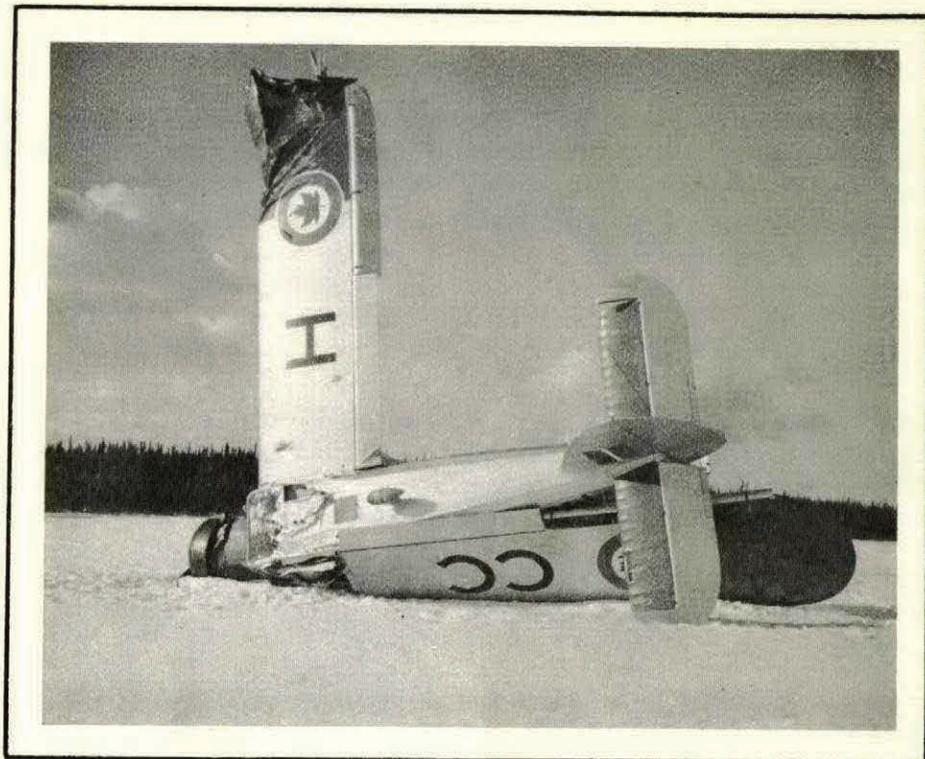
* NO. 19 -- CARTWHEEL

Overcast conditions and a broad expanse of snow set the stage for this "A" category crash.

The pilot in attempting to land misjudged his height and the port ski struck the snow before round-out had been completed. The port oleo leg broke causing the aircraft to swerve to the left. The ensuing skid caused the starboard ski to dig in and resulted in the aircraft swinging violently to starboard and then rolling over on its port side.

The cause of this accident was "pilot error" because the captain did not realize the loss of depth perception under certain light and snow conditions.

As mentioned earlier in this issue conversion to ski flying requires thorough and competent instruction.

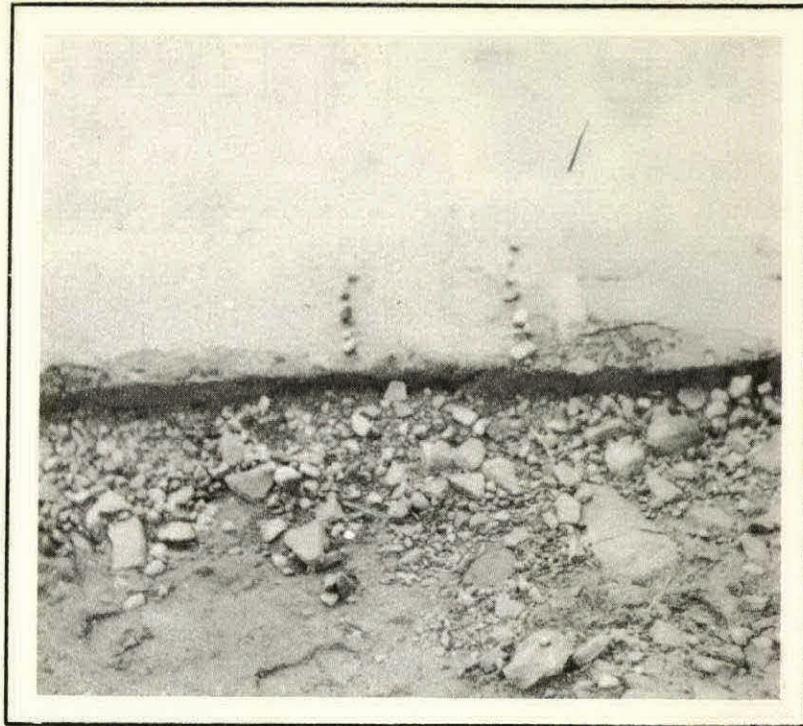
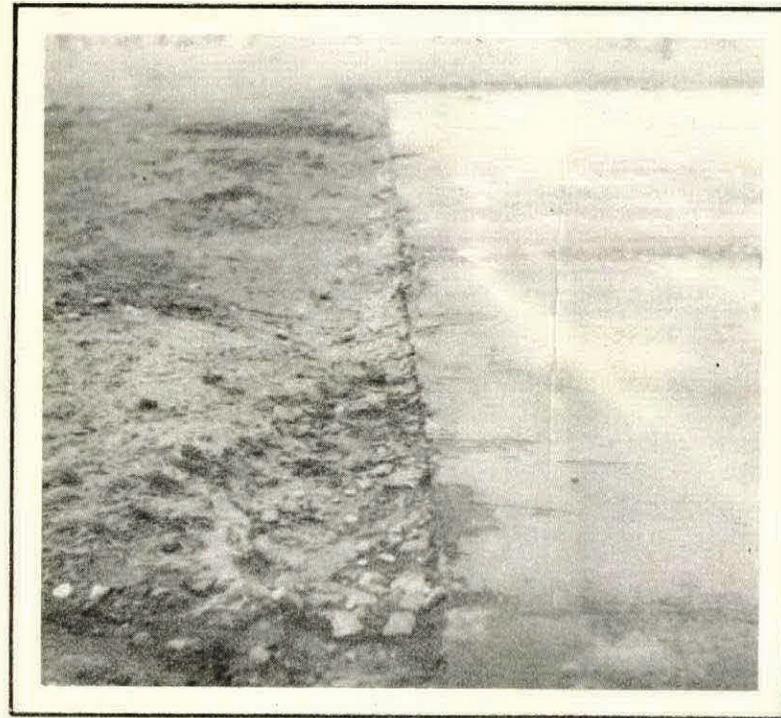
RUNWAY SERVICEABILITY

An undershoot here would cost us an aircraft.

TAKE A LOOK
AT
YOUR RUNWAYS
