FLIGHT COMMENT

ROYAL CANADIAN AIR FORCE

MAY • JUNE • 1959

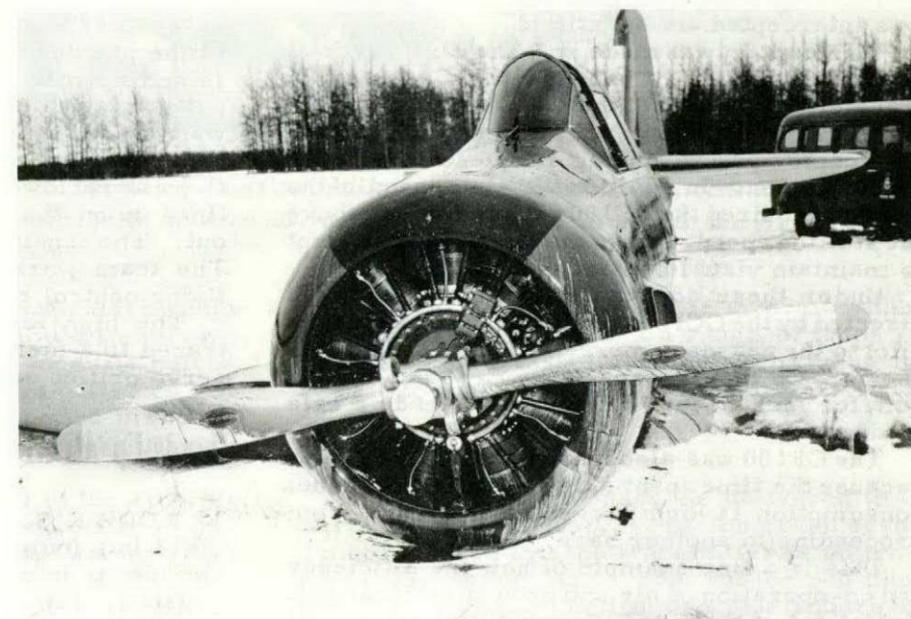
Ruptured Cylinder Head

Investigation revealed that number 9 cylinder head had ruptured. It is probable that a crack developed initially over the crown of the cylinder head between the spark plugs, then extended around the circumference of the cylinder head. Complete failure of the cylinder head and valve assemblies followed. This was accompanied by a loss of oil and complete power failure.

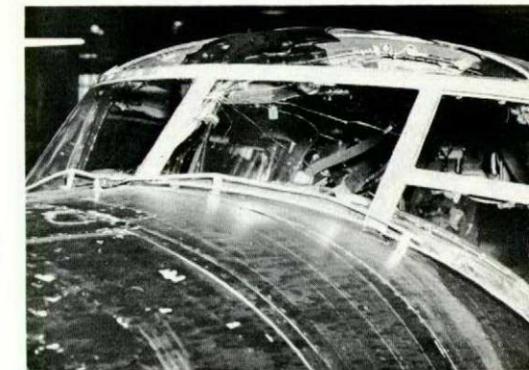
With jet aircraft, however, with their high TAS, half-inch stones can be damaging, and big stones very dangerous. The nose section, the leading edges of the wing and tail, cowlings, tip tanks, rocket pods, radar domes, and deicer boots are particularly vulnerable. Jet engines may be affected—not only the spinners and cowlings but also the compressor where damage may result from hail ingestion.

Hail did this

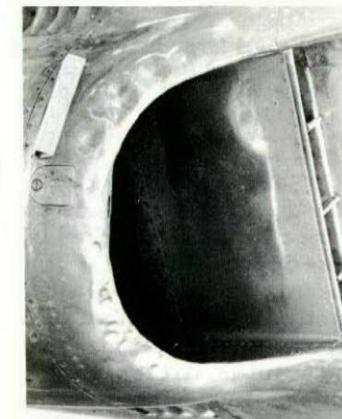
Aside from the price and time involved in repair, there is the consideration that for the particular mission during which the hail encounter occurs the aircraft's performance will be reduced below its original maximum. It has been reported that jet aircraft have lost as much as 80 knots from their original top speed from bashed cowlings and leading edges.

Dents can interfere with airflow

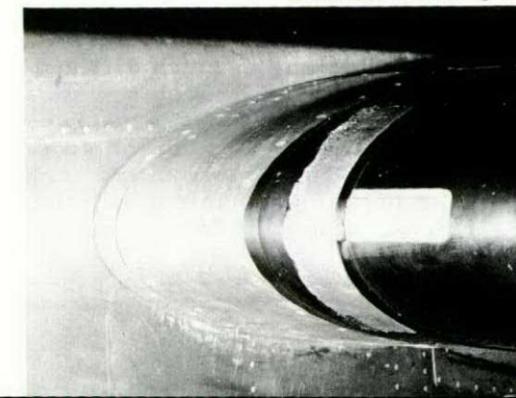
Deicer boot ruined by hail

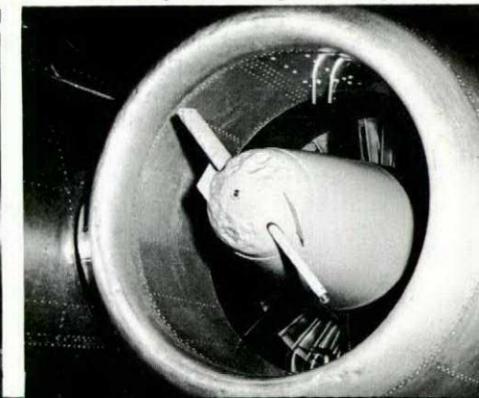
Hail may also damage the compressor

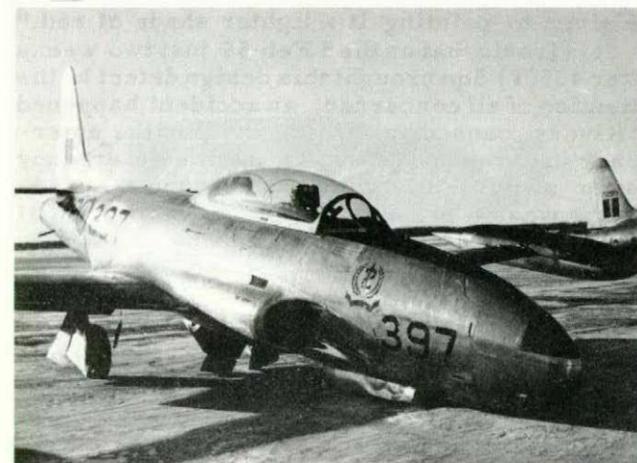
The next morning the Cpl and his crew proceeded with the brake bleeding and attached the test rig. The results are here for you to see. When the hydraulic pressure reached 700 psi the nosewheel retracted, and the aircraft fell on its nose damaging the radar nose assembly, airframe structure, some plumbing under the port engine and a Comstock motor generator assembly. An investigation revealed the undercarriage selector button was in the up position. The cost of this — well over \$10,000.

Soon as the cycle began . . . Crunch

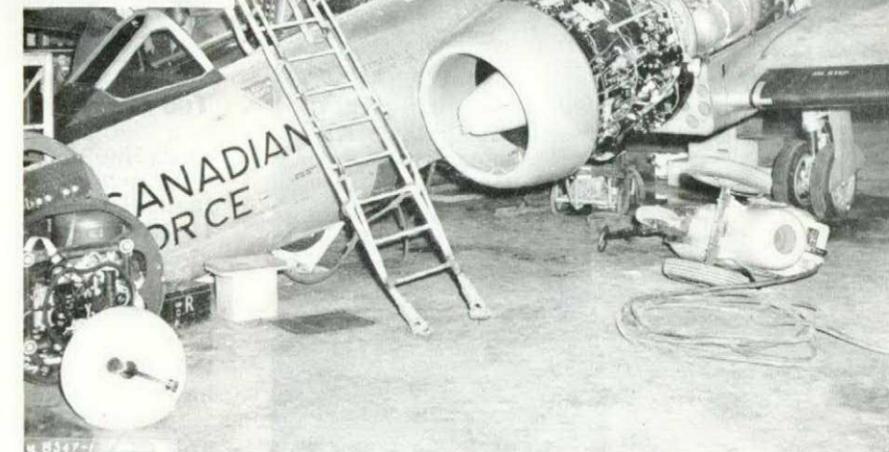
Why did it happen? One: the undercarriage ground safety pin was not installed. Why one couldn't be found is another story. Two: another crew worked on the aircraft during the night, unknown to the Cpl. Three: a cockpit check

700 psi and \$10,000 later

was not made before work commenced in the morning. Four: the Sgt supervisor was employed on barrack duties putting the load on the Cpl. It's the same old story, with the same old ending, all because the position of the undercarriage selector was not checked before pressure was applied to the system.

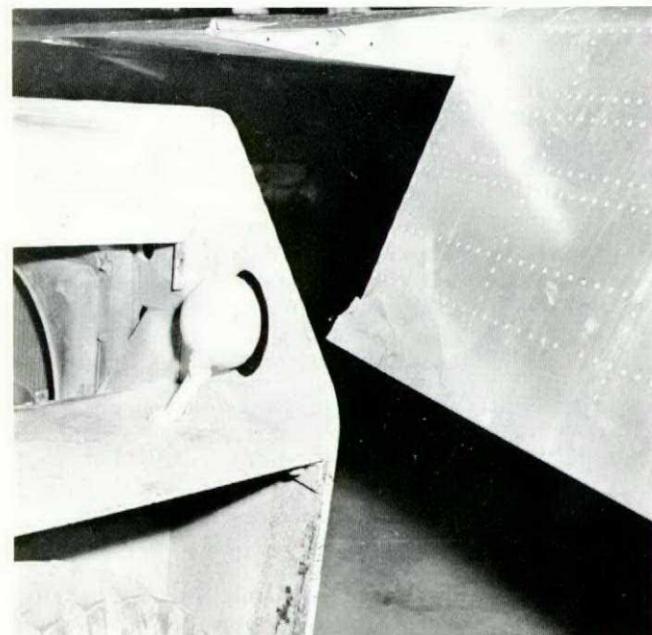
Eying the damage
