FLIGHT **COMMENT**

ROYAL CANADIAN AIR FORCE

JANUARY • FEBRUARY • 1961

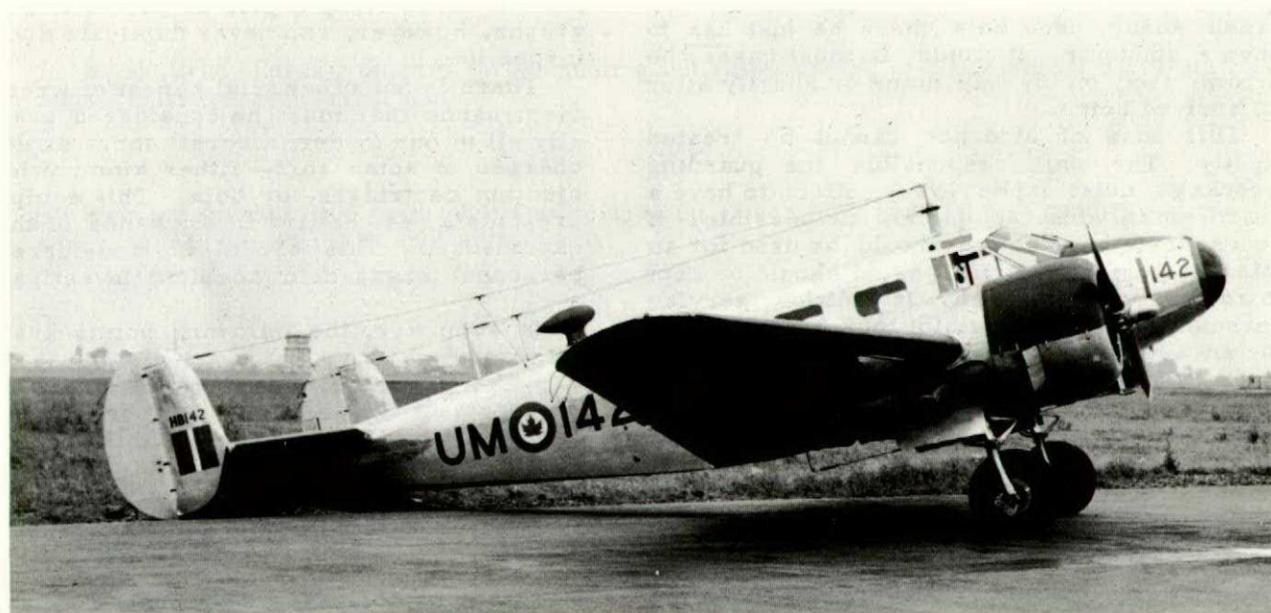
The port rudder and the starboard fin were buckled

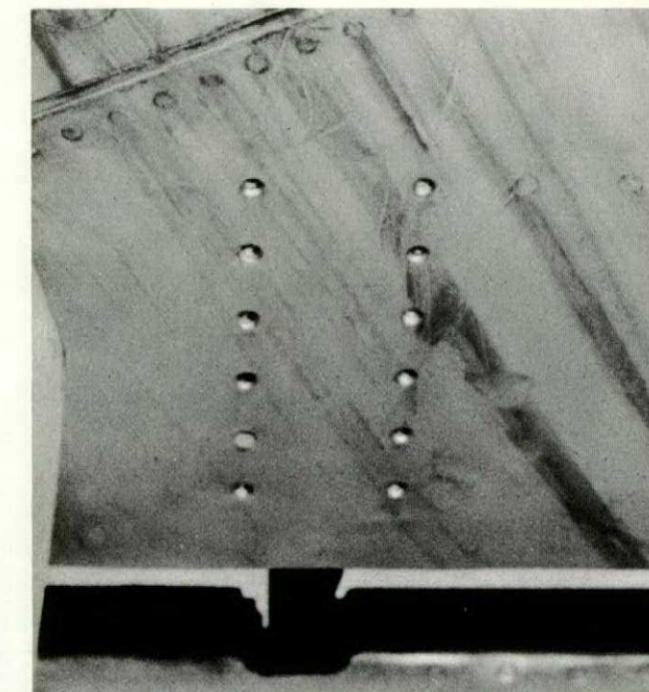
On return to base, the lead slowed his aircraft and lowered, then raised his flaps. During de-briefing the lead mentioned that he might have oversped his flaps during the pull-through. But no unserviceability was entered

Pilot didn't enter these oversped flaps on the L14

by the pilot in the L14!

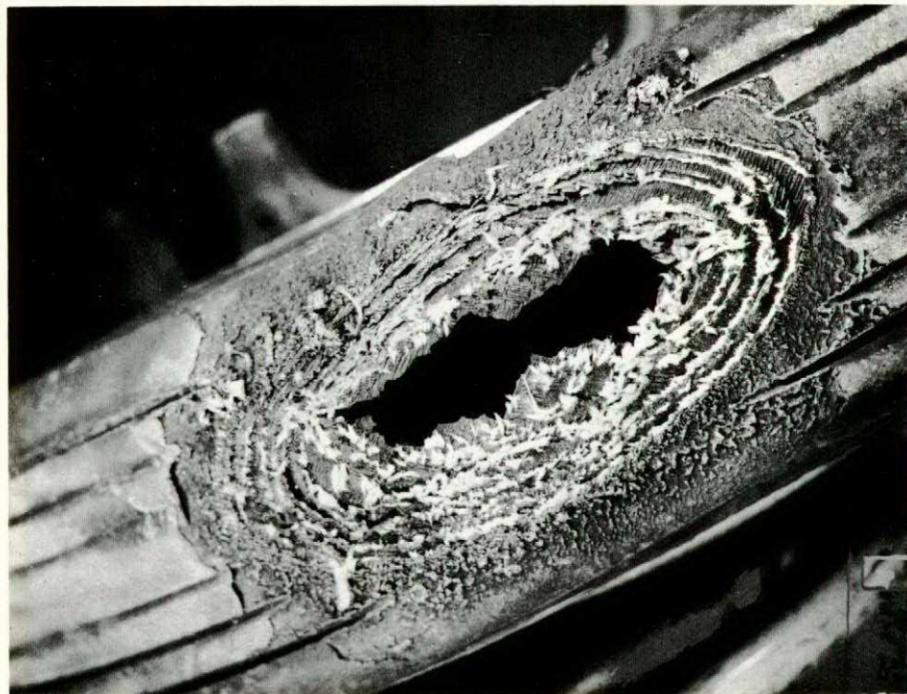
Excessive brake blows a/c tires and COs' tops!

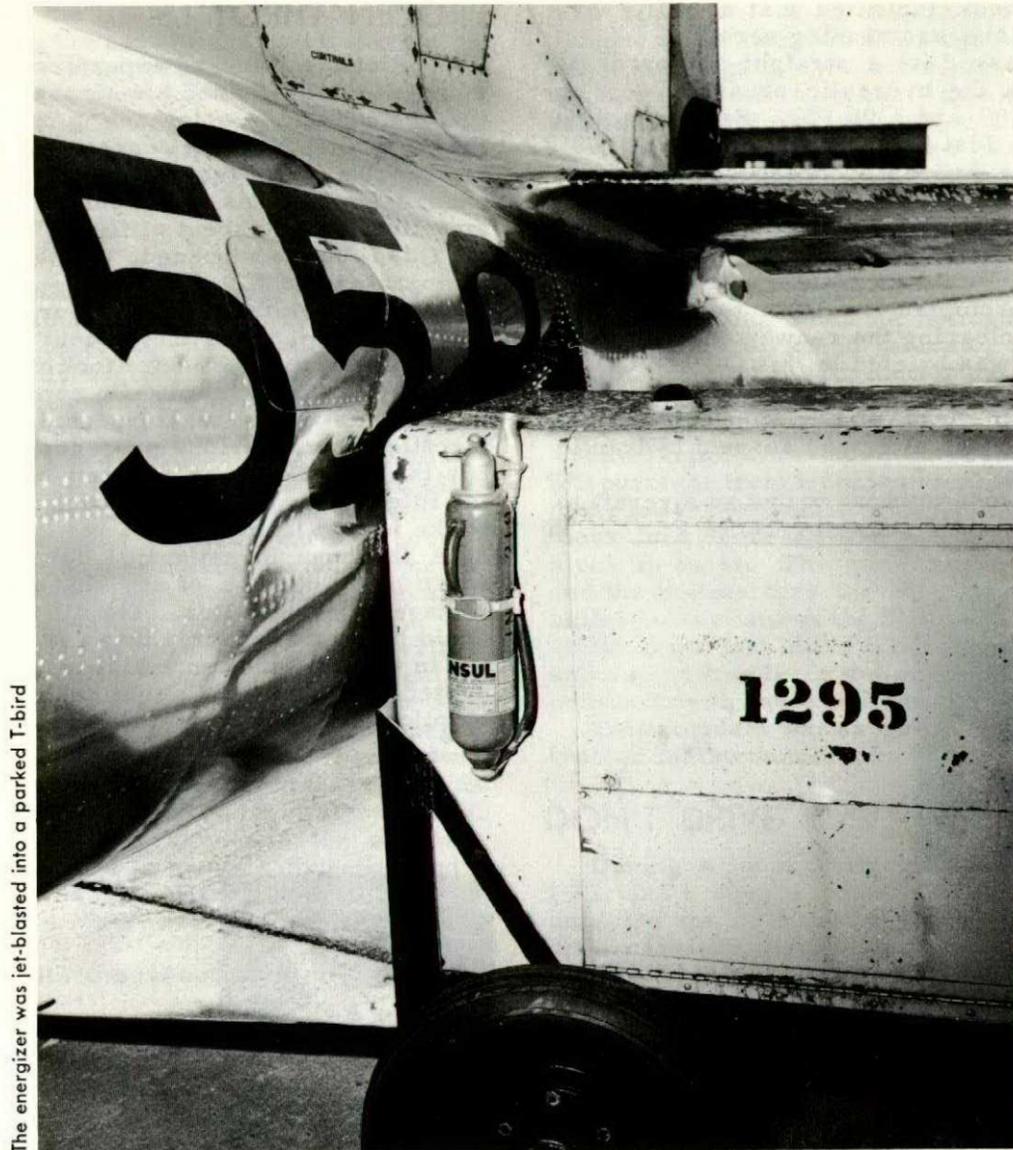
The energizer was jet-blasted into a parked T-bird
