FLIGHT **COMMENT**

ROYAL CANADIAN AIR FORCE

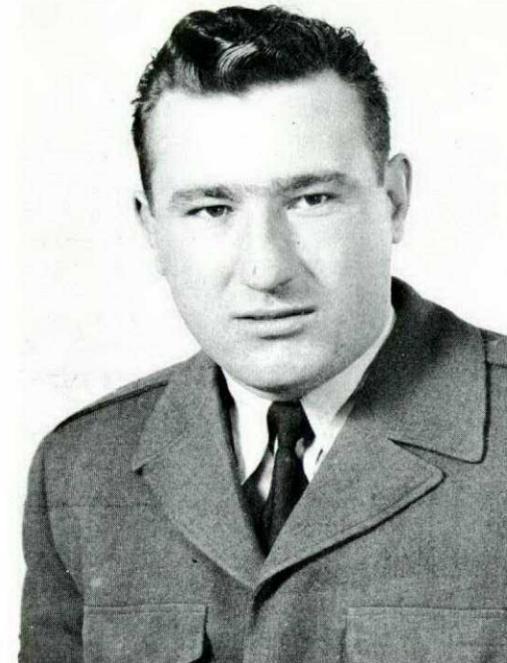
LAC S. PREMECH

Case 1: While carrying out a BFI on a visiting USAF T-33, LAC S Premech noticed what appeared to be a corner missing off a turbine blade. To get a closer look at the spot he climbed up the tail section and found that a small piece of one of the blades had been broken off. He reported his findings and the engine was removed for closer examination.

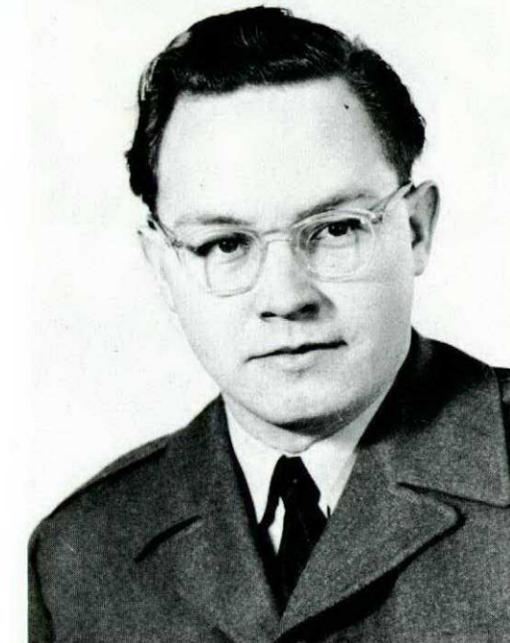
LAC L.H. BERGLUND

Case 2: On another visiting T-33, LAC LH Berglund was examining the turbine blades during the BFI. During the examination he noticed a shiny spot on the metal at the base of one of the turbine blades. He crawled up the tail pipe and he found that the spot of light that caught his attention, was caused by a turbine blade that could be moved forward and rearward in its fir tree slot. The engine was removed for repairs.

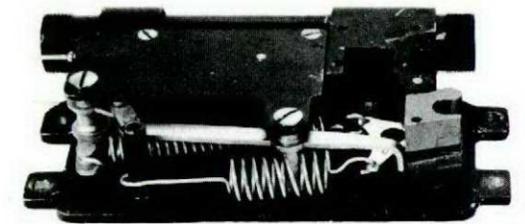
Why did the automatic release mechanism malfunction? The mechanism was dismantled and it was found that the supplementary spring had been inserted incorrectly.

INCORRECTLY INSTALLED
SUPPLEMENTARY SPRING

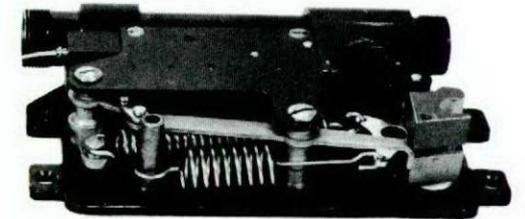
CORRECTLY INSTALLED
SUPPLEMENTARY SPRING

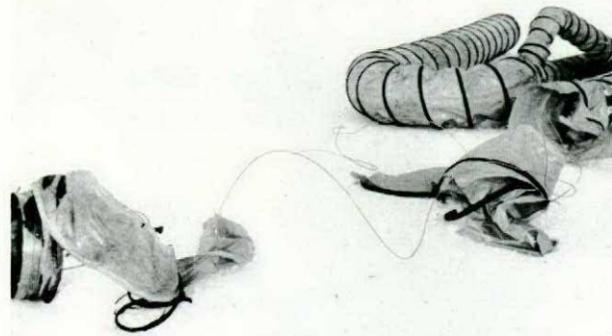
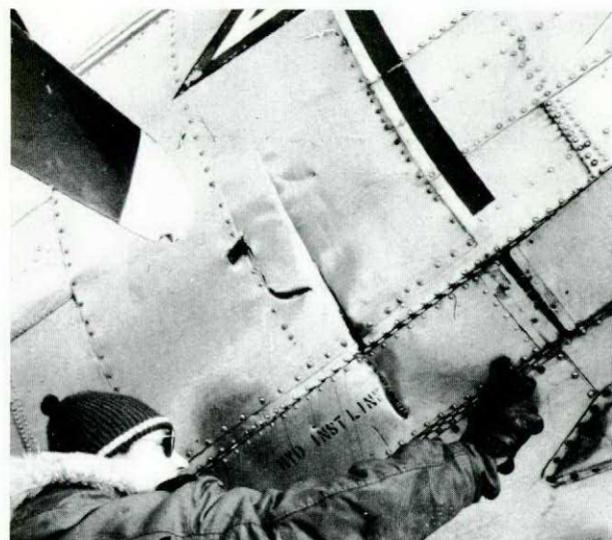
time, he saw pieces of yellow canvas flying by the window. By then, both engines were at idle.

Although the Herman Nelson blower hose had been sucked into the prop, the Herman Nelson itself was not close to the engine. There was no apparent damage to the aircraft, so the crewman decided to let the engines cool before stopping them. After a couple of minutes, another crewman noticed no hydraulic pressure on the gauge. The Cpl was outside waving his arms and giving the sign to stop.

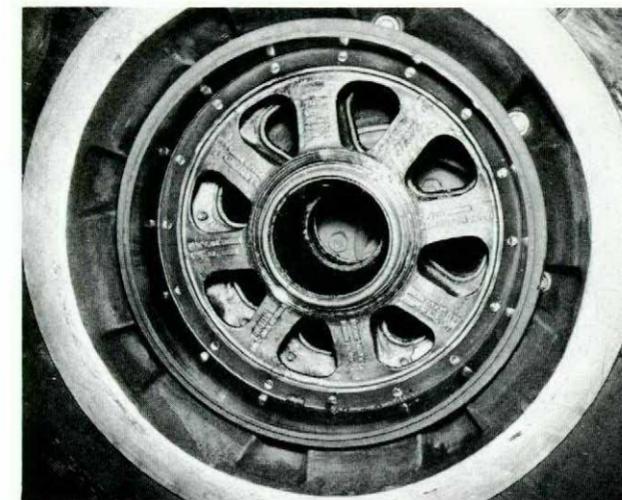
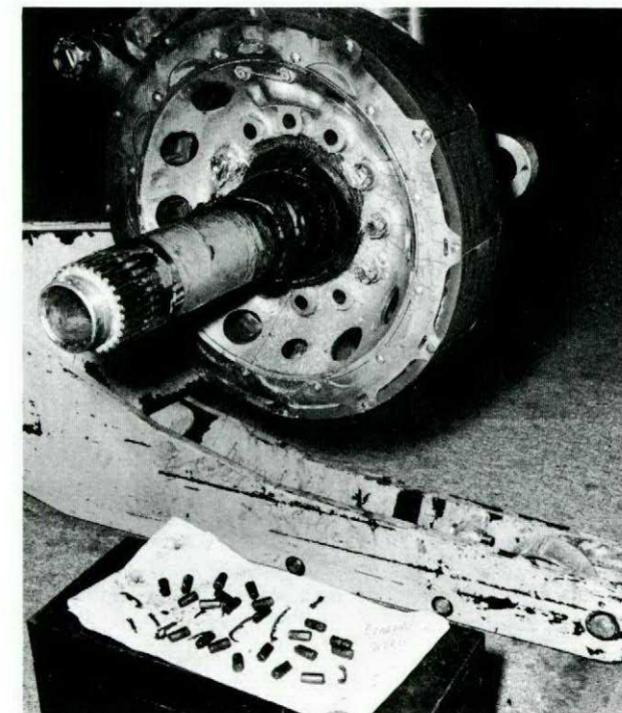
Investigation revealed that the starboard main wheel was canted at a slight angle in relation to the main oleo leg. This was caused by the failure of the inner bearing, Pt.No. 275/10248, which allowed the wheel to tilt, and the brake drum to ride on the brake block assembly.

This, in turn, had been caused by the omission of Pt. No. 144251, the collar main landing gear axle, during installation of the main wheel assembly. This allowed the bearing to move away from its proper position in the main wheel.
