- 2 the UCR
- 6 Good Shows
- 10 A little fuzzy on observations
- 12 Studded Tires
- 15 A Faulty Diaphragm...
- 16 Aeromedical Incidents in Canadian Forces Pilots
- 18 There is a limit...
- 19 On the Dials
- 20 Yukon Drain Hazard
- 22 BRAKE... or BREAK
- 23 Gen from 210
- 24 Letters to the Editor

Editor—F/L JT Richards

Flight Comment is produced by the CFHQ Directorate of Flight Safety. The contents do not necessarily reflect official policy and unless otherwise stated should not be construed as regulations, orders or directives. Contributions, comments and criticisms are welcome; the promotion of flight safety is best served by disseminating ideas and on-the-job experience. Send submissions to: Editor, Flight Comment, CFHQ/DFS, Ottawa 4, Ontario. Subscriptions available from Queen's Printer, Hull, P.Q. Annual subscription rate is \$1.50 for Canada and USA.

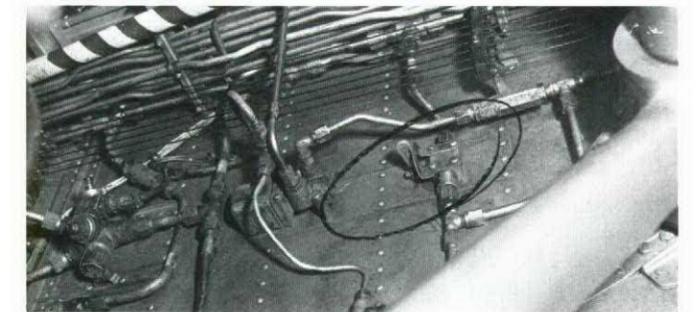
The main brake accumulator dump valve in the nosewheel well was found left in the open position by mistake. This little lever on the dump valve and the surrounding area is to be painted conspicuous matching colours to alert technicians to the safe and unsafe positions.

Main brake hyd check valve in safe position

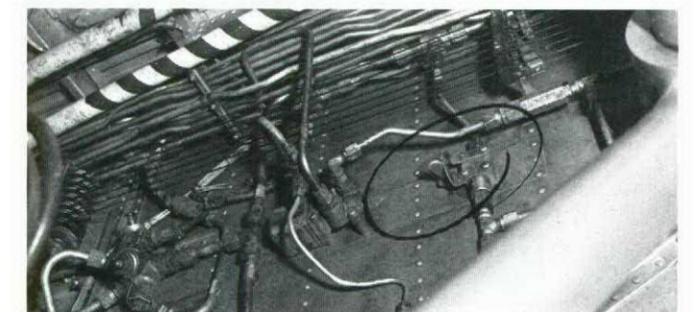
It's an invitation to error to install a hand-operated on-off lever and place it in a dark wheel-well - and then leave it completely unmarked.

Main brake hyd check valve in unsafe position

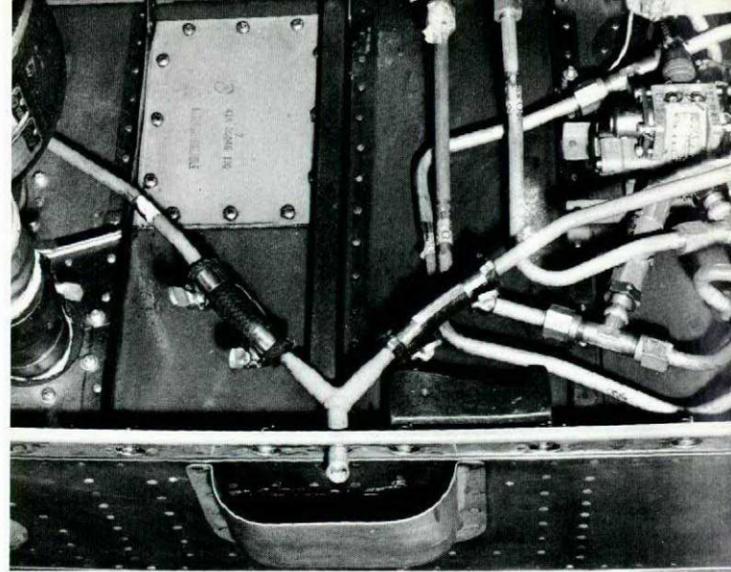
By accident (to use the term loosely) someone had abandoned a two-pound bucking bar on the rear lip of a Tutor's engine lower access hole.

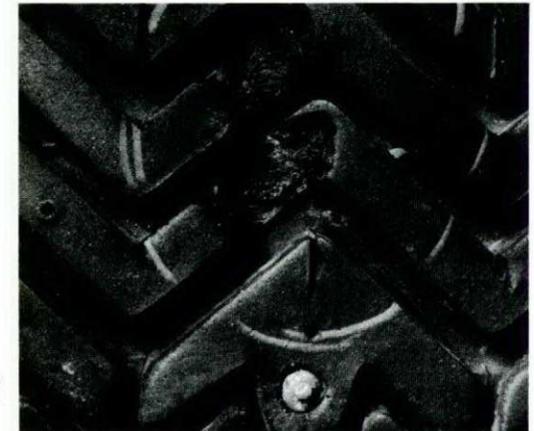
Figure 2

Studs mounted in tread lugs of insufficient rubber tore out readily, damaging the tire.

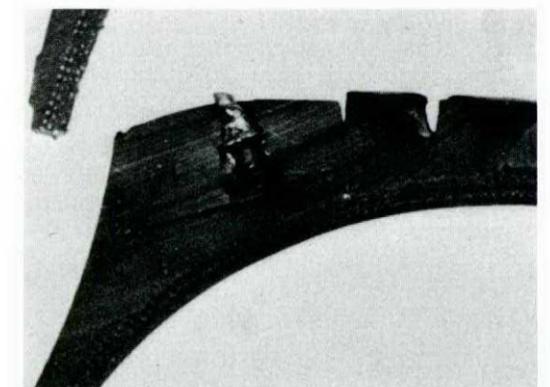
Figure 3

Abnormal wear of a stud mounted off the vertical.

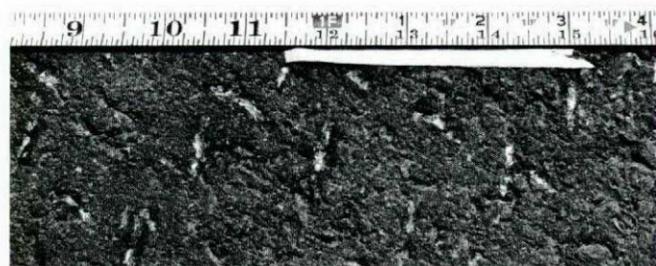
Figure 6

Towing tractor produced these marks in asphalt pavement during a sharp turn.

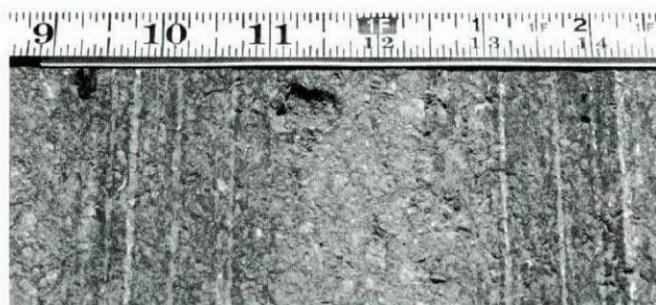
Figure 7 Car studs on light vehicle produced these furrows with locked-wheel braking on asphalt pavement.

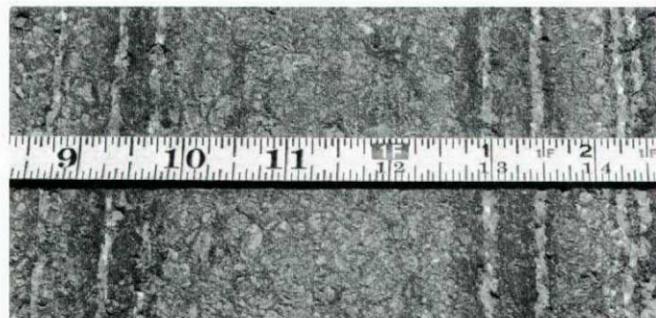
Figure 8 Locked-wheel braking by towing tractor produced grooves in asphalt pavement.

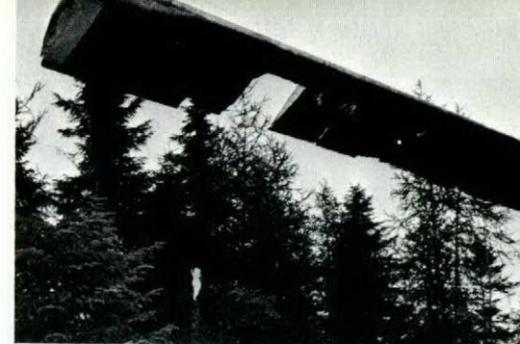
Severe rotor damage after severing trees.

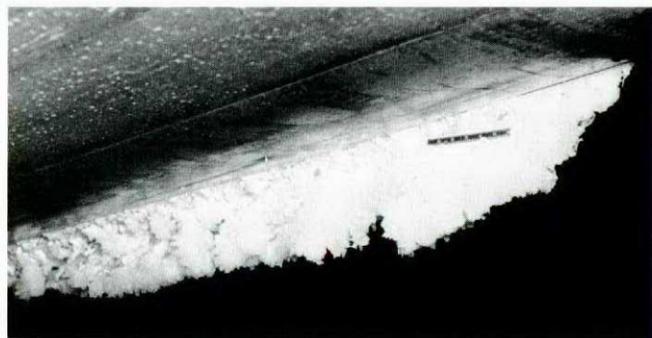
Extensive build-up with unmodified drain.

Ice chunk broke free, bending prop.

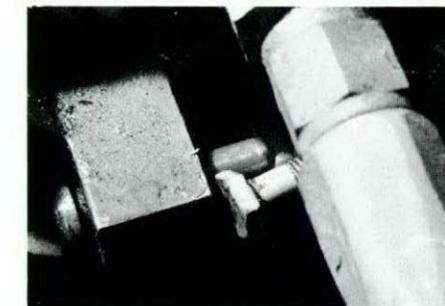
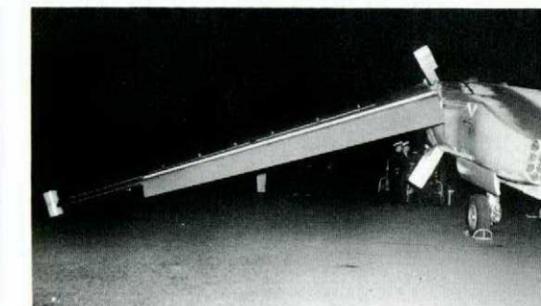
Earlier, two men had removed and reinstalled the port wing fold lock cylinder sequence valve. Neither the two technicians or the supervisor checked the final position of the lock sequence valve adjustment bolt

for correct alignment. (Its misalignment can be seen in photograph).

That the component itself is capable of being installed misaligned is regrettable (this is not the first

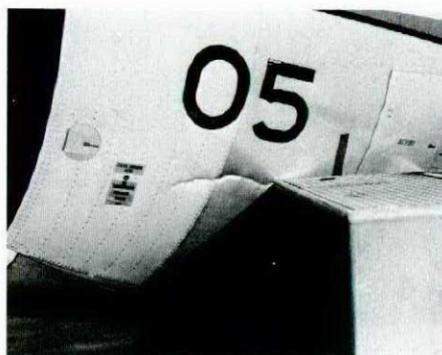
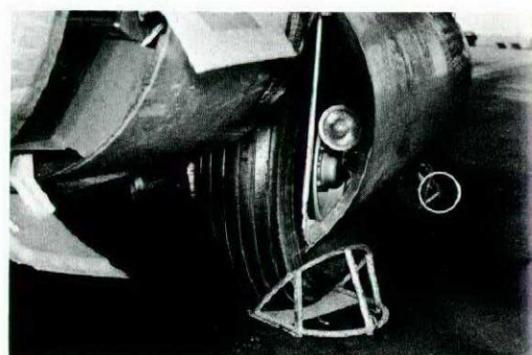
What came to light as a result of this occurrence is seen starkly in the photograph. The chock on the rear wheel is a Yukon type; a missing shoe (circled) renders this one u/s. The chock on the front

wheel—sitting askew from being pushed aside—is an original C119 chock. Of the three shoes fitted to the forward frame, two are missing.

Looks like using incorrect, un-serviceable chocks to hold aircraft on a sloping ramp was asking for trouble.
