WINTER 1998

Flight Comment

Directorate of Flight Safety

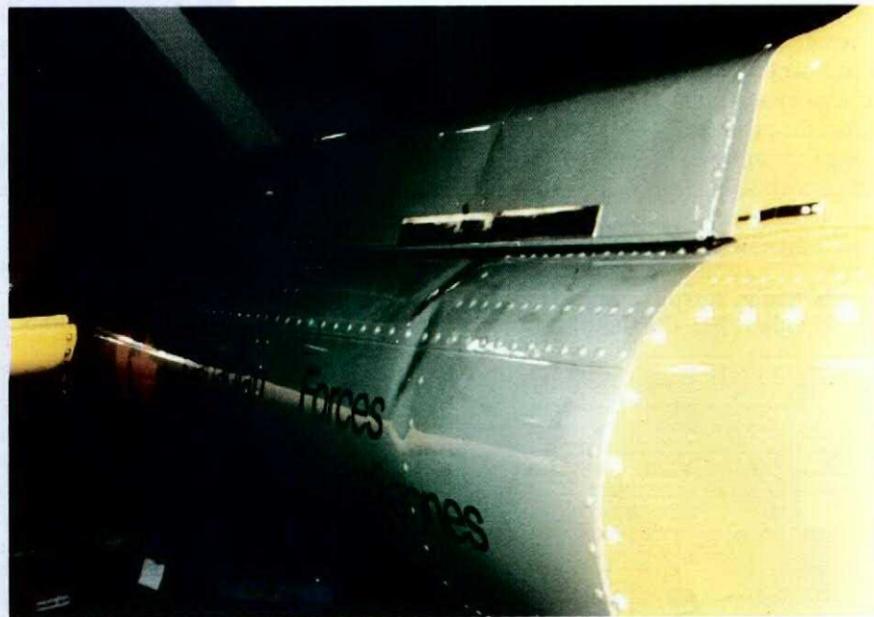
On 11 June 96 Jet Ranger CH139306 suffered 'B' Category damage following a hard landing during night autorotation training at Portage la Prairie. The mission was a Night Lesson Plan 1, with the instructor as Aircraft Commander (AC) in the left seat and Co-Pilot (student) in the right seat. During an attempted overshoot from a demonstration autorotation the aircraft touched down hard in a nose low attitude, bounced and came to rest about 170 feet short of the Pad 2 landing area. The investigation into the accident is now complete.

Skin Wrinkle – Right side

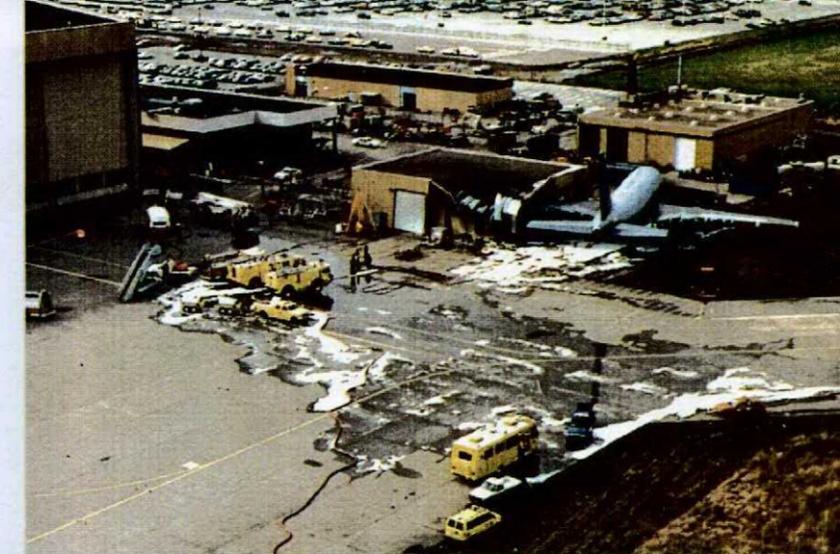
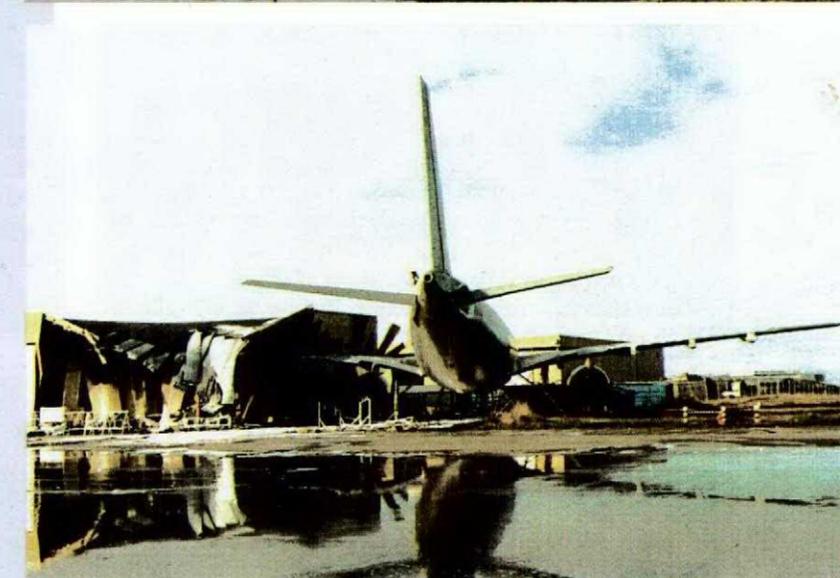
The run-up checklist called for the aircraft to be chocked using large run-up chocks. As these chocks were unavailable at CAI's maintenance facility, smaller parking chocks were used instead. The combination of these smaller chocks, lack of wheel brakes and a high power setting resulted in the aircraft jumping over the chocks and accelerating across the ramp. Idle power was immediately selected but as the aircraft thought it was airborne the engines went to flight idle which was considerably greater than ground idle. The crew's efforts to control the aircraft were unsuccessful due to the many systems that were not functional while in the flight mode.

Several latent factors compounded the actions of the crew members. They included lack of proper run-up chocks at this maintenance facility and insufficient run-up training that did not include breakaway recovery procedures. Weak incident reporting procedures at CAI led to maintenance personnel believing that maintenance incidents were not reportable to the company flight safety program. As a result, although several company personnel were aware of a similar incident where a CAI A310 had slid against its chocks a few years earlier when the same circuit breakers had been pulled, the incident had not been reported and no effective action to prevent recurrence had been taken.

To correct the problems identified in this investigation, run-up techs are now trained in breakaway procedures, proper run-up chocks have been obtained, and more emphasis has been placed on incident reporting to ensure maintenance occurrences are reported. As well the maintenance manual has been amended to include a warning that pulling the flight/ground circuit breakers will interrupt the normal operation of the brakes. ♦

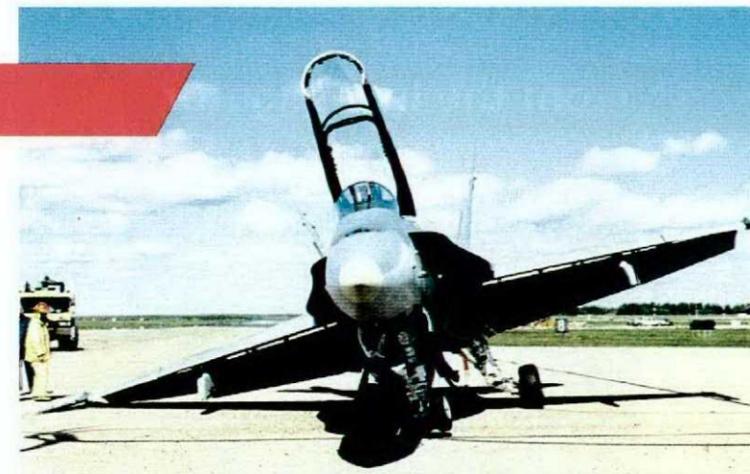
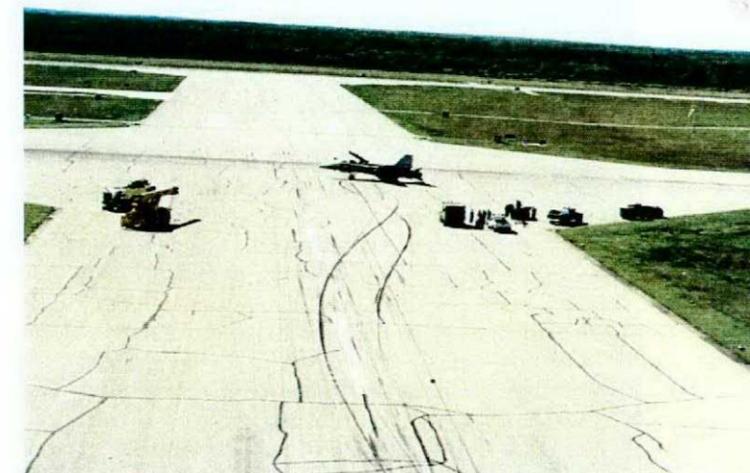
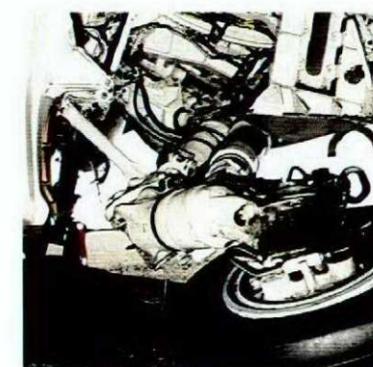
This aircraft had recently been modified with the new, more robust planing links that incorporate nested external compression springs. Of particular interest to the investigation was the planing assembly connecting link that was found bent, the side brace upper jury link that was fractured at the two lower lags and the initial oscillating RH tire tread marks – or shimmy – immediately after touchdown. Subsequent laboratory analysis determined that the connecting link failed first in compression, permitting the planing arm to unlock and the MLG to shimmy, thereby producing large lateral loads on the side brace. This, combined with excessive freeplay in the side brace and the lower strength aluminum upper jury link, resulted in the failure of the side brace and subsequent collapse of the landing gear.

As a result of this accident, the MLG side braces on all CF-18s were inspected for freeplay and wear. The requirements of that special inspection were also

incorporated in the new periodic card deck for the aircraft. Furthermore, an already existing plan to replace the current aluminum upper and lower jury links with stronger steel parts was hastened.

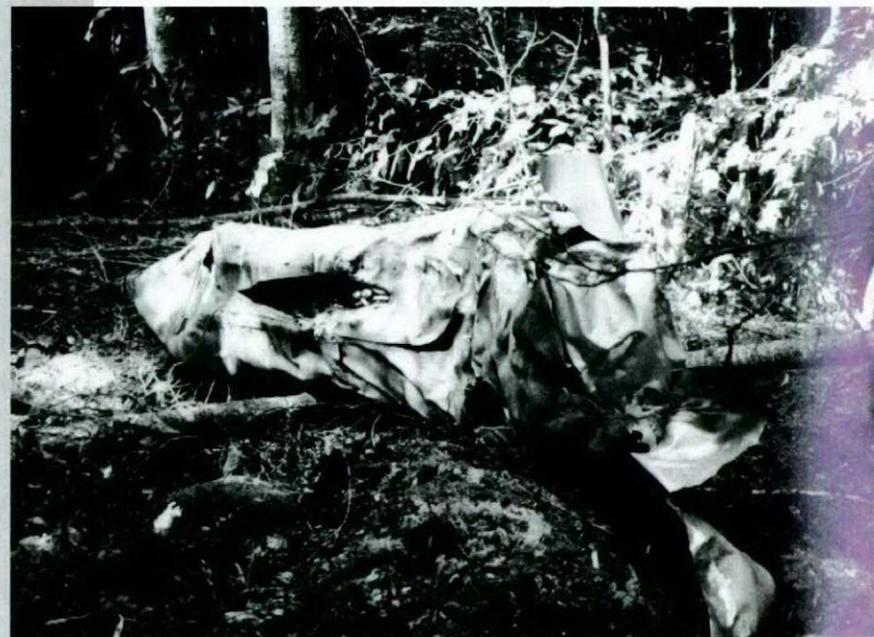
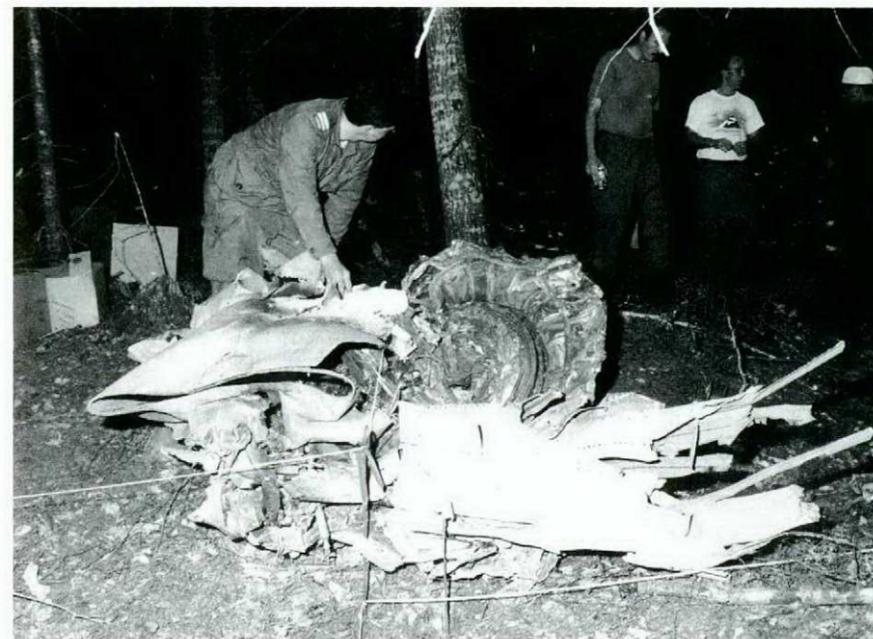
During the ejection sequence, the pilot was sprayed with a molten plastic substance. Microscopic deposits were found on the pilot's helmet visor, upper torso and right hand, and on the inside of the canopy and canopy frame. The spray

pattern of these particles strongly suggests that they were deposited by windblast. The chemical composition of the molten deposits was found to be identical to the caulking/sealant which is applied between aircraft structural components. Exhaustive analysis shows that the source of this molten material was forward of the cockpit, exposed to intense heat prior to ground impact, and open to the airstream. The nose section of the aircraft was examined and evidence of an intense pre-impact fire was found in stainless steel oxygen fittings. The investigating team concluded that a high-pressure oxygen-fed fire existed in the nose of the aircraft prior to ground impact.

A detailed search of the aircraft wreckage resulted in the identification of all the hinge parts associated with the right armament door, and sections of the door itself. On the left side, only the airframe mounted parts of the left armament door hinges were located. The airframe mounted parts of the left armament door hinges all exhibited signs of twisting, which is characteristic of a door departing in flight. None of the hinge parts associated with the right armament door exhibited signs of twisting. No portions of the left armament door, door latches or door mounted hinges were found in the aircraft wreckage. The investigating team concluded that the left armament door departed the aircraft in flight.
