SPRING 2001

Flight Comment

The Canadian Forces Flight Safety Magazine

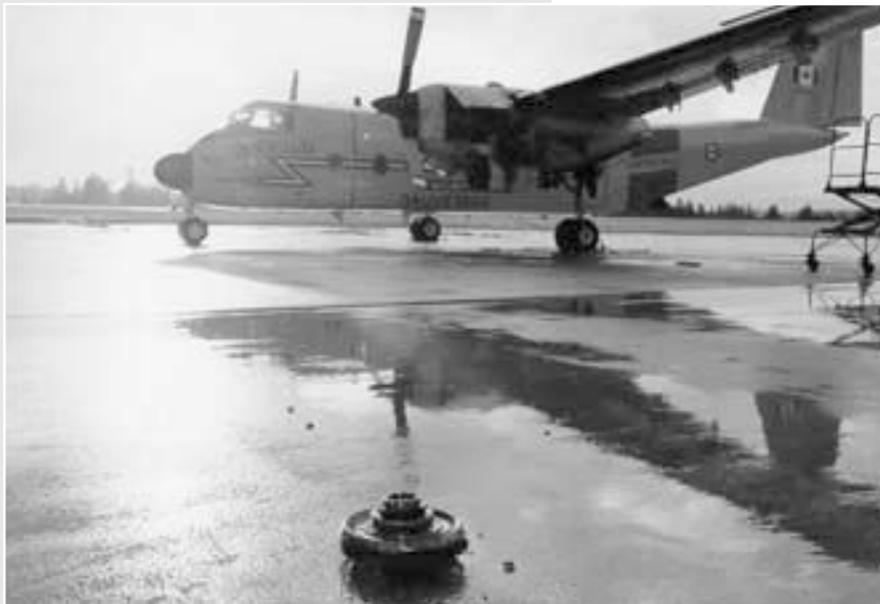
TYPE: CC115465
LOCATION: Comox, BC
DATE: 07 Feb 1998

Three technicians were conducting a maintenance ground run on Buffalo 115465 following engine maintenance. The run-up was conducted in accordance with the checklist and included the Power Lever Burst (PLB) procedure, which directed that the power lever be moved from the maximum forward thrust position to the maximum reverse thrust position within one second. During this procedure an unfamiliar engine sound was heard, followed immediately by a loud explosion and fire. The LH power lever was moved to idle and fire emergency procedures were carried out. Pulling the LH FIRE PULL T-Bar handle failed to activate the fire extinguisher and attempts to activate the second fire bottle failed. The RH engine was shut down and the aircraft evacuated. Three fire trucks arrived approximately 2.5 minutes later and extinguished the fire in approximately 3 minutes. There were no injuries in the accident, however, the aircraft sustained Category 'C' damage.

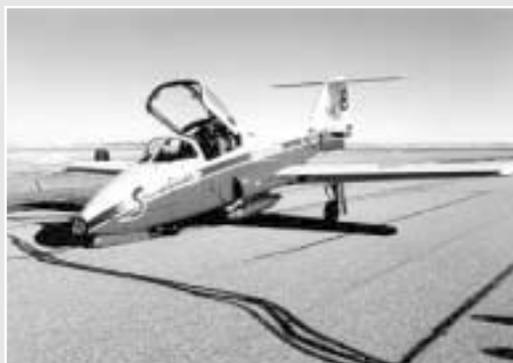
TYPE: CT114019
DATE: 27 Feb 1999
LOCATION: 15 Wing Moose Jaw,
Runway 29R

The aircraft was number six of a 7-plane formation landing after an on-field air show practice at 15 Wing Moose Jaw on 27 February 1999. During touchdown on runway 29R, the aircraft experienced a firm landing. The aircraft then bounced and became airborne again. The nose of the aircraft then rotated quickly towards the ground and the nose landing gear contacted the runway surface heavily. The aircraft veered to the right, the nose landing gear collapsed and the pilot maintained directional control using differential braking. The aircraft then skidded to a stop. There was no interference with the rest of the formation. The pilot shut down the engine, turned off electrical equipment and egressed from the aircraft. Fire fighting vehicles and an ambulance arrived on scene within minutes, but were not utilised. There were no injuries.

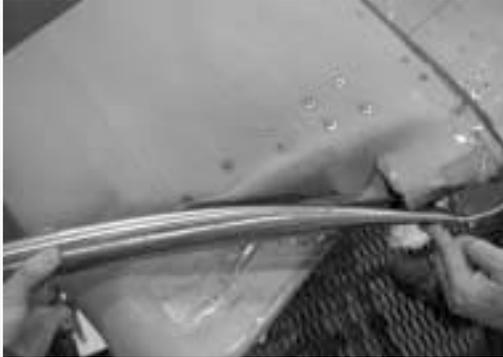
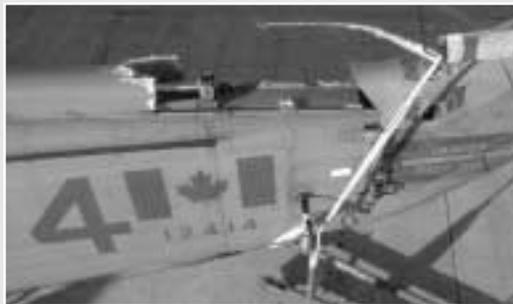
TYPE: CH-124A414 Sea King
DATE: 16 June 1999
LOCATION: Shearwater, NS

At 1420 Z 16 June 1999, a crew from 406 (HT) Squadron, consisting of one Waterbird Instructor Pilot and one Airborne Electronic Sensor Operator (AESOP), had just completed a crew change of the right seat student pilot on the ramp at Shearwater.

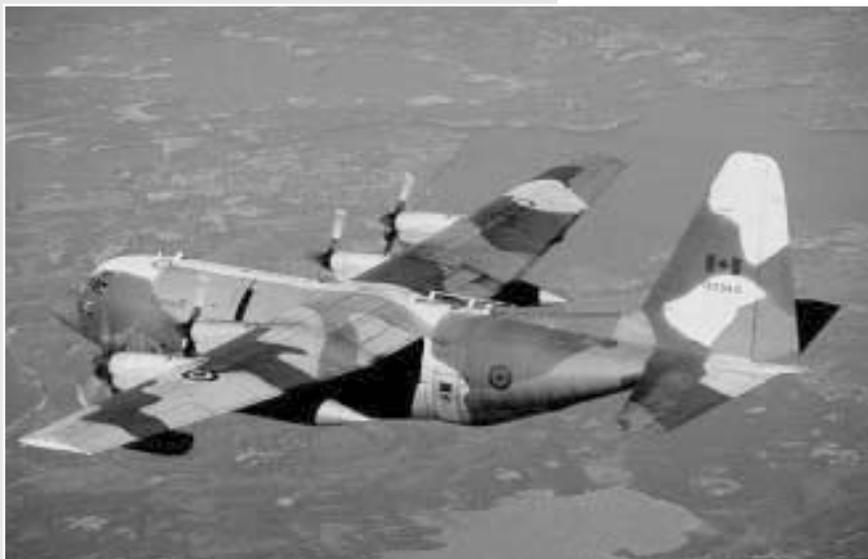
TYPE: CC130325
LOCATION: 90 NM North West of Thule Air Base, Greenland
DATE: 27 Aug 1998

During Operation BOXTOP a crew was on a daylight flight from Thule, Greenland to Eureka, NWT, to position two non-flying CC 130 crews to recover two diverted aircraft. A malfunctioning cargo compartment pressurization system led to a gradual increase in the cabin altitude such that at FL180 the cabin altitude was 10,000 feet. While attempting to rectify the pressurisation problem the cabin altitude reached 14–15,000 feet. At that point a non-flying aircraft commander (AC) proceeded to the cockpit to inform the crew that he and others were experiencing symptoms of hypoxia. He recommended, to the flying AC, a descent to 10,000 feet and the use of oxygen for the flying crew. The emergency checklist was actioned and due to calculated Minimum Obstruction Clearance Altitude (MOCA) the aircraft was descended to 13,000 feet (11,000 — cabin altitude), followed, 15 minutes later, by a descent to 10,000 feet. With below limits weather at Eureka, the aircraft returned to Thule at 10,000 feet without further

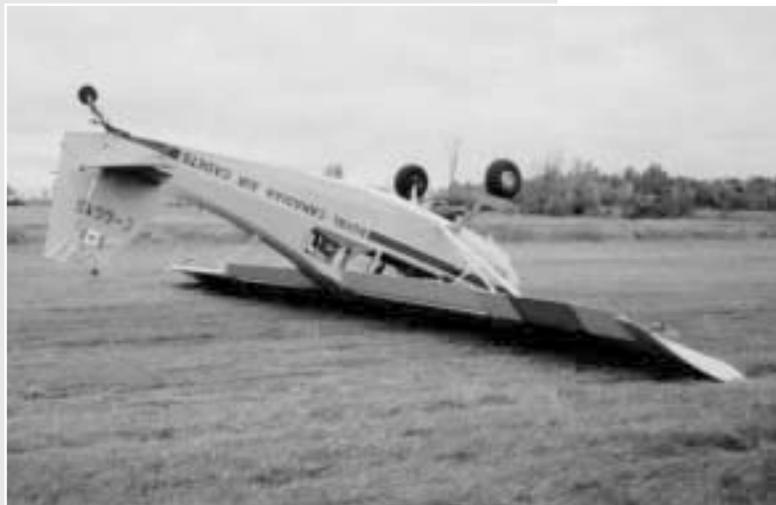
TYPE: Bellanca Scout C-GGYS
DATE: 8 October 2000
LOCATION: Alexandria, Ontario

One tow aircraft and two gliders from the Quinte Gliding Centre (Mountainview) were deployed to the Alexandria municipal airport to provide local Air Cadet squadrons glider familiarisation flights as mandated in the Air Cadet Gliding Program. The experienced pilot of the accident aircraft took off at approximately 0815 on the Sunday morning and carried out nine successful glider tows. On landing from his ninth tow, the pilot was observed to be slightly “longer” than previously. The aircraft landed slightly farther than normal and heavier braking was used in order to stop at the launch point.

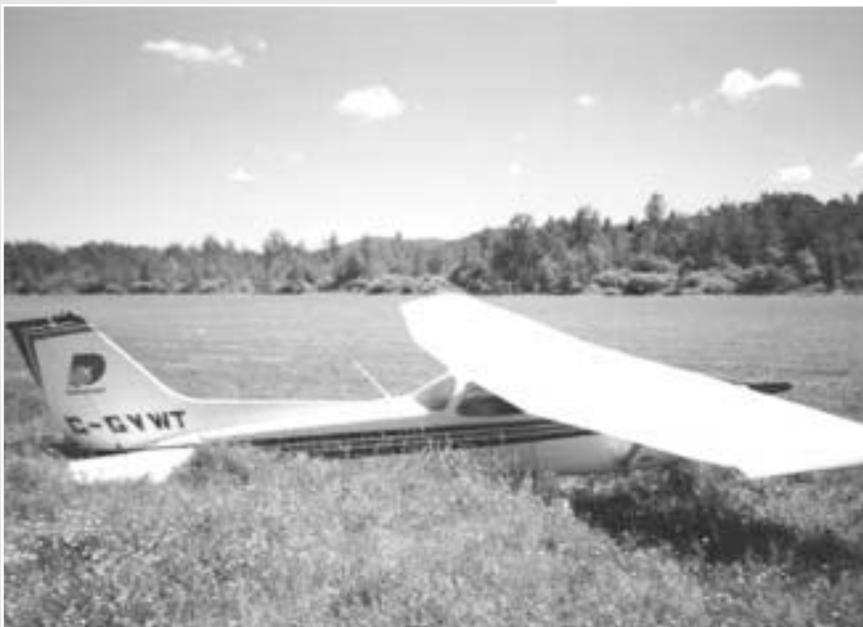
TYPE: Cessna 172 C-GVWT
DATE: 26 July 2000
LOCATION: Bromont, Québec

On the morning of 26 July 2000, a solo Air Cadet undergoing private pilot training under the Air Cadet flying scholarship program, departed St-Jean PQ for Bromont PQ in a Cessna 172M. The purposes of the flight were to acquire more solo cross country time in order to meet the 5 hours requirement for the private pilot licence and to practise touch and go landings away from the student's base at St-Jean as that airport was also host to the Air Cadet League's regional glider school and the circuit was very busy.
