Riding the Rocket Seat

High Risk Fleets for Mid-Air Collisions

The erosion of manual flying skills in highly automated aircraft

Thinking Outside the Toolbox

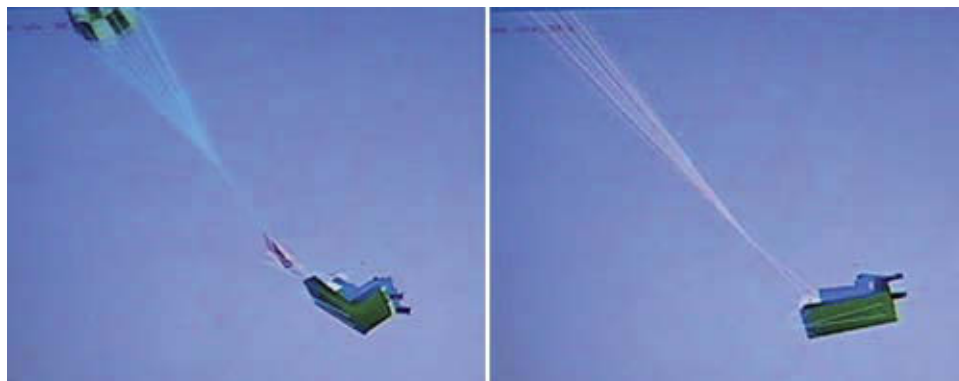
The investigation revealed that the mechanism of the fatal injury was a sudden and large sideways force applied

to the pilot when the main parachute opened at high velocity. The pilot's head was forced through the shoulder harness to the left.

The SJU 9/10 seat (otherwise known as Martin-Baker Mk 10L) which was used in this ejection uses a single point drogue chute for initial seat aerodynamic stabilization, deceleration and to extract the main parachute from the headbox. However, at low altitudes (below 7500' ASL), this drogue chute will only be in action for about 1 second prior to extracting the main parachute. Thus, during a low level, high speed ejection, a large deceleration force will be imparted to the pilot during the main parachute opening phase. In this case, it was estimated at approximately 25 G's. This large force was applied sideways because the seat was not properly aligned with the airflow at the time of main parachute opening (see figure 2).

Figure 2. Extraction of main parachute by drogue chute; approximation of misalignment of seat/pilot with main chute axis on inflation

well as the introduction of the CF188 joint helmet mounted cueing system (JHMCS). The need to increase the seat's inherent aerodynamic stability, and to reduce the main parachute opening shock were, amongst other parameters, clearly identified. As a result, the procurement of the NACES ejection seat described earlier in this article was approved in early 2006, with a forecast implementation during 2009. In the meantime, a revised escape system modernization provided for the replacement of the SCH with a PCU-56 torso harness, an improved seat cushion, the new LPSV, as well as a revised placement of the oxygen regulator.

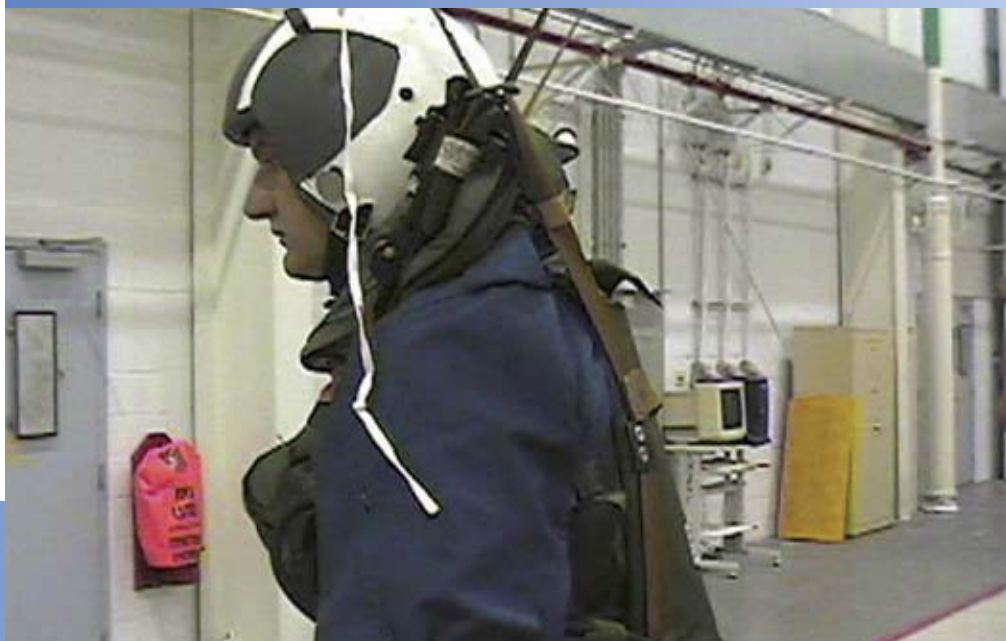
The strap in procedures employed by many aircrew (including the accident pilot) at the time of the accident were incorrect. The full procedure, as mandated by the manufacturer, was not fully accomplished, and resulted in the pilot being improperly restrained during ejection. Notably, the simplified combined harness (SCH) was not sufficiently tightened, resulting in the so-called “triangular void” above the pilot’s shoulders (figure 3). Tests demonstrated that this gap can be in the order of 7 inches when the pilot is suspended. The investigation also revealed that many aircrew felt “nice and snug” in the harness when in the seating position in the cockpit, even when it was improperly adjusted. Also, an improper tightening of the leg restraint snubber lines resulted in the pilot’s right leg going outside of the seat bucket during ejection, adding to the seat’s instability. AOI’s were subsequently modified to enforce the correct strap-in procedures.

Figure 3. Suspension test showing excessive triangular void above the shoulders

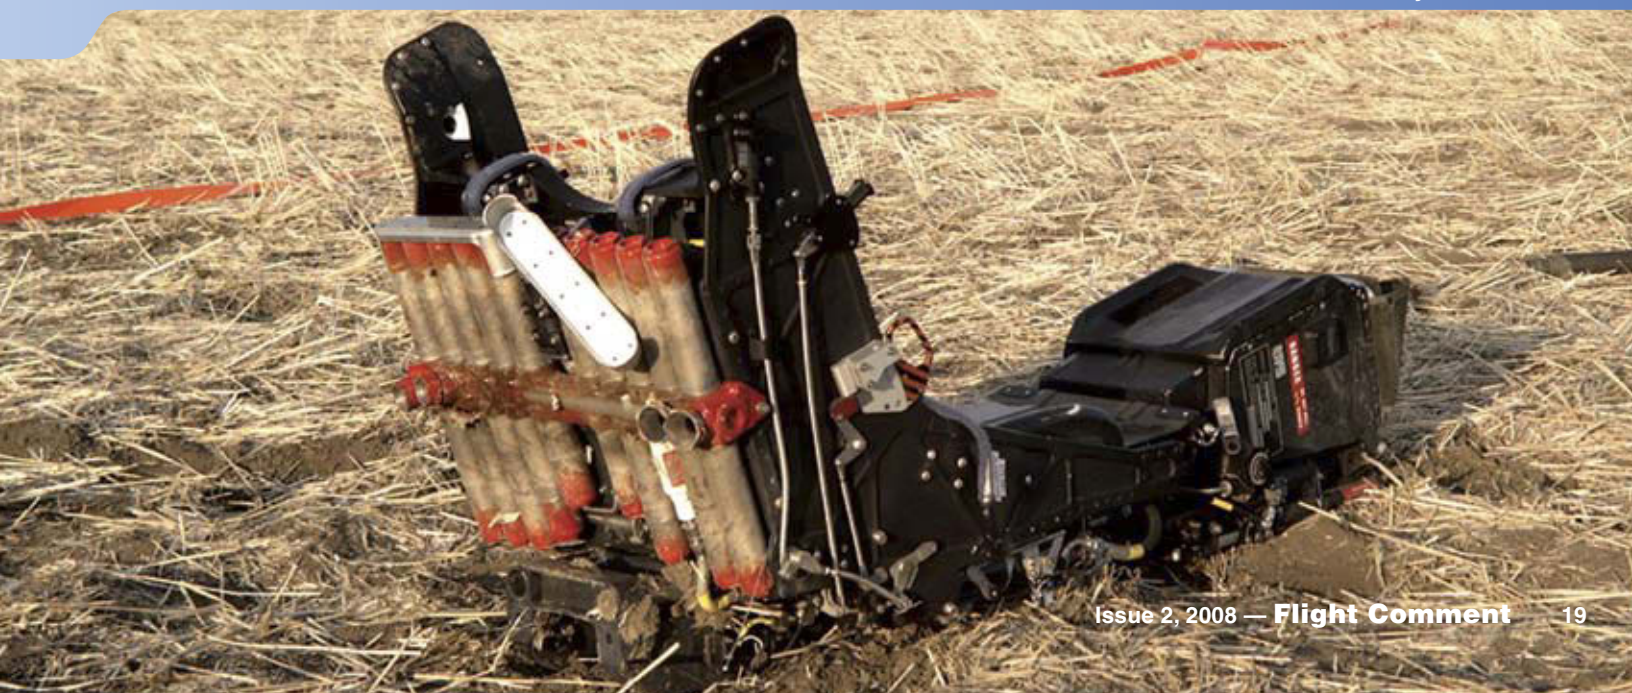
CT155 Hawk, 155202, 14 May 2004

The IP suffered injuries during the catapult phase, which were likely due to the fact that he was in a head down, and slightly hunched position at the time the seat fired. He immediately felt a sharp pain as the seat was propelled up the rails. After parachute opening, he attempted to relieve pressure/pain during the descent by lifting himself with the risers. This had the effect of rotating his parachute through 360 degrees as it descended and increased his descent rate. No attempt was made to deploy the parachute survival pack (PSP). He also suffered serious injuries on landing. The non-deployed PSP and high descent rate contributed to these ground impact injuries. The IP's ejection was classified as « unsuccessful/survivable ». An ejection is classified as successful if the aircrew can escape and evade (war time) or return to flying status within 24 hrs (peacetime).

This accident again highlighted the importance of following the proper strap-in procedure as per the AOI's. The IP had, here again, an excessive triangular void due to an improperly tightened harness, which

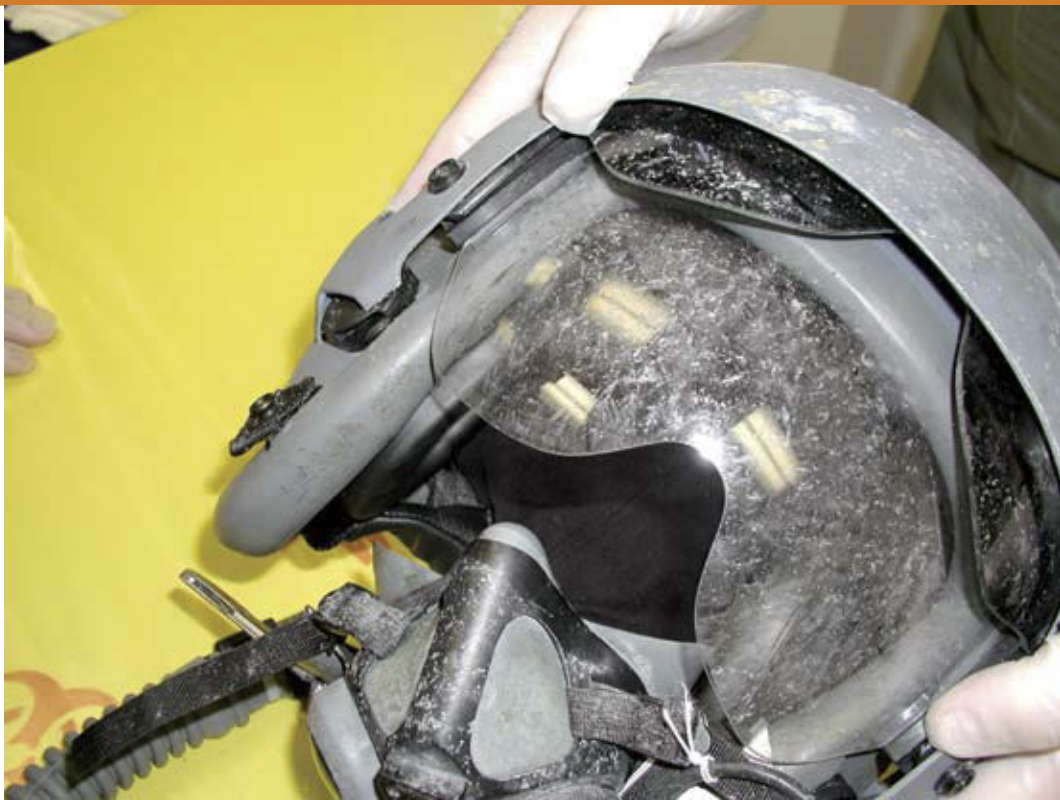
Figure 4. Helmet, visor and mask damage due to MDC and canopy material

Both pilots suffered burns from contact with molten MDC material during the ejection. Both helmets and visors showed signs of pitting, scratches and residue deposits (figure 4). As well, the blast cover of one Beaufort Mk30LC LPSV was perforated rendering the floatation bladder, stored within the carrier, unserviceable. The investigation

revealed that the punctures in the bladder were due to sharp canopy fragments impact during the ejection. This truly brings home the importance of wearing dual layered flying clothing, and to properly use the helmet-visor-mask ensemble for maximum protection. The Aerospace Engineering Test Establishment (AETE) escape systems (ES) team is currently evaluating a replacement solution in order to increase the resistance to perforation of the LPSV.

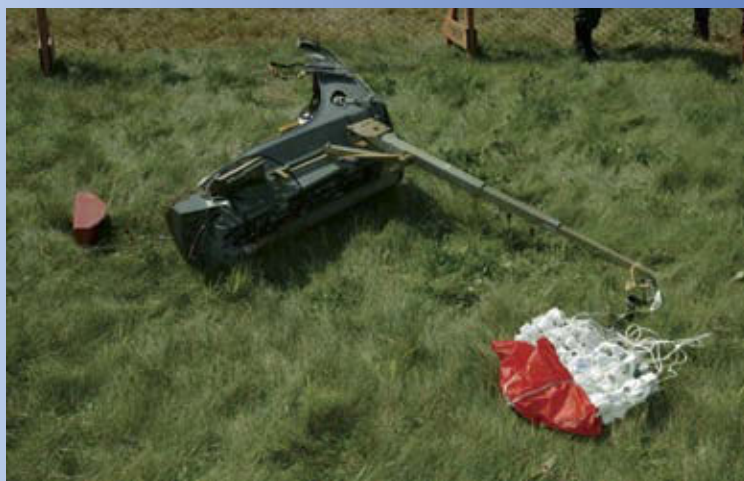
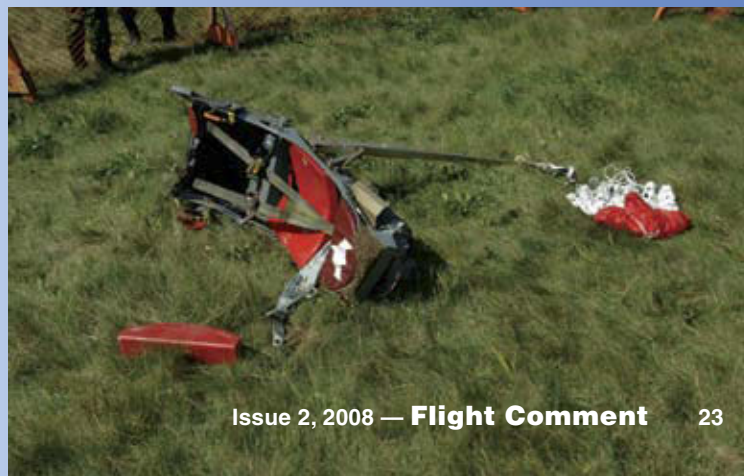
CT114 Tutor, 114120, August 24th, 2005

Following the ejection sequence, the pilot realised that his Seat Pack Survival Kit, including the contents, were no longer attached to his life preserver/universal carrier (LP/UC). Thus, the pilot was deprived of his survival kit after landing. The seat pack survival kit, once deployed by the pilot after the ejection, is suspended under the pilot by the maritime lanyard, which in turn is attached to the LP/UC by a stitching patch. The investigation revealed that the stitching had failed, and did not conform to applicable orders. In all, out of 35 LP/UC deemed ready to use, 25 were found defective.

An examination of the pilot's parachute revealed that the cone plate had partially separated due to a previous repair that was not done

IAW the technical orders. This was determined to be an isolated incident.

Investigation of the pilots' helmet revealed that the dark visor did not match the oxygen mask. This in turn creates a gap between the mask and visor, which may result in injuries during ejection. Also, the helmet was found to have 12 coats of paint on it, versus the normal 5 coats. Although seemingly a minor deficiency, this can add to the weight of the helmet, which may contribute to neck injuries under heavy G loading.
