Flight Comment

ISSUE 1, 2020

VIEWS ON FLIGHT SAFETY

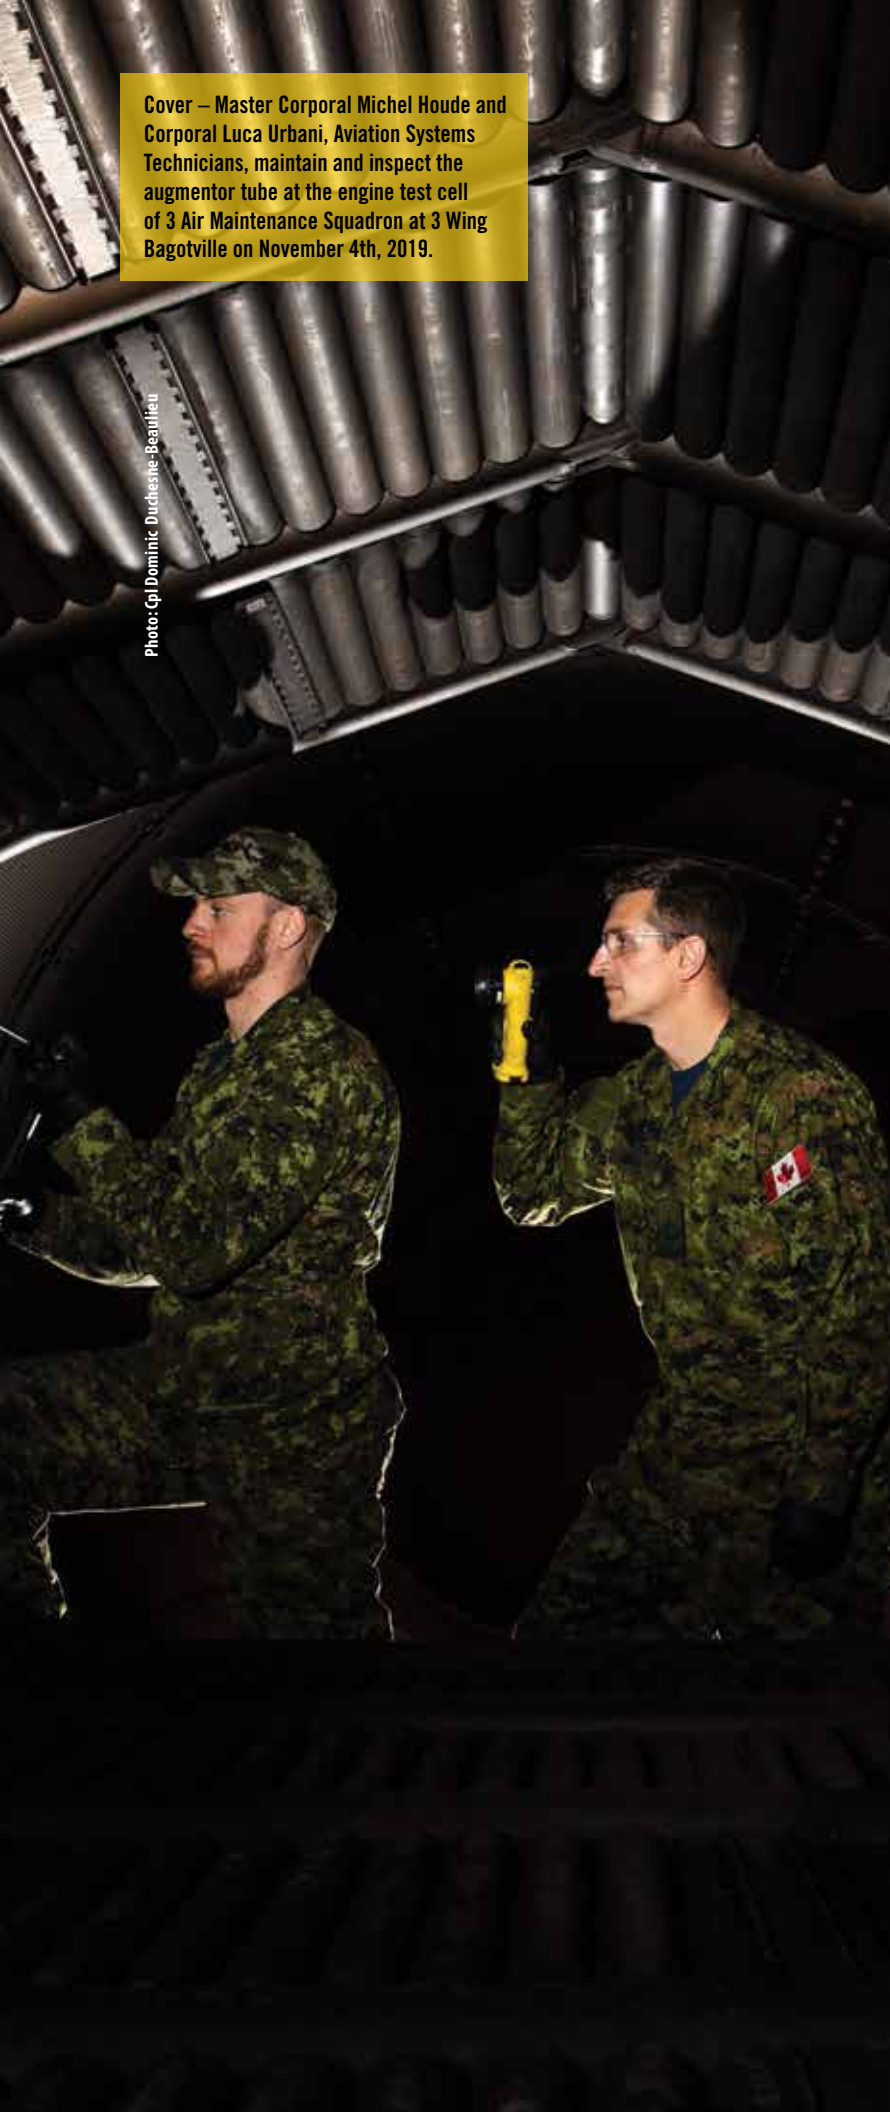
Cover – Master Corporal Michel Houde and Corporal Luca Urbani, Aviation Systems Technicians, maintain and inspect the augmentor tube at the engine test cell of 3 Air Maintenance Squadron at 3 Wing Bagotville on November 4th, 2019.

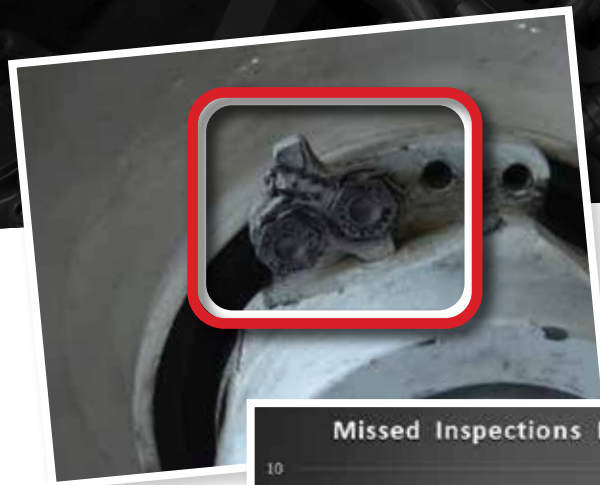
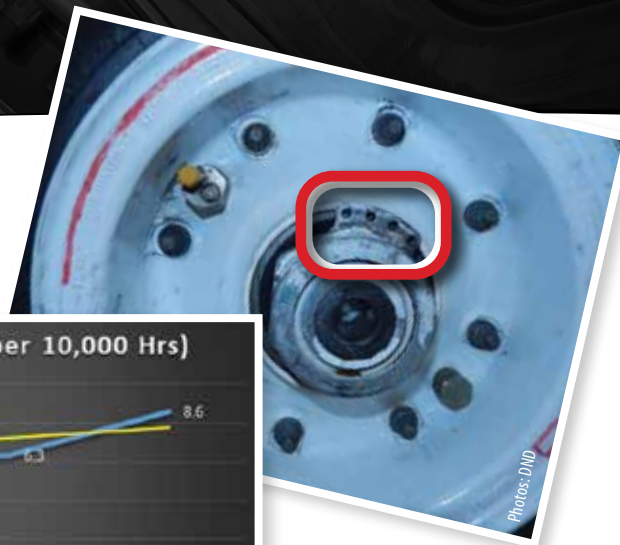
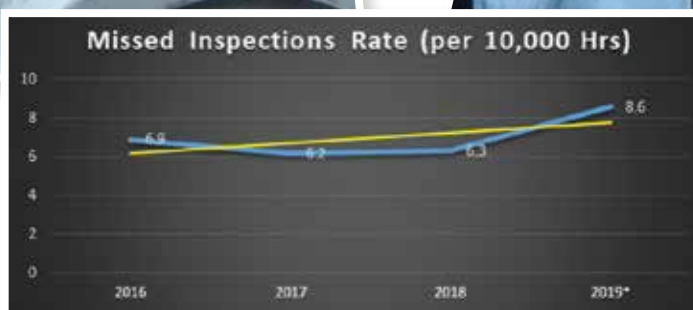
For the analysis step, we planned a holistic view of the RCAF from 1 Jan 2016 to 31 Oct 2019. We first established a missed inspection occurrence rate by normalizing the data per 10,000 Flying Hours and then broke down the percentage of missed inspection types and

portrayed the results in a pie graph. Next, we created a bar graph depicting the total number of missed inspections per fleet and then we began the Fleet Drill Down step. The overall national increase seemed to be distributed evenly amongst all the fleets (6.3% to 8.6% from 2018 to 2019, see graphic). We also found that the increase identified in one specific fleet was not causal to the national increase. In all, we were able to confirm that no single fleet was responsible for the overall national increase in missed inspections.

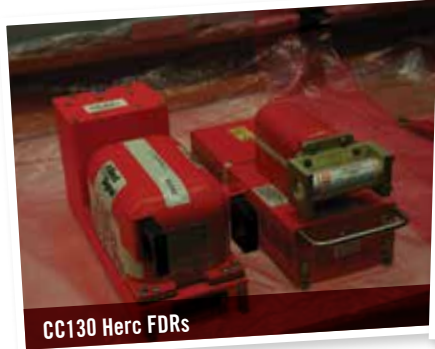
CC130 Herc FDRs

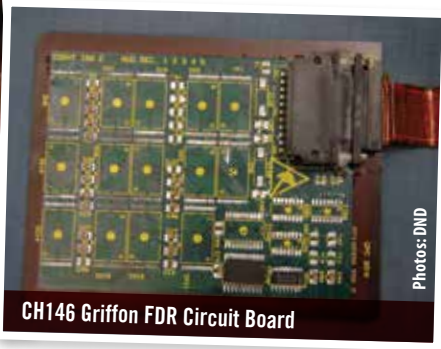
CH146 Griffon FDR Circuit Board

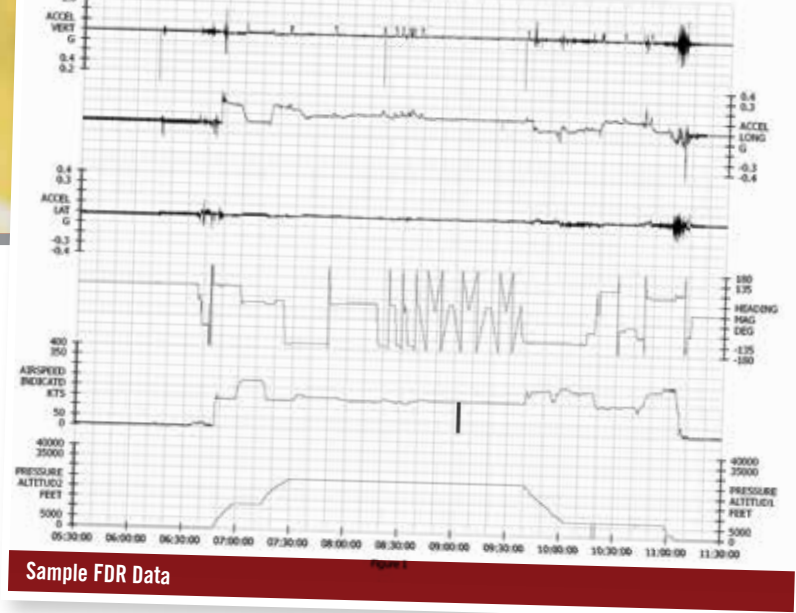
Sample FDR Data

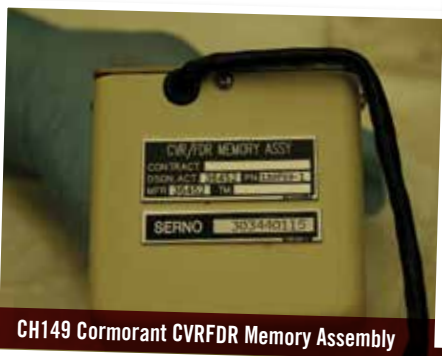
CH149 Cormorant CVR/FDR Memory Assembly

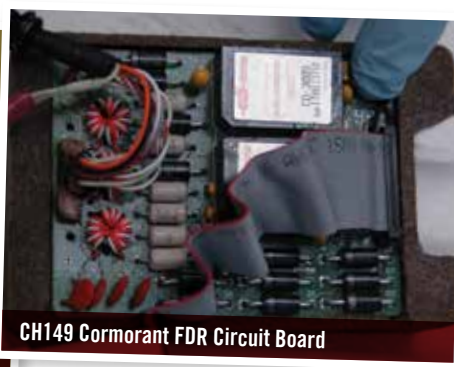
CH149 Cormorant FDR Circuit Board

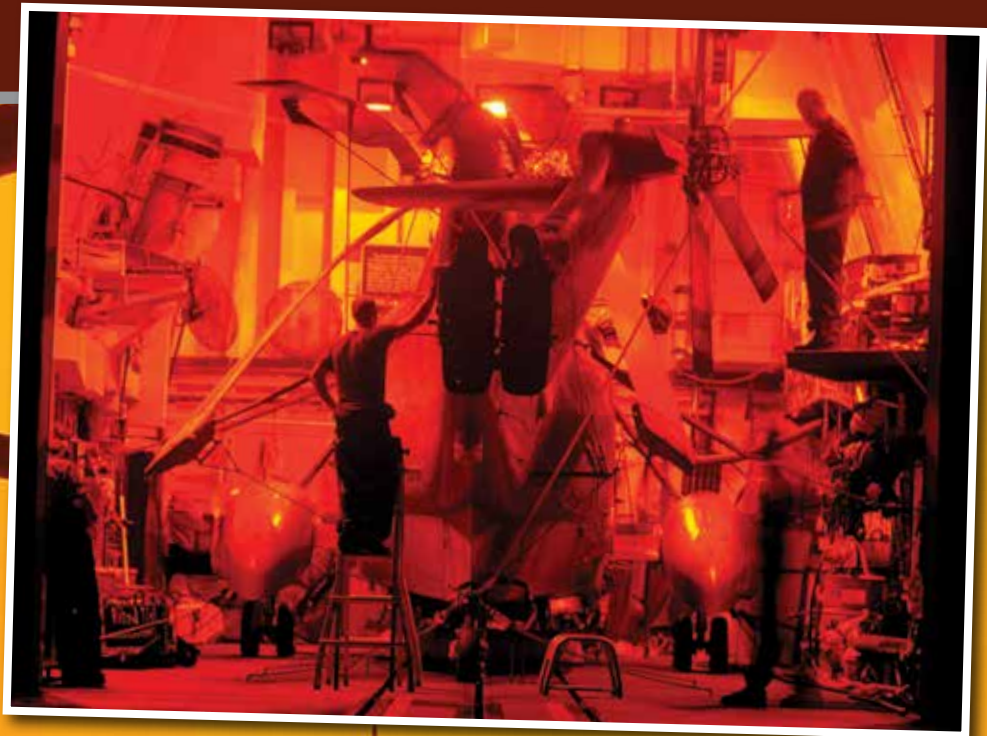
Not thinking too much of this at first, I conducted the rest of my check. Everything looked normal and the fluids were within range. I went to the opposite side of the helicopter and was in a better position to see where the fluids were potentially coming from. Looking around, there was no real evidence of a leak but, to be sure, I began physically grabbing the lines. After confirming a few lines were secure, I grabbed the pressure line that came off of the primary hydraulic pump. Without any strength, I had no problem pulling the fitting out and

discovered that the actual threads of the fitting had been completely stripped. This was not good. Even though there was a back-up hydraulic system, flying without the primary hydraulic system was considered an emergency situation.

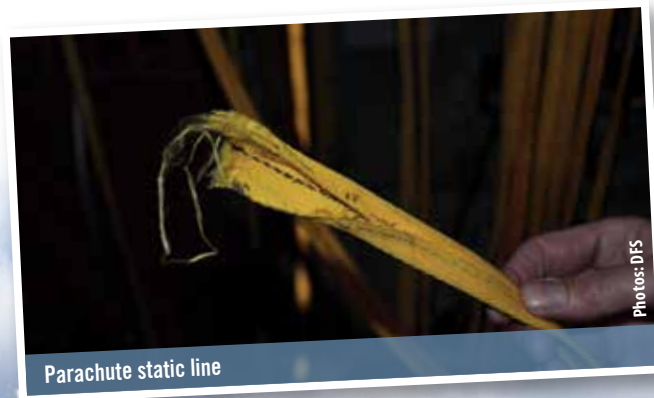
Parachute static line

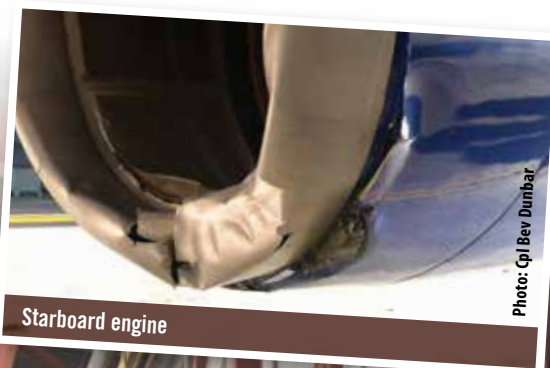
Starboard engine
