ISSUE 2, 2020

Flight Comment

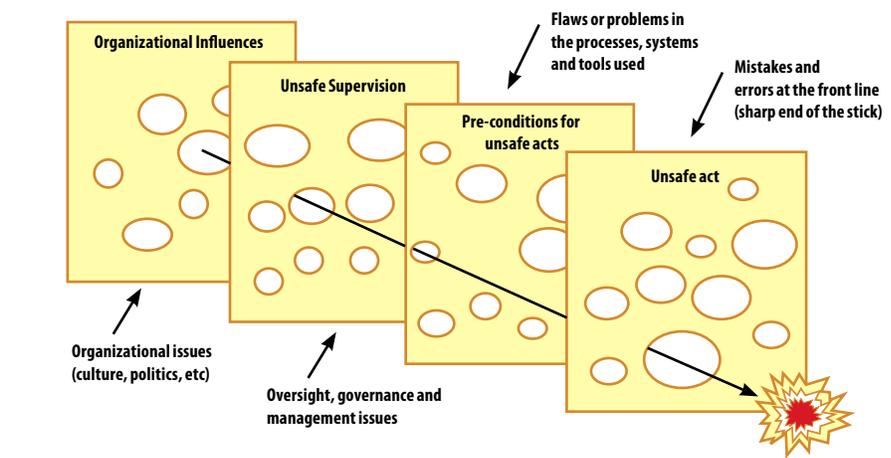
Swiss Cheese Model – James Reason

In Flight Safety, one often hears of James Reason's Swiss Cheese model in regards to human factors and accident causation where "an organization's defences against failure are modelled as a series of barriers, represented as slices of the cheese. The holes in the cheese slices represent individual weaknesses in individual parts of the system, and are continually varying in size and position in all slices. The system as a whole produces failures when holes in all of the slices momentarily align, permitting "a trajectory of accident opportunity", so that a hazard passes through holes in all of the defences, leading to an accident."¹

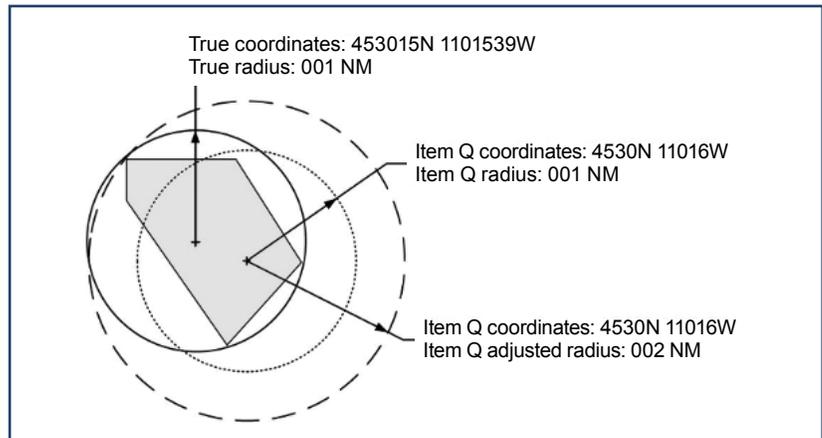
Figure 2. In the following example, the NOTAM area is represented by the smaller and darker shape. The true coordinates are rounded down resulting in the centre point displacement (smaller dotted circle). If the radius of Item Q remained 001 (1 NM), the NOTAM briefing would not contain the NOTAM. Therefore, the radius is adjusted to 002 (2 NM).⁵ Image courtesy of NAV CANADA.

So how does CFPS search for NOTAMs? First, the user is directed to a search bar where the search criteria is 'georeferenced', effectively meaning you can use: Aerodromes, FIRs, NAVAIDs, Intersections, Cameras, Upper Wind measuring site or a name in plain language² to search for your desired info. Following that, NOTAMs are retrieved based on your search criteria (flight path, point and desired radius) and how CFPS is programmed in 'layers' and 'georeferencing' of objects and areas. For example, how a NOTAM author enters in the georeferenced point (NOTE: CFPS does not use 'seconds') and selects the radius of the activity determines if a NOTAM will intersect with your flight path or not. Further, although discrete 'bounded' areas may be described in the NOTAM; CFPS only uses a 'radius logic' for determining if a NOTAM should be included in a search or not (see Figure 2).

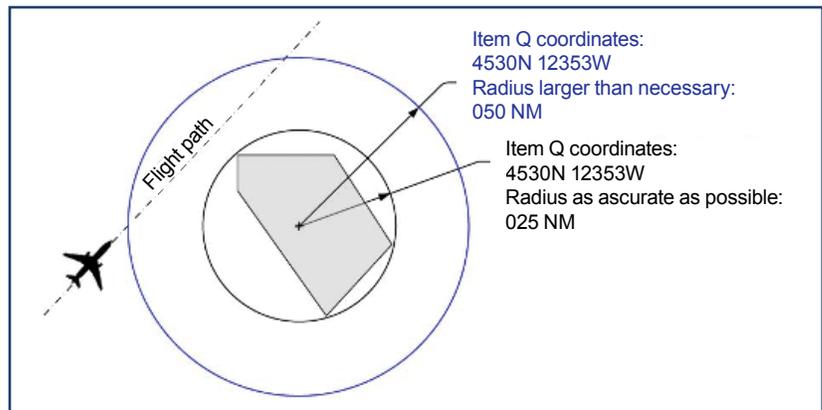
Figure 3. If a NOTAM author programs too large a radius then non-pertinent NOTAMs may be retrieved.⁶ Image courtesy of NAV CANADA.

This is important according to NAV CANADA's direction to NOTAM authors – it is essential that the radius is neither too large nor too small to encompass the concerned area. Too large and the NOTAM will be retrieved for flight paths that should not be concerned with it, too small and flight crew might infract airspace without being aware (see Figure 3).

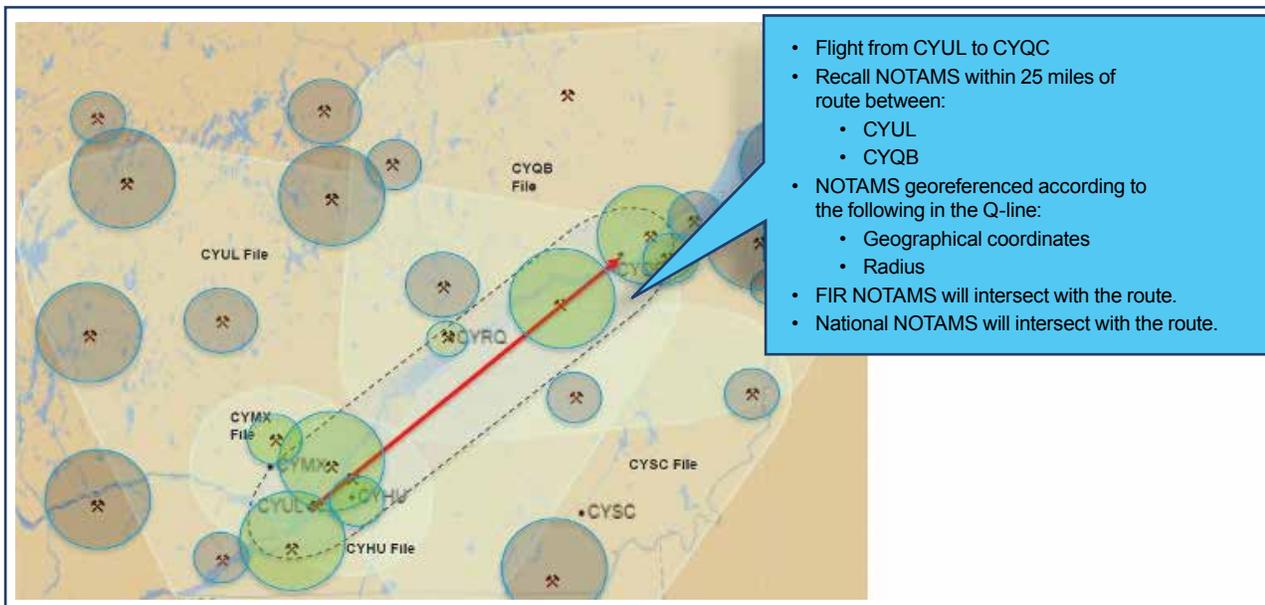
- Flight from CYUL to CYQC
- Recall NOTAMS within 25 miles of route between:
 - CYUL
 - CYQB
- NOTAMS georeferenced according to the following in the Q-line:
 - Geographical coordinates
 - Radius
- FIR NOTAMS will intersect with the route.
- National NOTAMS will intersect with the route.

Figure 4. An example of how CFPS retrieves NOTAMs based on its programming and your search criteria. The little 'tool' icon displays a 'georeferenced' point – it's not the topographic symbol for a mine.

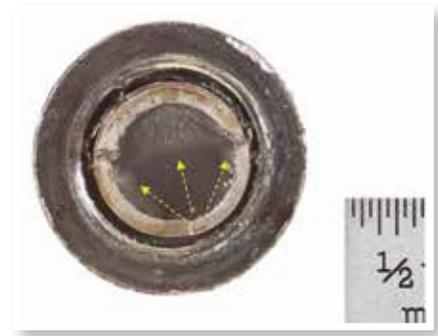
Figure 1. The fracture surface of a failed Rosan stud from position 9 displaying flow lines. The yellow arrows indicate the direction of the flow lines. (QETE Project A021812)

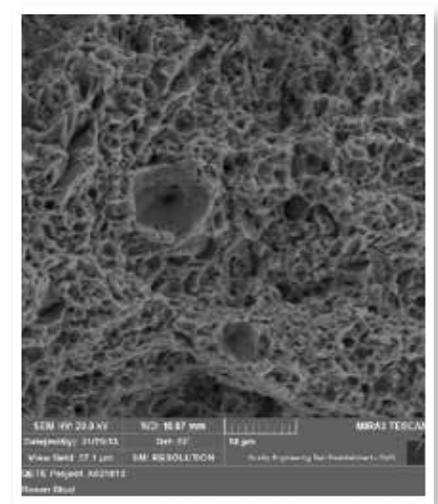
Figure 2. An SEM micrograph showing ductile dimples which are characteristic of overload. (QETE Project A021812)
