National
Defence

Flight Comment

ISSUE 2, 2022

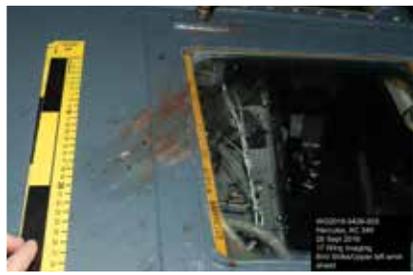
Birdstrike Good

Photo is well exposed, and any glare has been eliminated. You can see all the details of the area of impact, and a ruler was used to show to scale. A perfect example of how to capture a detailed picture while avoiding glare from either the sun or an external light source.

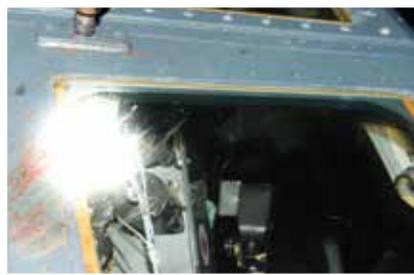
Birdstrike Bad

Photo is cropped in too tight, so not all damage is visible. There is also terrible glare in the photo, either from the sun or an external light source that is obscuring the damage, and there is no ruler to show scale. Overall an unusable photo.

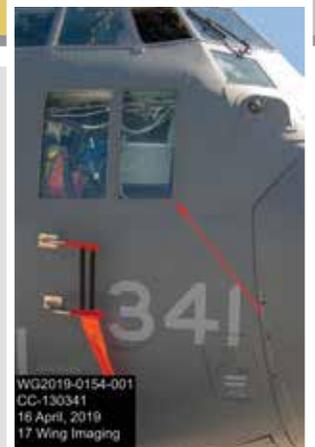
Cracked Glass Bad

Photo is underexposed, which causes a lack of details to be visible. Even though it was shot outside, it was in a shadowed area and would have benefited from some external light, even from just a flashlight. The crop is also too tight, resulting in the aircraft tail number being cut off. While the crop being crooked is not a showstopper, do aim to have a properly aligned horizon in your shots as it can be disorienting to the viewer, and takes away from what you are trying to show.

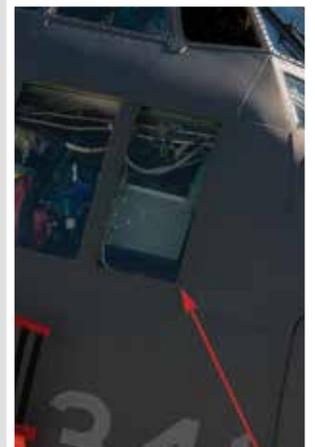
FOD Found Bad

The area was not lit with an external light source, resulting in an underexposed photo that doesn't provide a lot of details. The crop is too tight as well, making it very difficult to get an idea of where on the aircraft the FOD was found. When taking the photo remember, you know your aircraft well, but others viewing your pictures may not be familiar with it, so make sure to include as many details as possible to help tell your story.

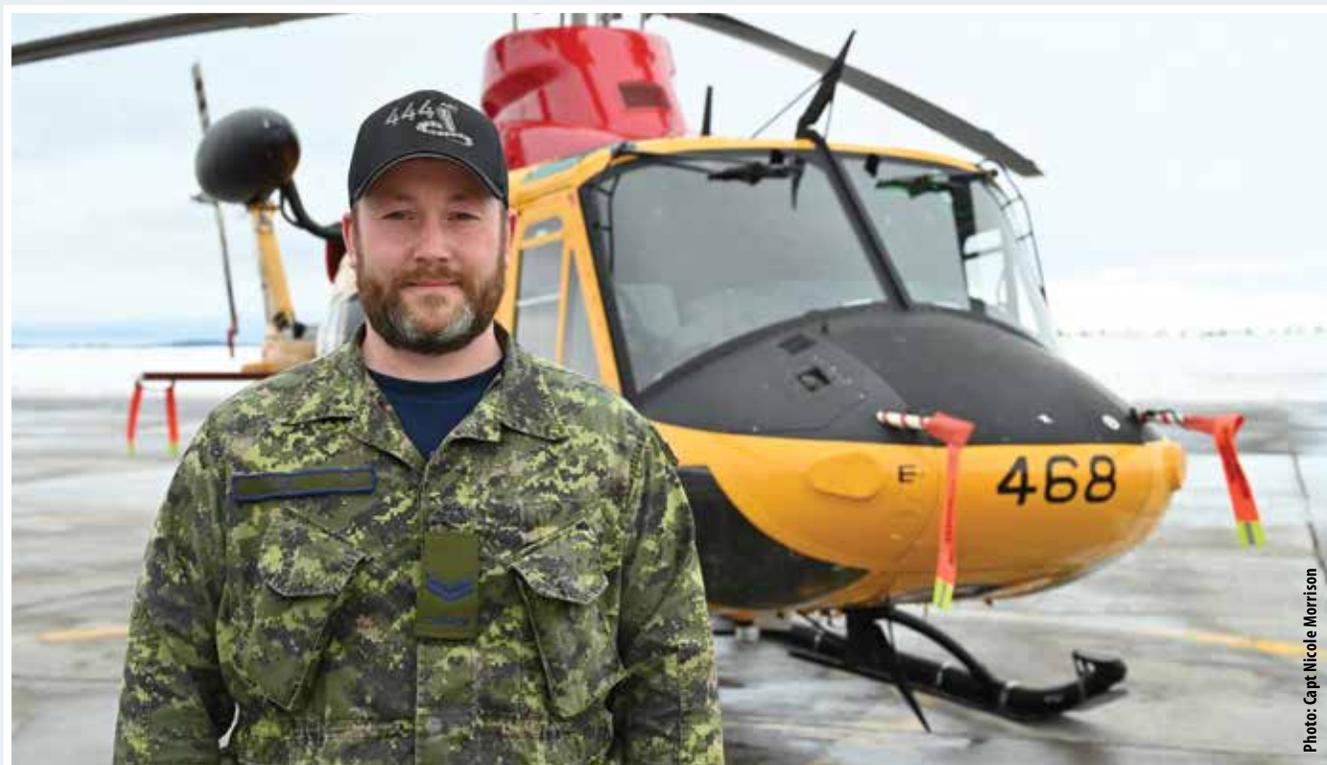
On the morning of 19 Nov 2021, while performing a 25 Hour/30 Day inspection on a CH-146 Griffon at 444 Squadron, Goose Bay, Cpl Ryan Shea discovered a Hydraulic line coming from the #2 system pump case rubbing against the aircraft's left-hand beam assembly. Flight Safety was contacted, appropriate steps taken, line removed, and damage inspected. However, Cpl Shea didn't stop there; he then informed the UFSNCM that he recently adjusted one of those lines on a different aircraft. The Hydraulic

line was rubbing against a panel, which attached to the main structure of the aircraft. The line had chafed well beyond its limit. Failure of this line would have depleted hydraulic system 2 causing a "LAND AS SOON AS POSSIBLE" emergency in a remote area at below-freezing temperatures. The damage sustained required a maintenance repair party from another unit. While discussing the issue with a member, it was discovered that 400 Squadron had the same issue on one of their aircraft which was undergoing maintenance.

This, combined with Cpl Shea's previous experience, revealed a possible systematic issue. DFS and Bell Helicopters recommended a fleet-wide Special Inspection which is still pending.

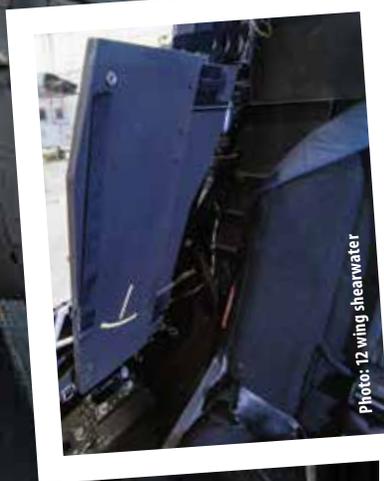
During my time as a CH148 Cyclone pilot at 12 Wing, I noticed on several occasions that when flying from the left seat without the Slim Line Backpack (SLBP), an ALSE requirement for overwater flight, the cockpit wing armour would press against my left arm (the one moving the collective for those non-rotary folks), particularly when in the hover. I never thought of it beyond a nuisance and added it to the list of annoying things about the cockpit. Furthermore, this aircraft was cleared to fly so this nuisance must have already been addressed. It wasn't until I returned to flying the CH148, as a Test Pilot for AETE, that I realized my mistake.

I had forgotten about this "nuisance" and was reminded during a proficiency flight prior to some testing in Shearwater. The moment I felt that wing armour press into my arm my test pilot mind kicked into gear. Using an aircraft in the hangar on ground power, I conducted a quick "reach and accommodation test" for various ALSE configurations. What I found shocked me; I could only get adequate collective travel through the first 50% of the collective range when seated without the SLBP. My arm would get sandwiched between the stowed wing armour and the outer edge of the seat back. In most cases Cyclone pilots don't need to use more than 50% collective, but what would happen when you needed it? (Think autorotation or a poorly controlled approach.) For the previous two years, 12 Wing pilots had been flying like this on overland missions.

I filed a Hazard Report through 12 Wing Flight Safety (FS) to make sure this issue would get addressed quickly. The wing armour was removed and is only used when operationally required. The wing armour installation is now being looked at in more detail to provide a safe solution which will allow pilots to fly without the SLBP.
