Flight Comment

Issue 2, 2023

NEW! FLIGHT SAFETY APP

RIME SALT

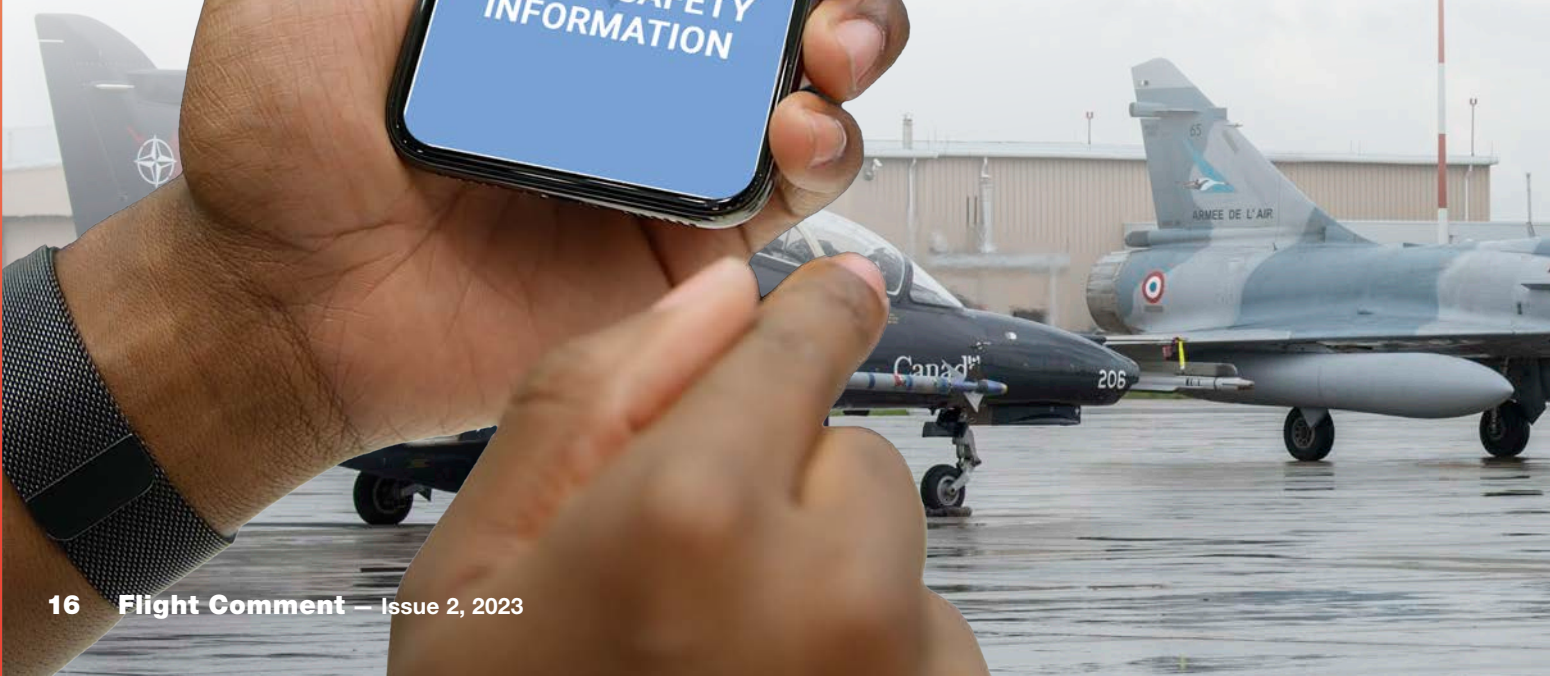
Picture this: a user-friendly interface with two primary zones. The red zone is your Flight Safety reporting hub, while the blue zone is all about Flight Safety information and promotion. For our French-speaking friends, language selection is just a tap away in the top right-hand menu. You'll also find contact info and a nifty QR code share option in the top-right corner.

But let's soar deeper into the app's cockpit. Reporting an occurrence is as easy as flipping a switch. Just hit the "Flight Safety Reporting" tab, and you're brought to the Occurrence or Hazard report section. Fill in the details, and just hit submit! When you're ready to return to base (the main page), click on the logo in the top-left corner.

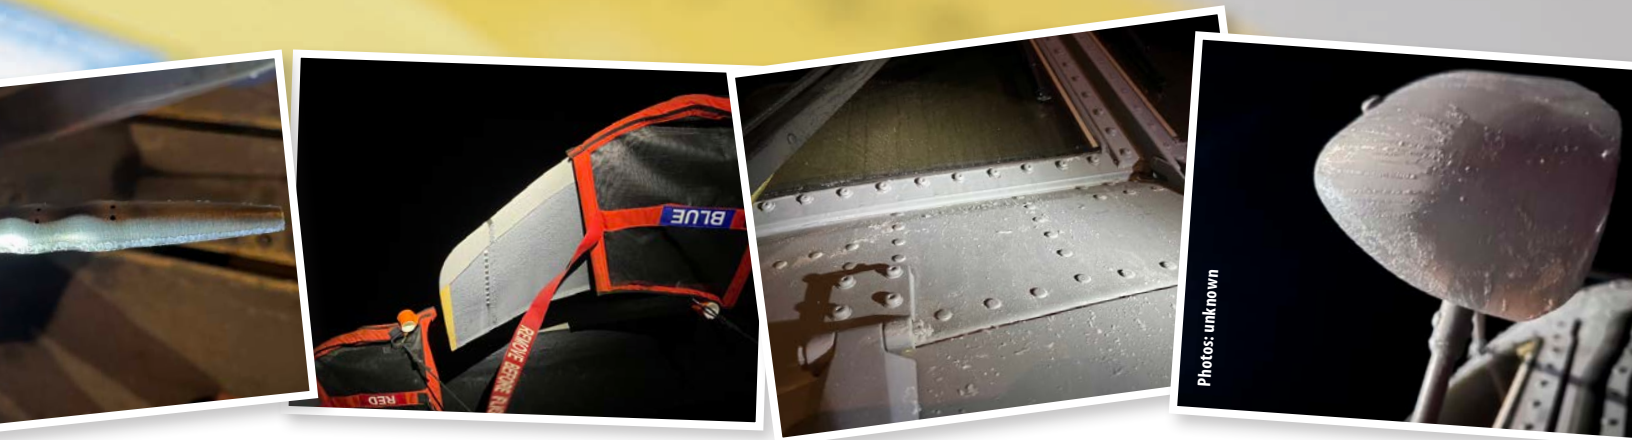
The crew of the third sortie proceeded to the dip with a calculated Hover Out of Ground Effect (HOGE) power required of approximately 98%. This number did not take wind into account, and we knew there was around 5–10 knots of wind, so we anticipated that our WATTS checks would indicate similar performance figures to the previous sorties, likely around 95% torque. We marked dip and found ourselves hovering at 104–106% torque, our maximum continuous torque is 113% while below 90 KIAS (knots indicated airspeed). This was a much tighter margin than we expected, making the situation slightly unpleasant. It was made even more uncomfortable because that particular trip was at night, so visibility was dramatically reduced. The pilots remarked that the high value was abnormal but could not immediately develop a reason why it should be so much higher aside from a possible decrease in wind speed as the evening progressed.

On this particular day during Exercise DYNAMIC MANTA, each PHOENIX sortie was spending between 1.5 to 2 hours of their 2.5-hour trip in the dip. By the end of the third sortie, the helicopter had been hovering at 80 feet above the water for almost five hours in total. During the first flight, we saw performance numbers well within the expected range. The crew of the second sortie noted slightly higher numbers, but logically assumed it was due to a decrease in wind. When the third sortie launched, the crew found the numbers to be higher still.

We continued with our support of the CASEX and did extensive dipping during that third trip. We noted our fuel flow and TGT to be higher than usual, though corresponding with the high torque values. By conducting our routine WATTS checks, we are alert to potential losses of power due to salt water being ingested into the engines. A few members of our HELAIRDET remember conducting routine WATTS checks from our previous CH124 Sea King experience and are attuned to the risk dipping poses in terms of salt encrustation on turbine engine stator vanes. Indeed, the process of post-flight engine rinses used in the Sea King has continued in the Cyclone era to ensure engine performance is maintained during ASW operations.

In any case, we continued with the dipping operations and throughout the final trip noted only a slight decrease in power, with values close to 96% torque in the final dip. We then returned to our ship for landing and noted similarly high torque values throughout the transit. The Aircraft Captain considered requesting an engine wash (beyond the routine engine rinse), but the symptoms we encountered did not seem to correlate with decreased efficiency within the engines themselves.

The crew theorized that due to the low winds of the day, the helicopter rotor wash was not being pushed aft of the helicopter, but rather was just being recirculated up and around the helicopter continuously. Due to the extent of dipping throughout the three sorties, this gave extensive opportunities for the salt to build up and degrade the efficiency of the rotor blades. Perhaps the increased salinity of the Mediterranean Sea compared to the Atlantic Ocean was a contributing factor as well. One pilot on the HELAIRDET astutely noted that if salt water in the engines were the only consideration, there would be no corresponding increase in torque as the salt buildup continued after multiple dips, only an increase in TGT. So, it made sense that salt buildup on the control surfaces was the more significant factor here. In retrospect it seems obvious, but we had never experienced nor heard of such a phenomenon.

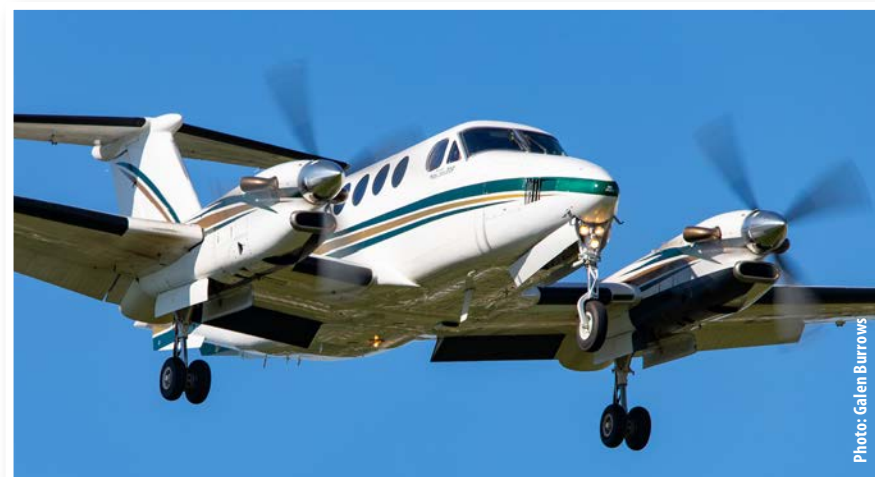
Photo: Galen Burrows

Approximately two miles back from the runway and with the airport visual, the pilot elected to continue the remainder of the approach manually and disconnected the autopilot. As the aircraft crossed over the runway threshold with a height above ground of approximately 50 ft, the pilot flying moved both power levers to idle with the intent of landing.

A left yaw quickly developed followed by a rapid drop of the left wing. The pilot monitoring the approach took control and initiated an overshoot, however the left wing tip contacted the runway surface and the aircraft progressed

uncontrolled into the snow-covered infield. Once the aircraft came to rest, the three crewmembers egressed the aircraft.

The aircraft sustained very serious damage and the pilot flying suffered a minor injury, while the other crewmembers were not injured.

The investigation determined that the aircraft was documented serviceable prior to the flight and that no issues were evident to the crew before the power levers were brought to idle. Post-accident analysis of the recovered aircraft

flight data and componentry determined that a part within the propeller speed governing system failed to function nominally, specifically the beta valve or the beta solenoid. This led to the left-hand propeller windmilling, which was the most likely cause of the accident. Since the beta valve was damaged and internal parts lost during the accident sequence, a definitive determination of its serviceability could not be conducted. ❖

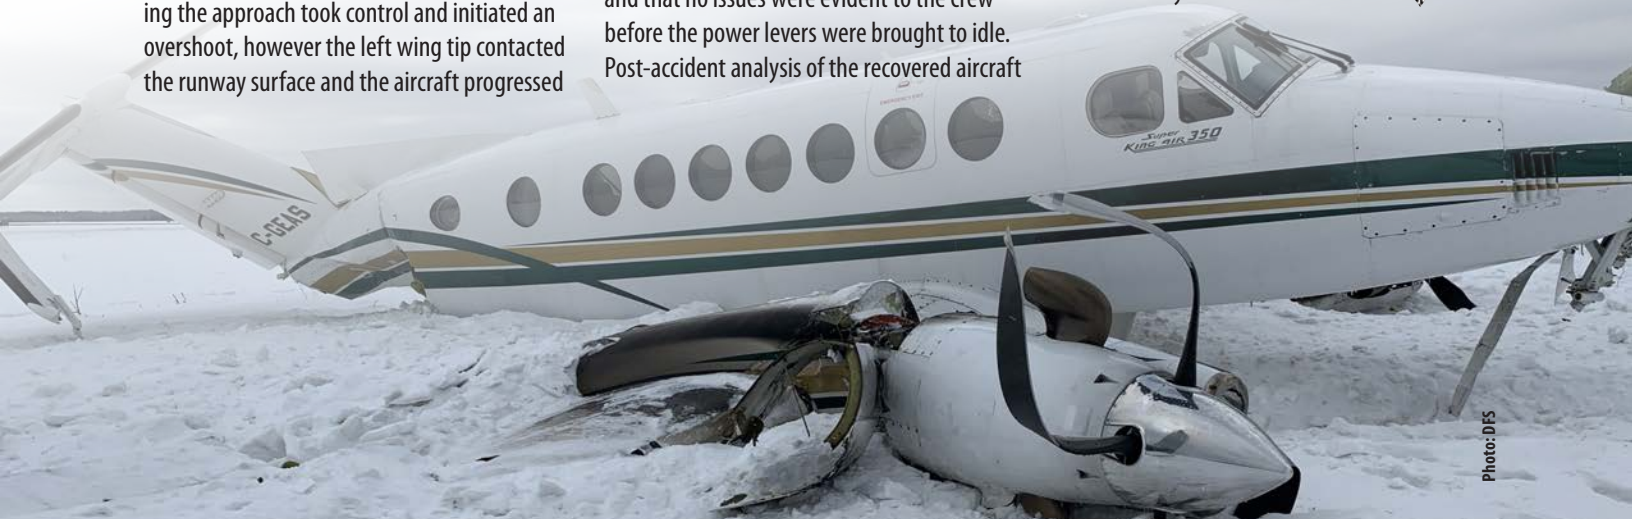
Photo: DFS

Epilogue

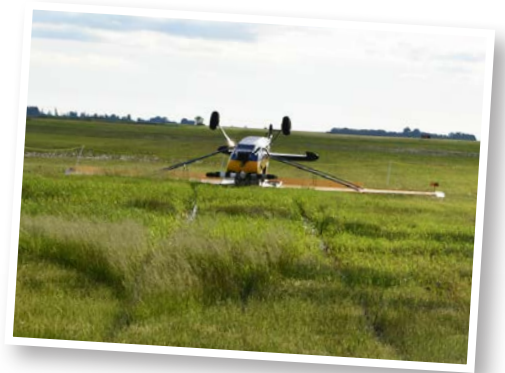
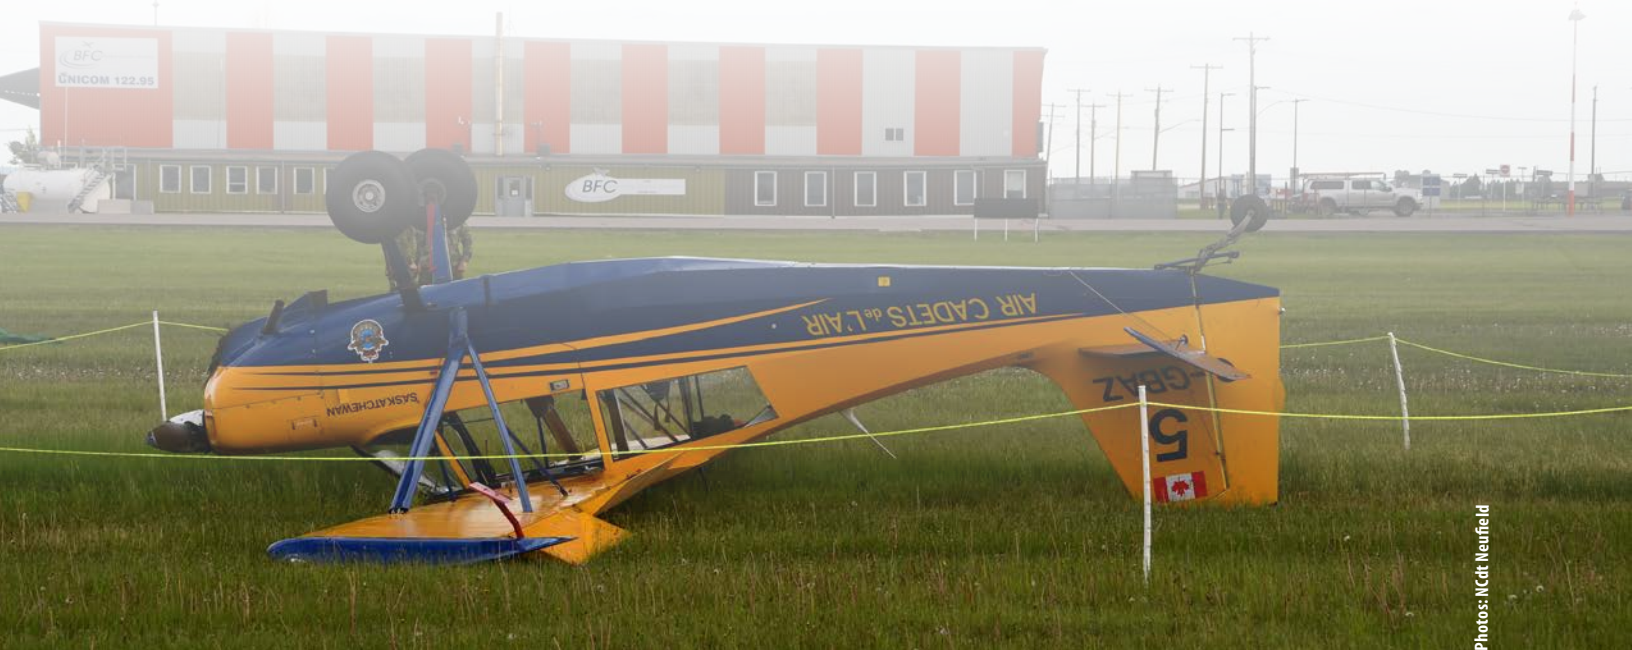
Photos: NCdt Neufeld

The aircraft sustained very serious damage. The pilot and passenger were not injured.

The investigation did not reveal any evidence of technical issues with the aircraft and focused on human factors. Due to an inadequate inspection of the proposed operational area, and relative obscurity of the visual cues that may have indicated the potential water hazard, the pilot was unaware of the existence of the water, and its depth, prior to landing. Given the speed on landing, combined with the hydrodynamic forces of the water acting on the forward landing gear, once contact with the water was made the roll-over became inevitable.

The preventive measures recommended include modifications to the published inspection procedures and criteria as well as initial and routine training on recognition of visual cues that may indicate potential hazards for all personnel within the Cadet Training Program. 🚩

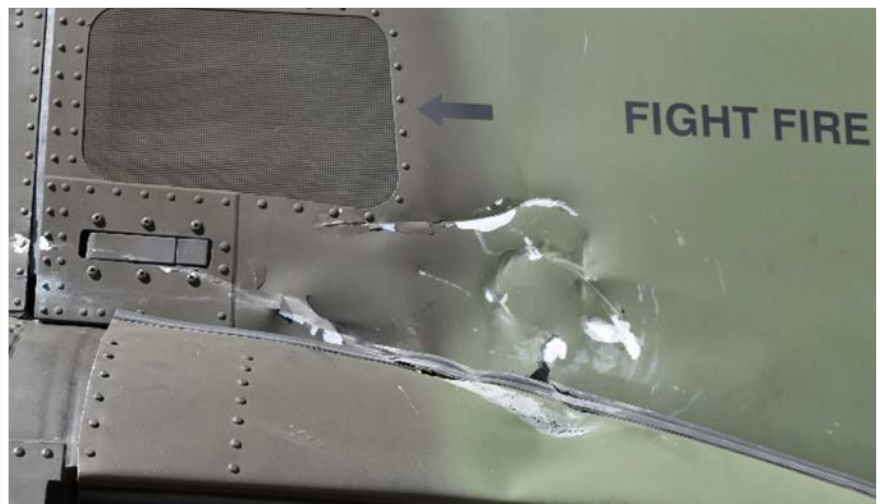
The formation involved aircraft CH146449 (*Gander 21*) and CH146495 (*Gander 22*), with *Gander 21* in the lead for the first portion of the mission. After a planned lead change *Gander 22* took the lead for the second half of the tactical low-level navigation. It was during that portion of the mission that *Gander 22* struck a distribution power line when the aircraft was flown in a gap in the trees above a road crossing. The wire strike occurred approximately 67 km northeast of the Edmonton Namao aerodrome, across Township Road 190.

After the wire strike *Gander 22* did not land but continued flying to the troop extraction point Redwater, after which the formation split. *Gander 22* returned to Edmonton Namao airport without further incident.

The aircraft sustained serious damage and there were no injuries. The severed live wire started a small grass fire that was extinguished by the Smokey Lake Fire Department. Eighteen homes lost power for approximately four hours before repairs were completed.

The investigation determined that due to distraction from unrelated discussions in the

cockpit, the crew was in a relaxed state and reduced their vigilance to the low-level environment obstacle threats. It was found that cultural aspects at the unit led to crew decisions which ignored published procedures.

Recommendations include changes to procedures as well as further training in Human Performance in Military Aviation. 🦋
