National
Defence

ISSUE 2, 2025

Flight Comment

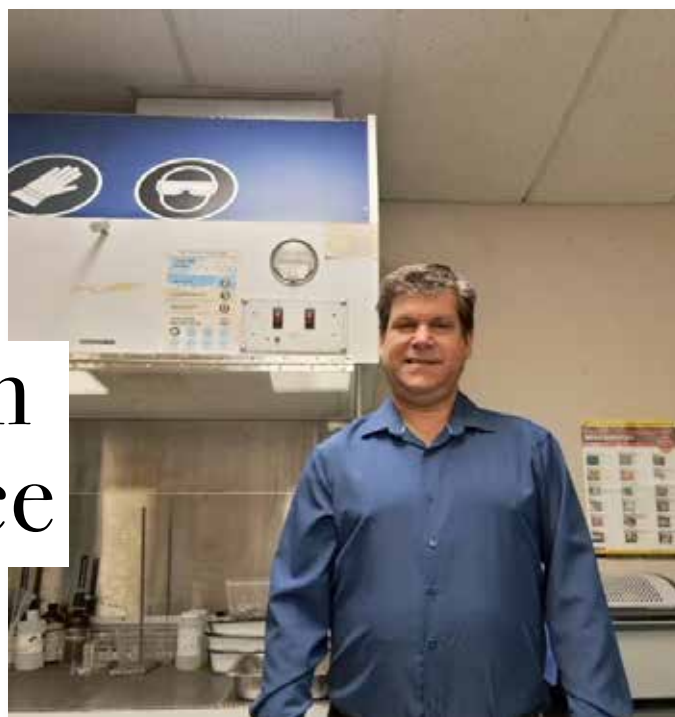
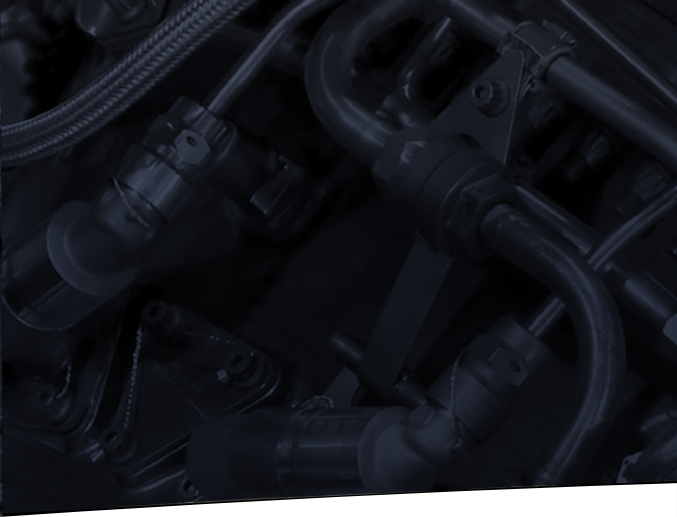
ultraviolet fluorescence, and scanning electron microscopy, he analyzes fluid cleanliness during failure and accident investigations. "By examining the particles' size, shape, and surface features, we can learn about the contaminant, help shed light on what's happening inside the system and address potential performance issues," Stephen explains.

A key part of Filter Debris Analysis is differentiating between two types of contamination: **wear debris** (from mechanical actions within the system) and **environmental contaminants** (from external sources). Wear debris such as metal particles from bearings or sliding wear particles from sliding surfaces (Figure 1) may indicate potential degradation within the system, while environmental contaminants, like synthetic fibers or insects, may obstruct filters or valves. Environmental contamination in the form of sand grains may cause abrasion of fluid wetted systems, especially hydraulic systems.

"Walnut shell blasting media is an abrasive material made from crushed walnut shells. It's often used for cleaning out aircraft exteriors," Stephen explains. "Once I found out the client had used this material around the same time the contamination was observed, I replicated

the walnut shell blasting media production process using a coffee grinder to grind walnut shells. I isolated the particle size range to replicate the product the client had using sieves. Then, I compared the particles to those found in the system (Figure 2)," he added.

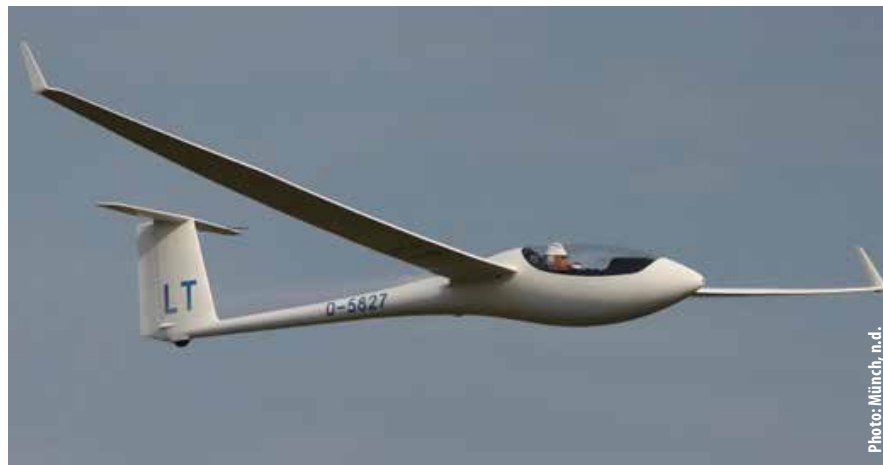
Figure 1. Schleicher ASW 27 glider

Conflictions with gliders and power-driven VFR and IFR aircraft are not a new phenomenon. On August 28, 2006, N879QS – a Hawker 800XP on descent near Reno, Nevada – collided with a Schleicher ASW 27 glider, as seen in Figure 1/ Figure 2, at approximately 16,000 feet above sea level. According to the National Transportation Safety Board (NTSB) report (Charnon, 2008), "...damage sustained by the Hawker disabled one engine and other systems; however, the flight crew was able to land the airplane" (p. 1). The NTSB's findings indicated that the closure rate between the aircraft rendered collision avoidance as improbable, if not impossible once the conflict became apparent.

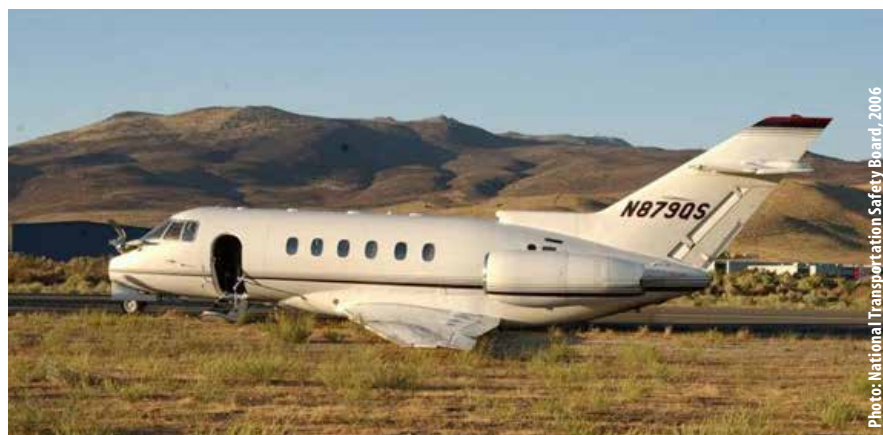
Figure 2. Hawker 800XP N879QS following a mid-air collision with glider

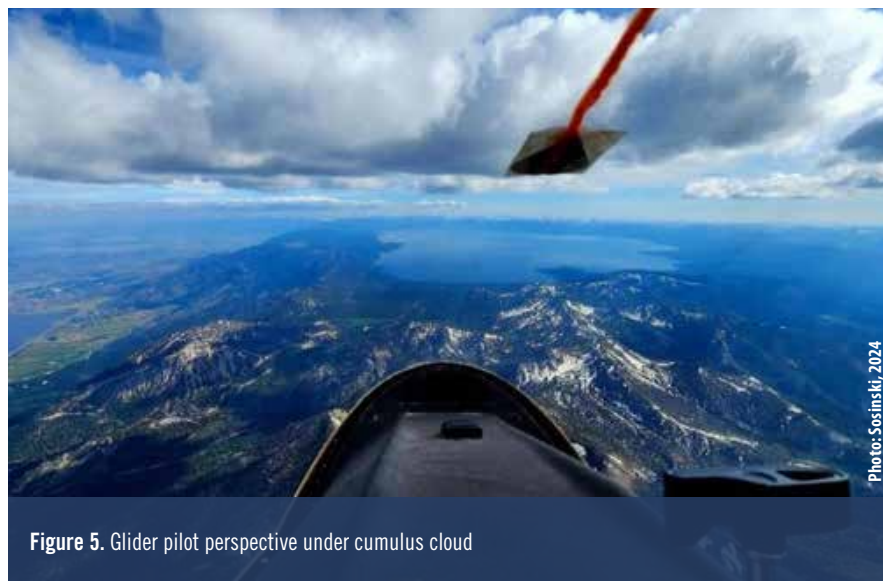
Figure 5. Glider pilot perspective under cumulus cloud

As such, consider the scenario of an IFR aircrew during arrival and approach phases of flight, descending through a small area of Class E airspace on an ATC clearance, prior to transitioning into a terminal control area or control zone. During this time, this crew may face heightened cognitive workloads and competing priorities – covering distances upwards of four nautical miles per minute, or greater – transitioning between VMC and IMC through scattered or broken clouds, such as depicted in Figure 5. In a multicrew environment, workload factors for the pilot monitoring include direct controller-pilot communications, and other “heads down” duties, requiring significant crew resource management skills to maintain SA.
