CRASH COMMENT

JANUARY FEBRUARY MARCH 1950

ISSUED BY
ACCIDENT INVESTIGATION BRANCH
R.C.A.F. HEADQUARTERS OTTAWA ONT

ACCIDENT RESUMÉ

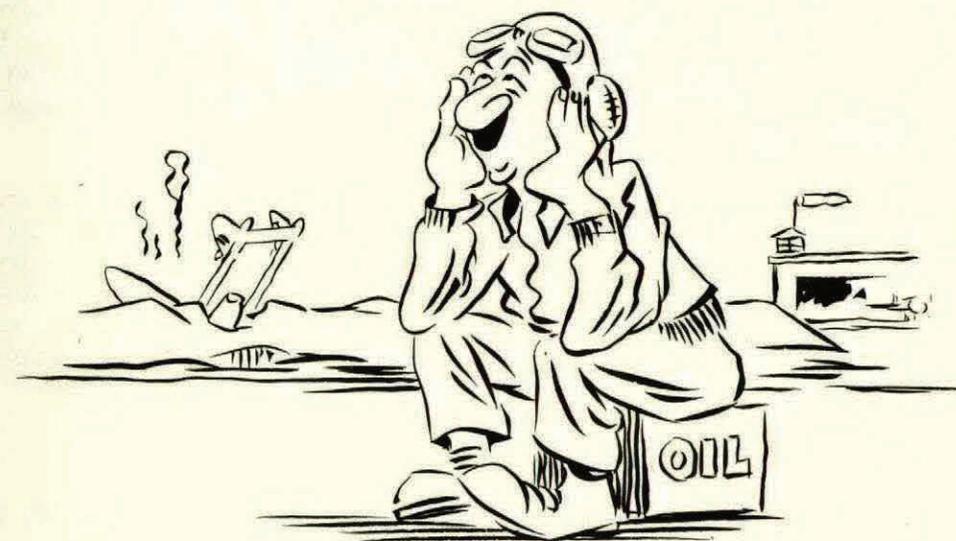
EXPEDITOR

The captain, an experienced instrument pilot, attempted a combination visual (head out window) and instrument take-off in moderate snow conditions. He failed to maintain directional control and allowed the aircraft to run off the edge of the runway into snow in which it subsequently overturned.

It is interesting to note that, according to the weather sequences, six minutes before the attempted take-off of the Expeditor the visibility was below the limits laid down for that particular airport. Although the visibility may have momentarily increased, to at or above limits, the pilot's judgement in commencing a take-off in such conditions is certainly open to censure. His method was equally questionable.

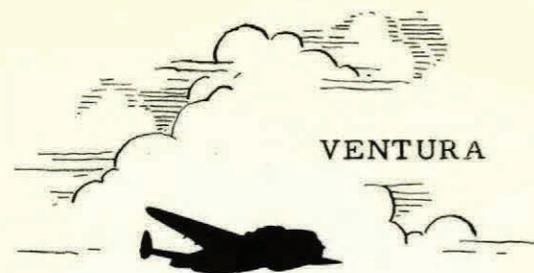
* NO. 8 -- UNDERSHOOT

The problem of short runways and nil wind presents a psychological problem as well as a physical hazard. This was aptly demonstrated recently when the captain of a Ventura allowed a pilot under instruction to undershoot to the extent that the aircraft undercarriage struck the top of a wire fence bordering the perimeter of the aerodrome. Fortunately only minor damage resulted and the aircraft was landed without further incident.

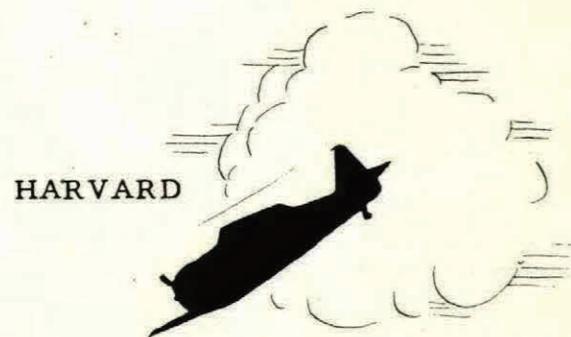
* NO. 9 -- SPEED ARTIST

The student pilot attempted to turn his aircraft in a confined space while travelling at excessive speed and while not maintaining an adequate lookout. Result - The starboard wing tip struck a control tender.

We sincerely hope that a reproof and a contribution towards partial compensation for damages incurred has impressed upon this pilot the Air Force attitude regarding preventable taxiing accidents.

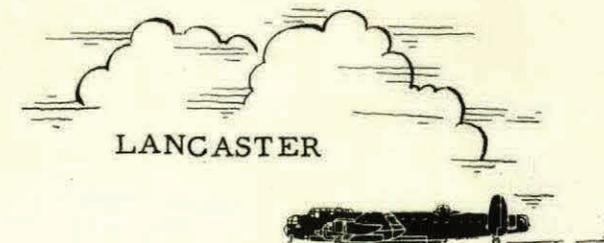
* NO. 20 -- PRACTICE MAKES PERFECT

Visibility $1\frac{1}{2}$ - $1\frac{3}{4}$ miles and ceiling 800 - 1000 feet, combined with darkness, almost led to tragic consequences for this Lancaster and crew.

The pilot had completed the IFS course two months previous to this time, but his logbook indicated that in the intervening period he had carried out no standard instrument approaches.

The captain was reduced to co-pilot status pending investigation and a check into his flying abilities.
