- 2 the UCR
- 6 Good Shows
- 10 A little fuzzy on observations
- 12 Studded Tires
- 15 A Faulty Diaphragm...
- 16 Aeromedical Incidents in Canadian Forces Pilots
- 18 There is a limit...
- 19 On the Dials
- 20 Yukon Drain Hazard
- 22 BRAKE... or BREAK
- 23 Gen from 210
- 24 Letters to the Editor

Editor—F/L JT Richards

Flight Comment is produced by the CFHQ Directorate of Flight Safety. The contents do not necessarily reflect official policy and unless otherwise stated should not be construed as regulations, orders or directives. Contributions, comments and criticisms are welcome; the promotion of flight safety is best served by disseminating ideas and on-the-job experience. Send submissions to: Editor, Flight Comment, CFHQ/DFS, Ottawa 4, Ontario. Subscriptions available from Queen's Printer, Hull, P.Q. Annual subscription rate is \$1.50 for Canada and USA.

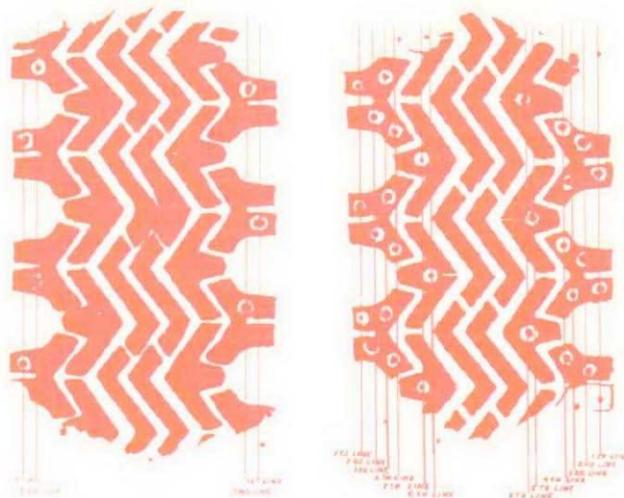
Figure 5

Tire on left has 72 studs in four-line pattern; the tire on the right has 366 studs in twelve lines.

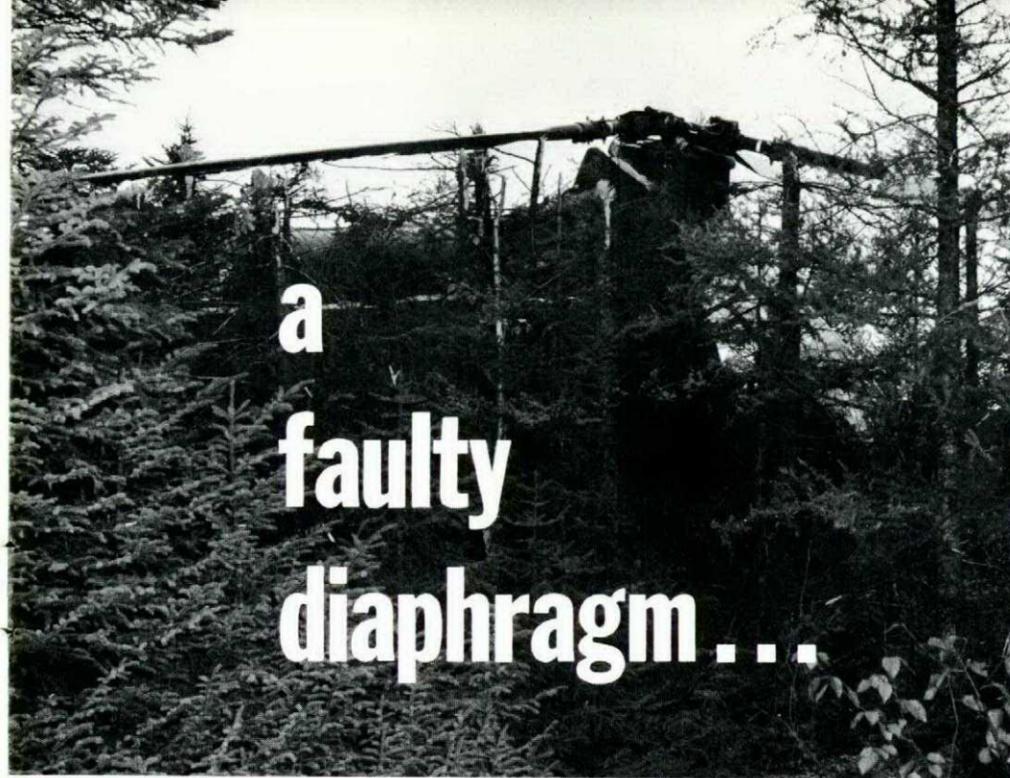
Severe rotor damage after severing trees.

◁ H21 sits rotor-deep in pines.

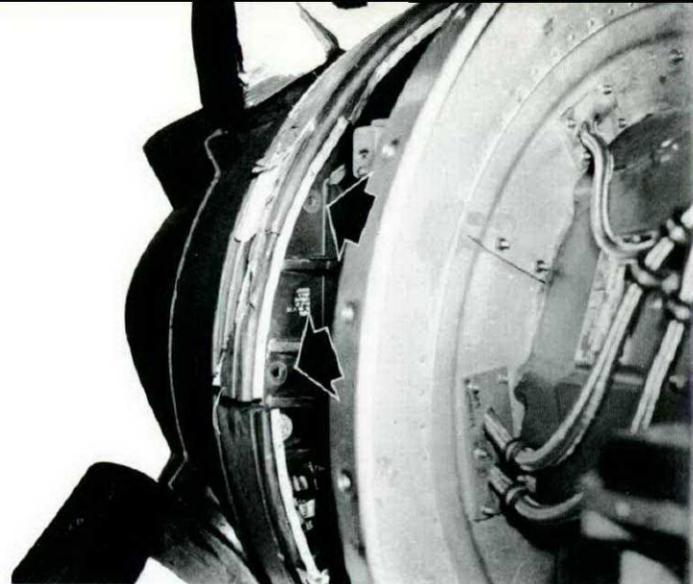
Who's at fault here?

"...After 28 hours in the most miserable sloppy weather conditions I've worked in, I went to bed."

At the end of a brief flight – the first after an engine change – the number four propeller was found badly damaged. Two bolts which probably had been installed partially to position the components, were never tightened and came loose in flight.

Too few working stands, appalling weather, darkness and inadequate lighting, and job interruptions plagued this crew – but their story tells it more graphically:

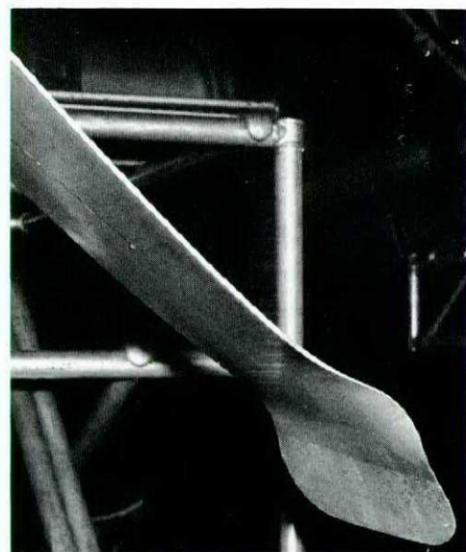
A substantial hunk of metal was missing from one of the propeller blades and another blade was badly bent. The 3-inch square piece which broke off penetrated the fuselage just below the main cabin floor. Fortunately, the internal bracing of the aircraft absorbed the impact of the prop tip; it could have entered the main cabin and injured a passenger.

The mystery was soon cleared up. Ice from the forward washroom drain had struck the number 2 propeller. A project was quickly underway to determine whether a new-design drain being prototyped would prevent the build-up. Test flights with the new drain proved that ice accretion was still dangerous; in fact, an engine had to be shut down on one of the flights to prevent possible damage to the propeller.

Ice chunk broke free, bending prop.

With ice accretion behind the modified galley drain still presenting a hazard to flight and possibly to persons and property on the ground the investigation will continue to determine if further improvement can be achieved to eliminate this hazard.

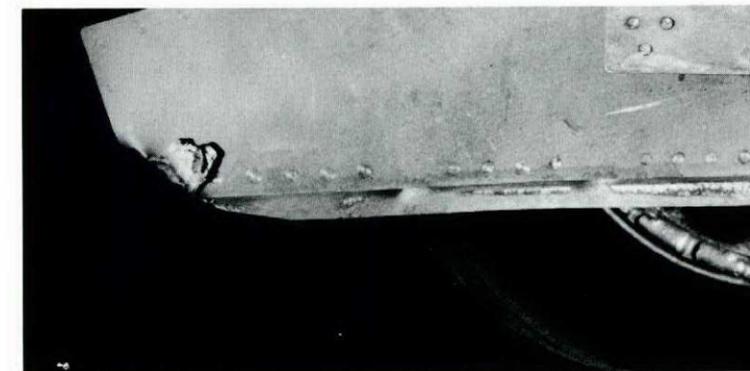
## Cable Dings Iron Bird

At the behest of the man in the tower the T33 captain exited the runway faster than normally, crossing a cable fast enough to damage the undercarriage door.

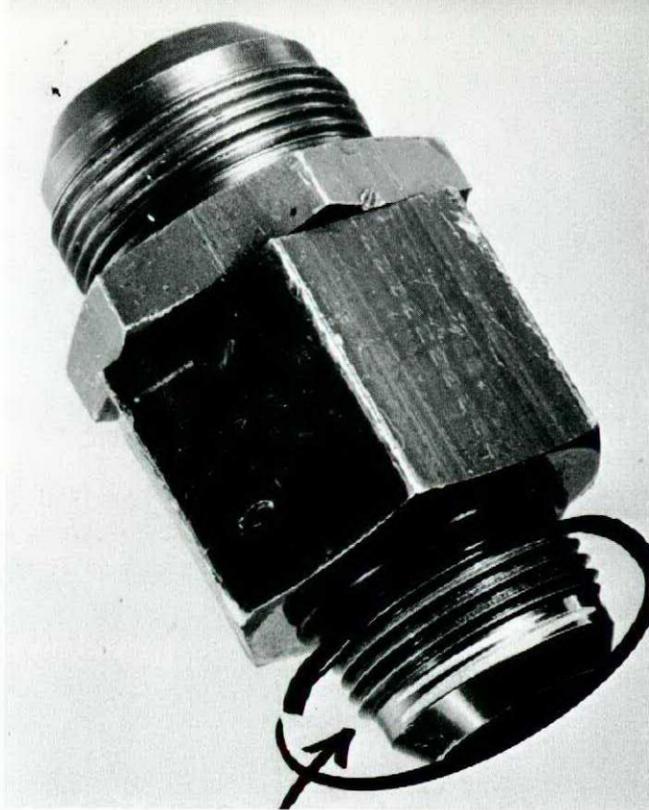
The report came in, bearing a photograph of the same part which had malfunctioned previously - for the same reason. Working from a message rather than a -6A Mod leaflet an experienced technician had re-installed a part which should have been replaced. The error was

further compounded by his supervisor failing to notice the error; he had trusted this man to do what appeared to be a relatively uncomplicated task. It was the lack of any reference to surplus or obsolete parts resulting from the job that did not alert both persons to the error.

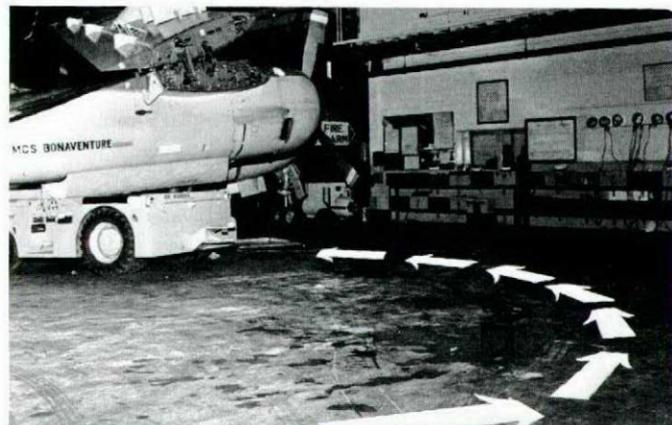
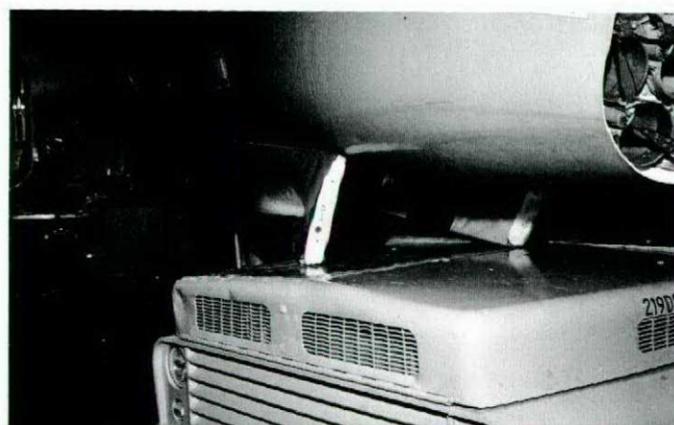
# BRAKE... or BREAK

First, the brake fluid in the hydraulic cylinder was low. The system was leaking fluid from a brakeline to the left rear wheel cylinder. This line - ordinarily steel for safety - had been replaced at an unknown time by an aluminum brakeline. Very susceptible to salt corrosion this line had deteriorated and begun leaking. Periodic inspections of the vehicle failed to uncover the mistake.

Further investigation uncovered one more unsettling item: on the opposite wheel was one of copper alloy!

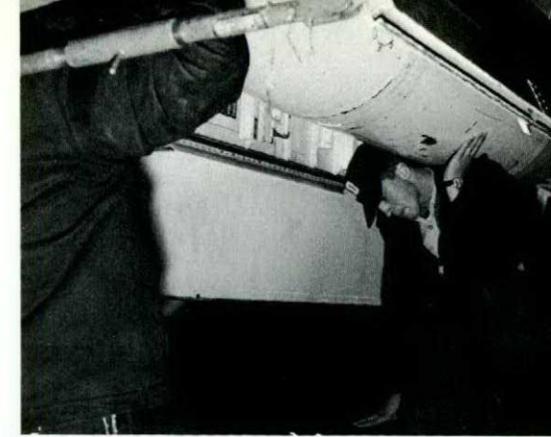
**TRACKER, MAN INJURED** Despite a squadron technical order requiring the long-range fuel tank to be drained prior to removal, the man in charge of a crew of three contented himself with "tapping the underside of the tank with a screwdriver and listening to the ensuing noise". (There is no

contents gauge.) He further checked by pushing the water trap drain and seeing that no fuel emitted, assumed the tank to be empty.

He stationed two men at the tank nose and one at the rear. The tank was released and promptly fell on its rear end surprising the two men in front with the unexpected weight. They were unable to hold the tank and dropped it onto another

man's ankle. The injured man got away with a severe bruising.

Weapon handling equipment will be used in future just in case someone gets careless again.

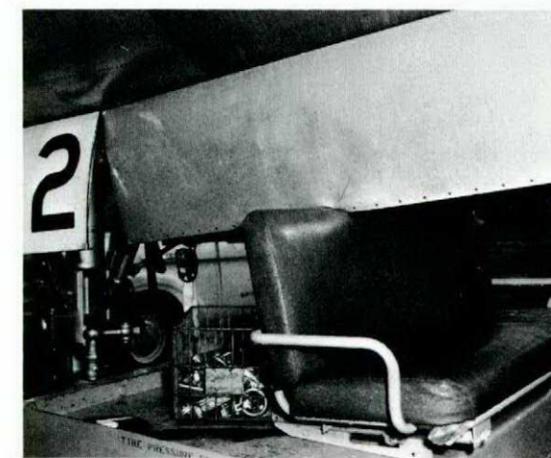
The requirement to tie down the nose of the aircraft during loading was never made known to the maintenance staff. Too, there is no information available in engineering orders. To create a further hazard the cross-member to which the tie-down strapping was attached is not stressed to be loaded in this manner.

New tie-down fittings are underway, as are more tie-down rings. In future tie-downs will be attached to the jacking points on the aircraft which are capable of taking the strain.
