Riding the Rocket Seat

High Risk Fleets for Mid-Air Collisions

The erosion of manual flying skills in highly automated aircraft

Thinking Outside the Toolbox

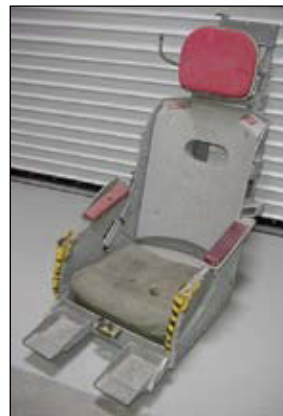
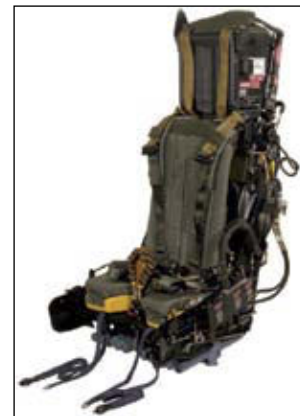
Figure 1. F86 Sabre (left) versus CF188 NACES (right)

Just to give you an example, the venerable F86 Sabre's ejection seat (figure 1, left) was of little use below 1000 feet above ground, and did little else than push the seat and pilot out of the aircraft with a catapult. The pilot had to manually eject the canopy and manually lock his harness prior to ejection. He also had to remember to bring his feet back and place them on the seat's footrests, and brace his arms on the armrests. Post ejection, he had to unstrap himself manually from the harness and quick away from the seat, and had to manually open the main parachute, which was directly attached to the pilot, and had to be carried in and out of the aircraft for each flight. Talk about a busy egress drill! Needless to say, the confidence in such a system was limited at best.

Now, compare this to the Mk 14 NACES seat (figure 1, right), which is scheduled to upgrade the CF188 Hornet escape system next year. The NACES uses a

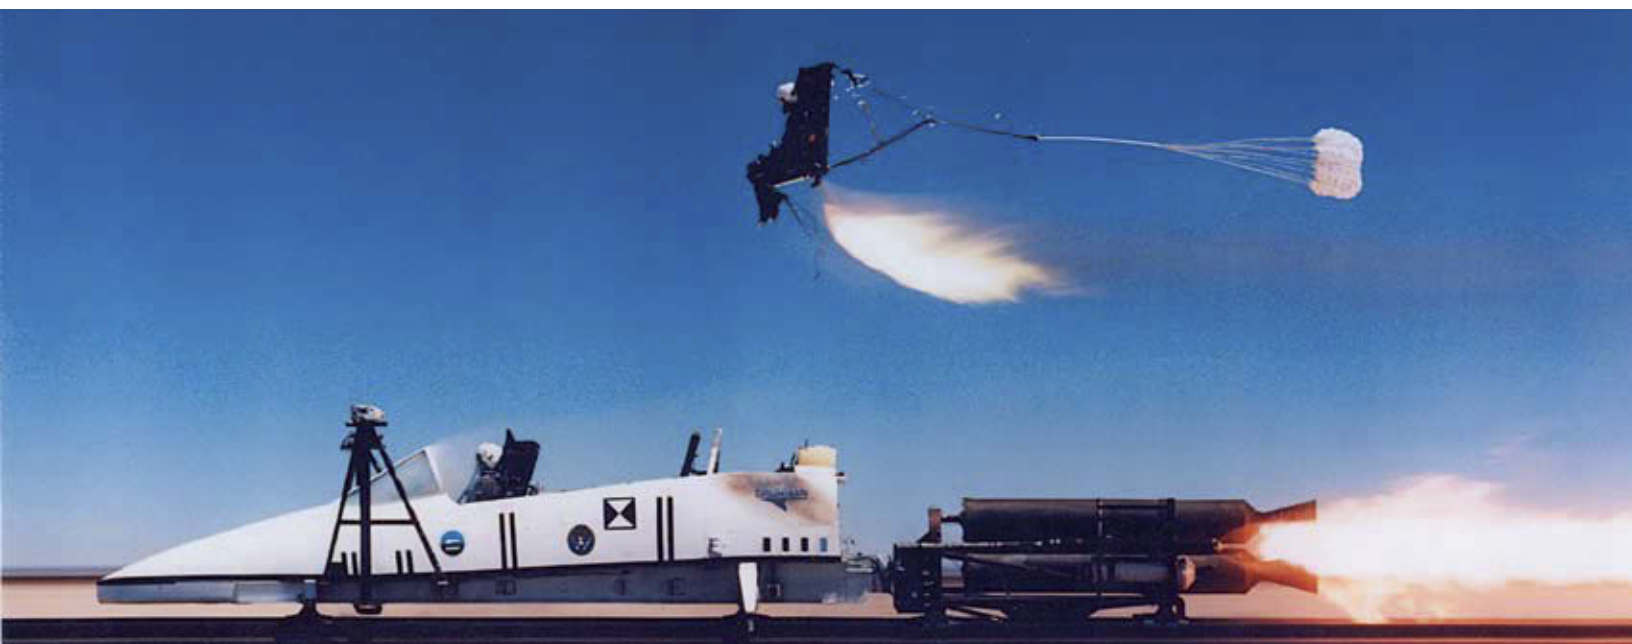
Figure 1a. NACES ejection test showing the multi-point attachment drogue chute

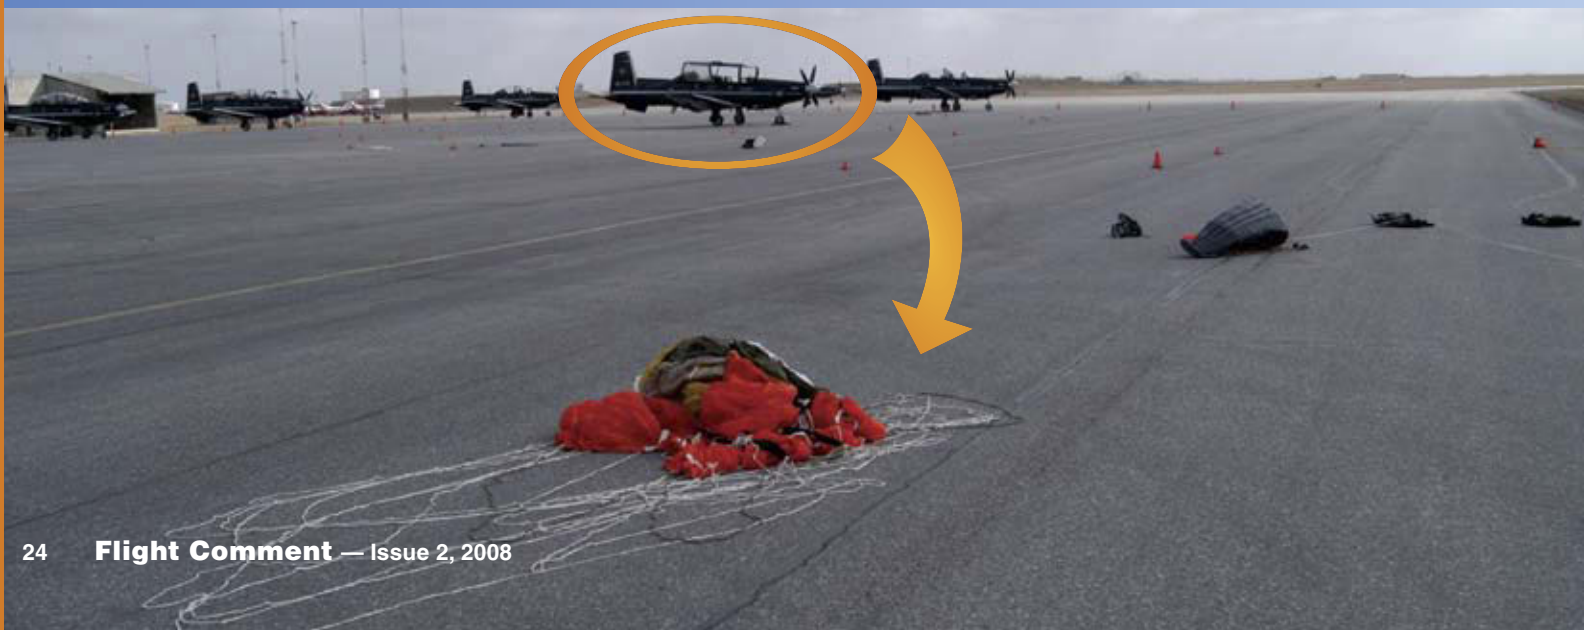
CT156 Harvard, 156112, April 4th, 2007

- A survey of CT156 aircraft in Moose Jaw revealed several differing lengths of communications lines on oxygen hoses.
- One of the two seat initiator cartridges did not fire, resulting in the non-activation of the harness powered retraction unit (HPRU), which forcefully restrains the pilot in the seat

and helps in adopting the proper posture. This was likely due to an improper stowing of the leg restraint lines by the pilot under the seat.

- There are physical differences between the aircraft seat and the mock-up seats in the flying training device (FTD) and the ejection seat trainer, which may have resulted in negative training for certain items.

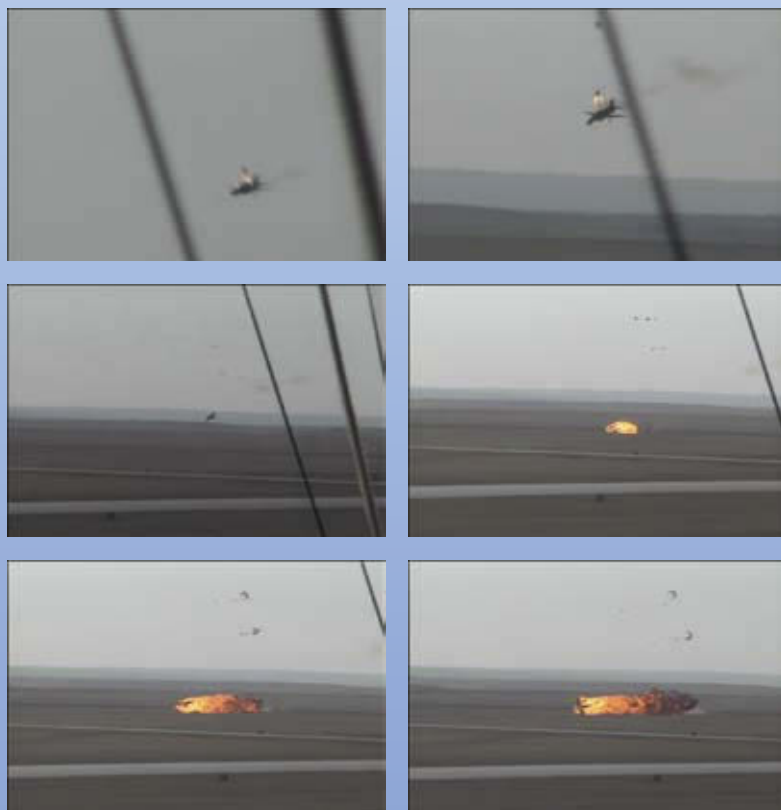
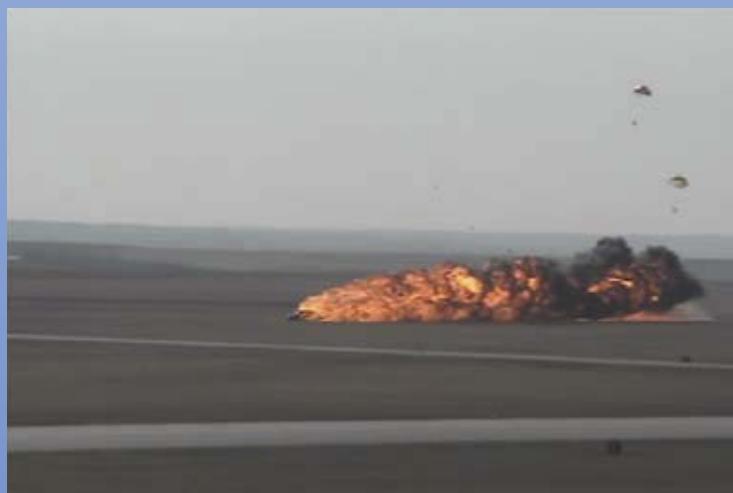
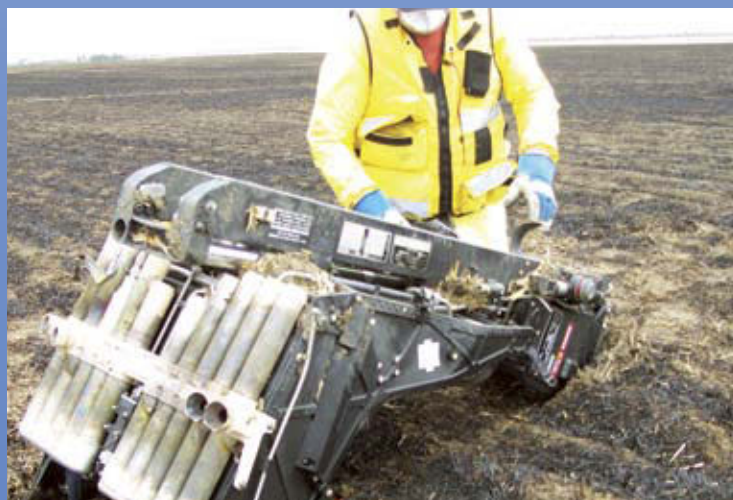
CT155 Hawk, 155215, Apr 18th, 2008

Following the initial takeoff and climbing through 10,000 feet, the occurrence aircraft, manned by a SP in the front seat and an IP in the back seat, experienced an engine malfunction, which resulted in an engine failure. The crew attempted to perform a forced landing profile in an effort to land back at the departure airfield. However, about 1 mile back from the runway, the IP realized that they would not make the runway, and informed the SP of the imminent ejection. The IP then command ejected both pilots from the rear seat. Both pilots ejected at an estimated altitude of 200 ft to 300 ft above the ground, 1.6 seconds before the aircraft struck the ground and exploded, setting a stubble field on fire in the process (See actual photo sequence, right). Both pilots landed in the burning field, and the IP had to help the SP unhook his survival kit and untangle it from the harness. The SP's parachute was, at this point, already on fire. The two pilots then moved away from the encroaching fire, and were met by the local crash fire rescue personnel.

- Both IP and SP suffered serious injuries. The IP's injuries are consistent with loads imparted during the catapult phase, where contact with the aircraft canopy plexiglas, prior to it being ballistically removed, likely contributed to the injuries. The SP's injuries are consistent with loads experienced during the ejection and landing phase sequence. Based on these injuries, both ejections were classified as unsuccessful/survivable.

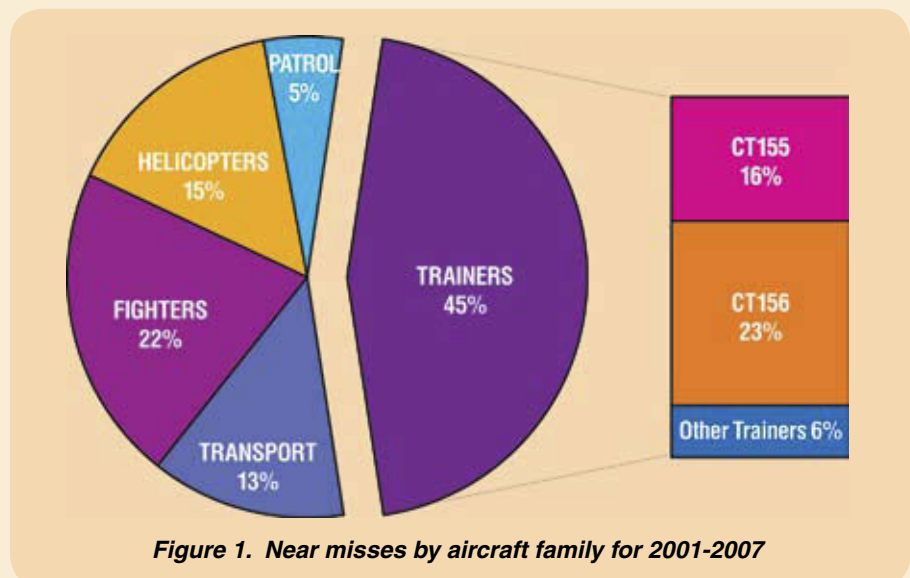
Figure 1 shows that the majority of near misses in the CF come from fighter and trainer fleets. In numbers, the CF188 Hornet (our sole fighter fleet) has seen the highest, followed closely by the CT156

Figure 1. Near misses by aircraft family for 2001-2007

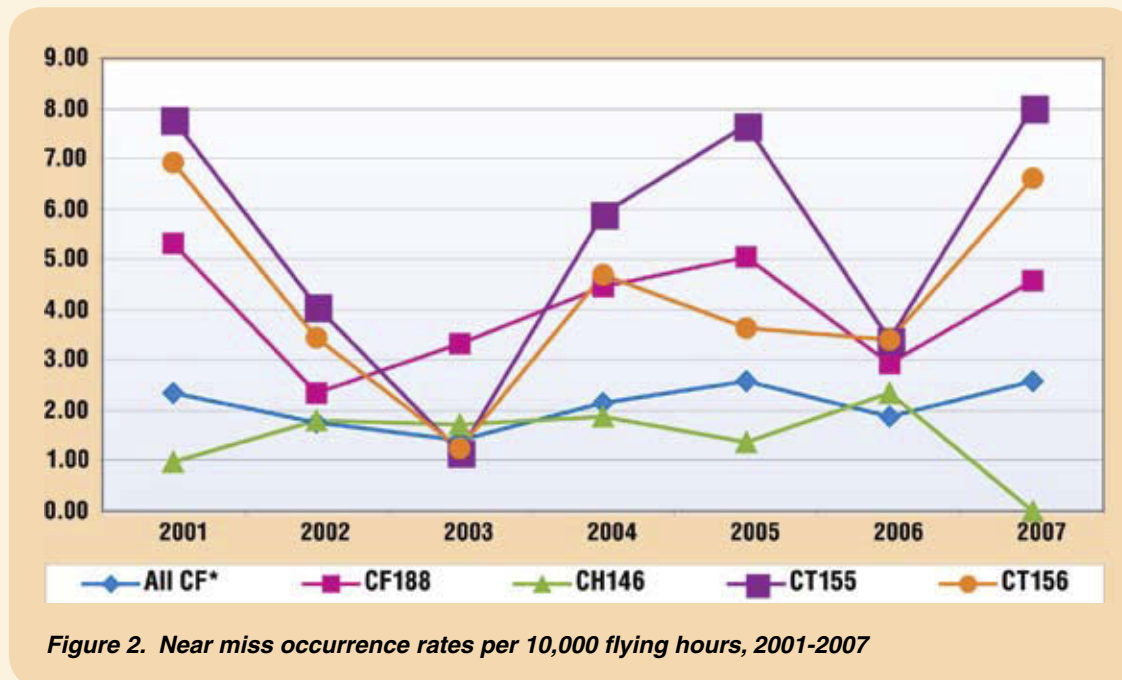
Figure 2. Near miss occurrence rates per 10,000 flying hours, 2001-2007

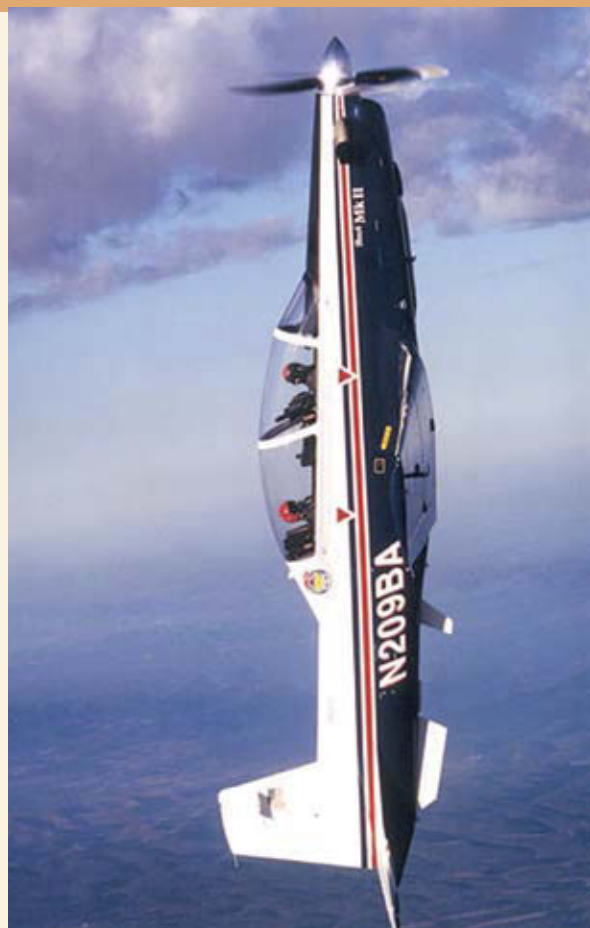
Figure 5. Recommended paint scheme for the CT156 Harvard. Shown here on an American aircraft

top to improve aircraft visibility when looked at from the top down. Thus, a recommendation to change the color of training aircraft was made in the same ESR mentioned above. See figure 5 for an example of the paint scheme recommended.

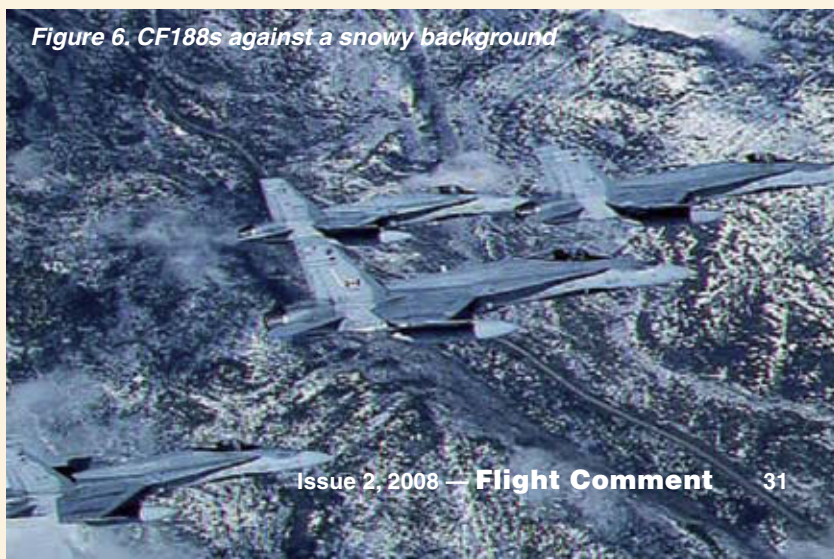
Figure 6. CF188s against a snowy background

Canadian background. The light gray colour of the Hornets make them rather difficult to see in certain background and lighting conditions. This is obviously a purposeful characteristic of fighter aircraft, which nonetheless makes a good lookout and communication discipline vitally important for the fighter community.

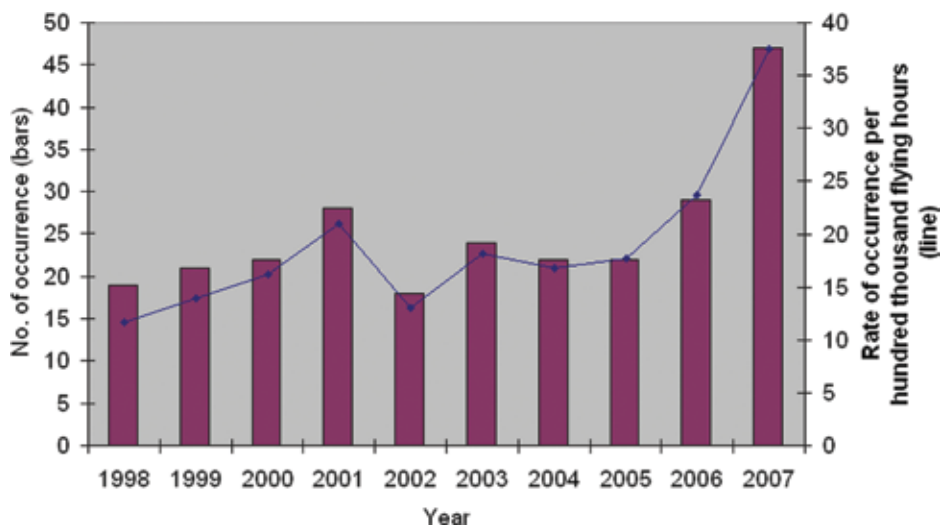
A review of flight safety data for the past 10 years (see figure 1) shows that occurrences related to tool control are slowly creeping up. Better reporting accounts for some of the increase. However, there are other contributing factors. The best way to deal with these contributing factors is to implement preventive measures

Figure 1. Number of occurrences related to Tool Control in the past 10 years in the CF.

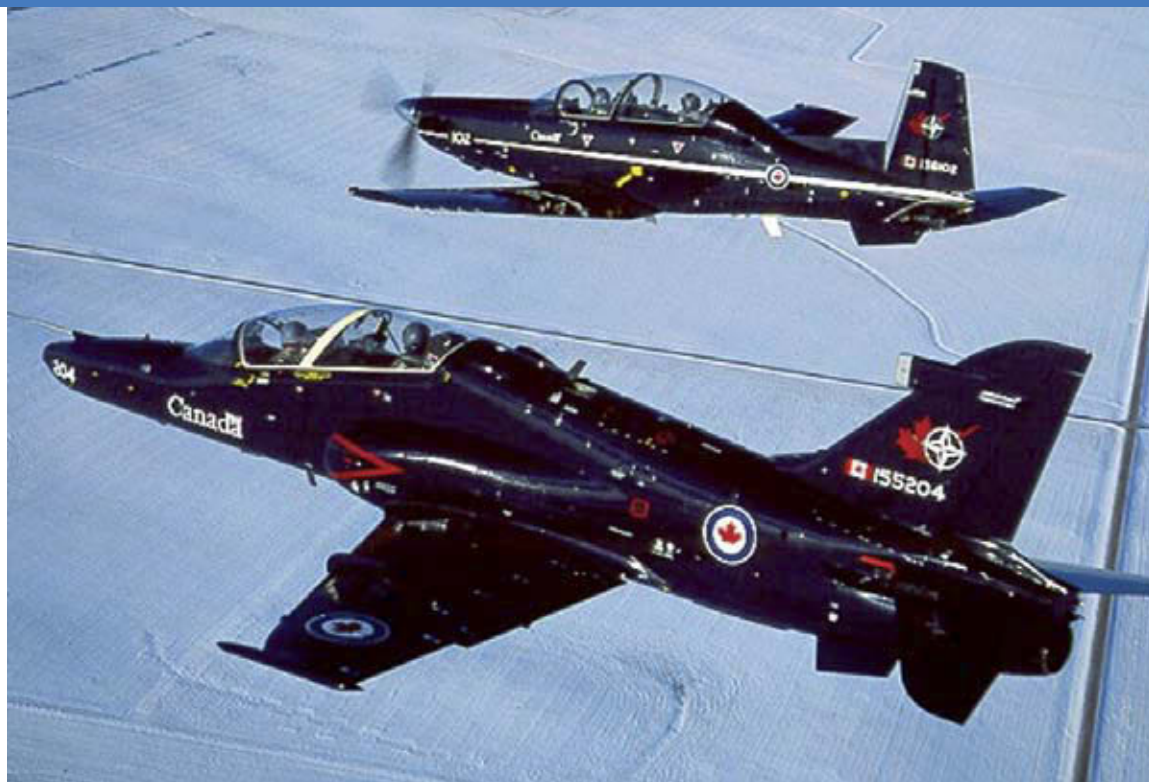
A Harvard II and a Hawk narrowly avoided a collision while flying in the MFA. The weather was VMC with blue sky against dark ground (fall in the prairies). The Harvard dual aircraft was in straight and level flight when suddenly the IP saw a “sudden dark flash” at his 8:30 position. The Hawk solo pilot had just engaged in a rapid descent via a “barrel down” manoeuvre and was in a 20 degrees nose down attitude at 320 KIAS. As he rolled back in the upright position he suddenly saw the Harvard aircraft going from left to right in a split second. Separation was estimated to be 100-200 feet.

The investigation found that at the time of the occurrence there was no airspace management in the MFA except for a few restricted areas. There were also no calls made by either aircraft on the common frequency (CH 14). 15 Wing operates under the “see and be seen” principle and there was no regulation for mandatory calls in the training area. The Hawk pilot did not clear the airspace below immediately prior to his descent manoeuvre. Investigation revealed a lack of guidance

Despite efforts on education and awareness briefs, near miss occurrences have been increasing in Moose Jaw. Shortly after this incident, 2 CFFTS published an AIF to help manage congested areas, limiting the maximum number of aircraft in a specific area. The investigation recommended using common frequencies as part of the airspace management AIF, and providing clear guidance regarding airspace safety prior to executing rapid descents. The investigation recommended that TCAS/ACAS 1 be implemented in both Harvard and Hawk fleets to increase traffic awareness. This measure has proven itself in similar flying training operations in other countries. It was also recommended that the current paint scheme be changed to a two tone (dark and reflective) to optimize aircraft conspicuity. ♦

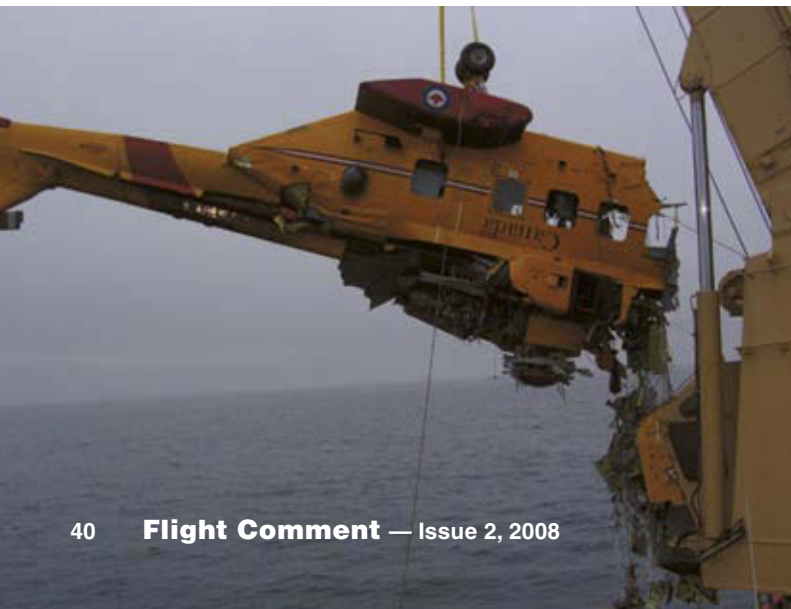
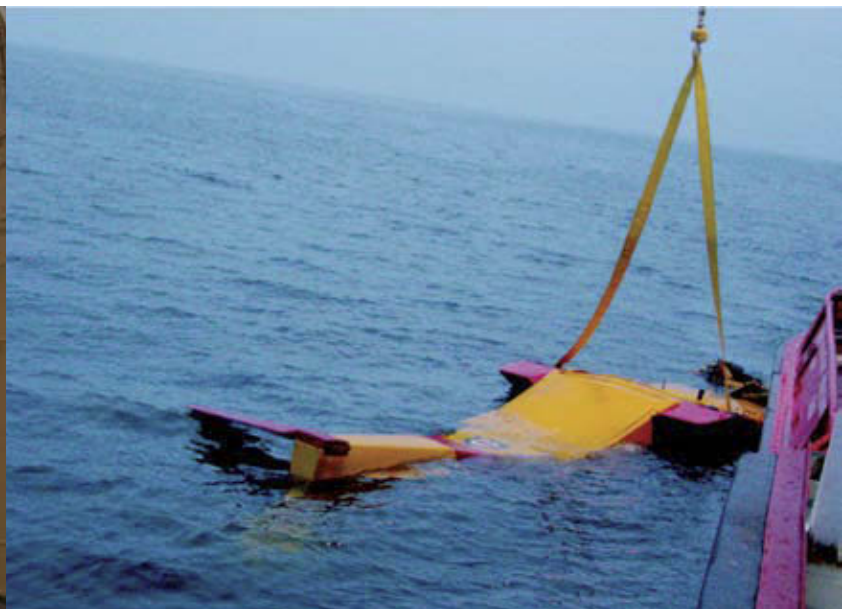
The accident occurred during an attempted go-around from an approach to a fishing vessel. During the go-around the helicopter entered a nose-low attitude and seconds later the aircraft impacted the water with 69 knots forward speed in an 18 degree nose-down attitude. The three pilots and the SAR Tech TL were injured but survived the crash. The two flight engineers and the SAR Tech TM were unable to egress the aircraft and did not survive. The aircraft sustained damage beyond economical repair.

No evidence was found that any system malfunction contributed to the accident, so the investigation focused on the environment, organizational and human factors. The investigation found that the flying pilot's trim technique caused the flight control pitch actuators to become saturated, which in turn caused the loss of the helicopter's automatic stabilization system. In this

condition, the helicopter's inherent instability combined with the pilot's inputs to create a large but unrecognized nose down attitude and descending flight path.

The environmental conditions (darkness, distant dim horizon and calm water) were not suitable for continued flight using outside references only. The nose down attitude and descent was not noticed by any of the three pilots in the low visual cueing environment because they did not adequately reference their flight instruments.

The investigation also found that prolonged training restrictions imposed due to on-going tail-rotor half-hub cracking had a serious detrimental effect on overall CH149 aircrew proficiency, particularly at 413(TR) Squadron. The resultant risk to operational airworthiness was underestimated and not effectively mitigated.

Although the four cabin area crew members survived the impact, only one was able to successfully egress the aircraft before his air supply was exhausted. Survivability issues included cabin layout, storage of equipment, and the suitability of the Aircraft Life Support Equipment. Activity is underway to rectify many of the safety deficiencies identified through the course of the investigation. The Flight Safety Investigation Report contains many recommendations to improve CH149 pilot proficiency, training and survivability / life support equipment issues for CH149 aircrew. ♦

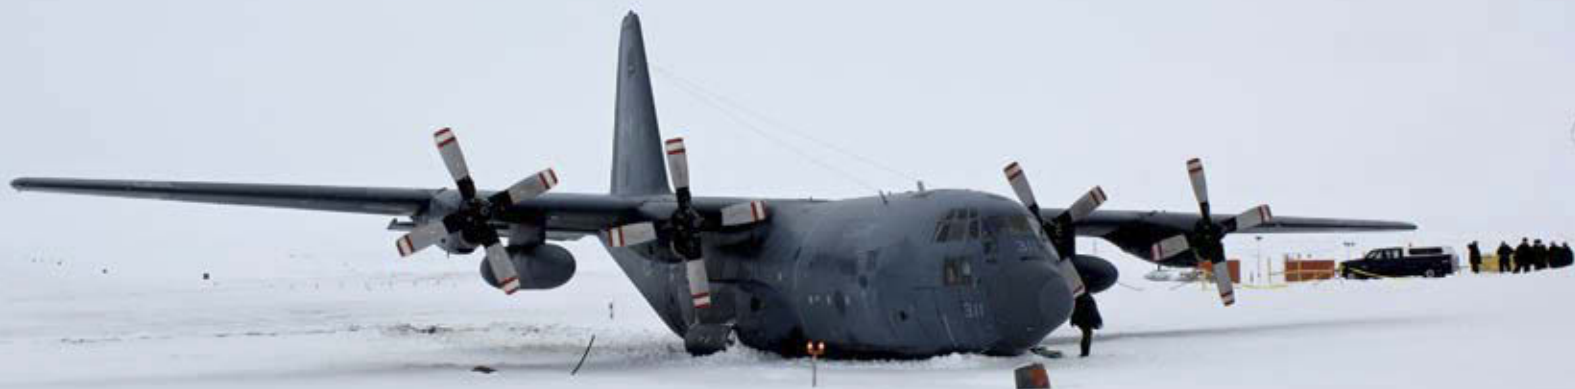
The incident occurred during the landing phase of a resupply mission to Canadian Forces Station Alert in support of Op BOXTOP. Upon completion of a precision radar approach (PAR), the aircraft landed long and after touchdown experienced directional control difficulties. The aircraft was unable to stop in the remaining runway available and departed the end, coming to rest in two-foot deep snow. There were no injuries. The aircraft sustained minor damage.

employed by the crew and regulatory stabilized approach and go-around criteria were not available to ensure the safest possible mission outcome. Symptoms, including degraded situational awareness, task saturation, channelized attention, normalized deviancy and an un-optimized authority gradient, were present in the cockpit and went unchecked. As a result, sound decision-making processes were displaced and the aircraft was unwittingly flown beyond the edge of its performance envelope.

Outstanding preventive measures include the development of an HPMA training module incorporating lessons learned from this occurrence and amendment to current CC130 pilot training associated with CC130 normal and maximum effort landing performance. Additional recommendations include the development of regulatory stabilized approach and G/A criteria for all types and phases of approaches, development of a PMA proficiency Standard and amendment to current direction pertaining to pilot monitored approach selection criteria. ♦

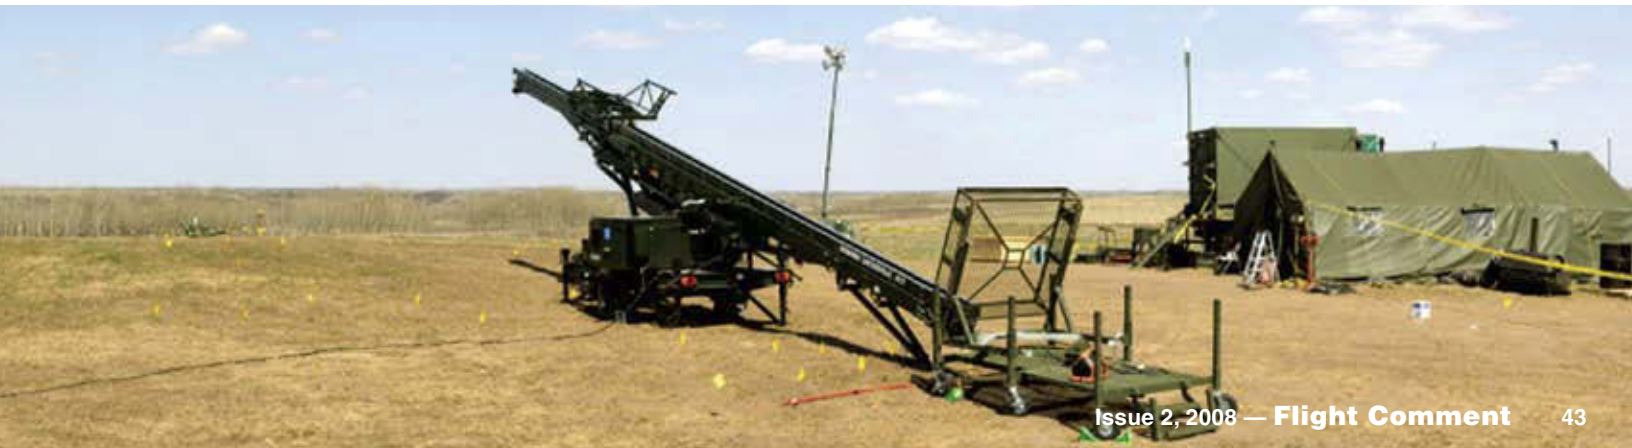
The accident occurred during post-launch procedures following a day UAV launch conducted at the Kandahar Airfield in support of Op ARCHER. The UAV launcher was being reloaded in preparation for the next mission. During the reload, which essentially involved the application of hydraulic force to compress two large pistons into their pneumatic cylinders, an explosion occurred. Two personnel received minor injuries and the launcher sustained very serious damage. The occurrence had no impact on the UAV mission.

of two pairs of large piston rods. At the time of the occurrence, the alignment was compromised which resulted in an explosive release of pneumatic pressure and the expulsion of numerous components. The investigation concluded that the launcher's design did not adequately and consistently ensure that the required alignment be maintained.

Outstanding recommendations include a redesign of the launcher to ensure that the required alignment be maintained and that the checklist include a step for operator inspection of the alignment interface at the appropriate phase of operation. ♦

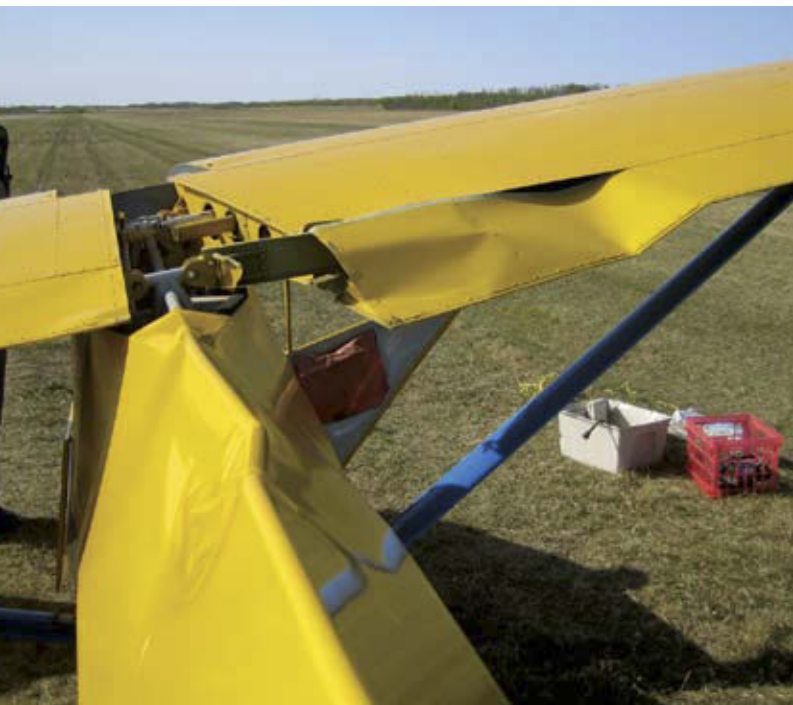
The accident occurred during the Air Cadet Spring Glider Familiarization Flying Program. During the winch launch sequence, as the glider climbed through approximately 150 feet above ground level (AGL), the winch operator saw a glint on the winch cable, followed by a loud bang that was accompanied by a sharp ‘lurch’ of the winch. The winch operator immediately cut power to the winch. As the power was cut, the glider pilot felt the deceleration and observed the airspeed decreasing slowly to 50 miles per hour (MPH), and then rapidly to 30 MPH. At this point the glider pilot attempted to lower the nose and release from the winch cable. The glider then stalled and impacted the ground on the glider’s skid plate. The glider bounced and came to rest 86 feet from its initial impact point. Both occupants were extricated from the glider by Emergency Medical Services personnel and transported to a local hospital where they were examined and released with minor injuries. The glider was destroyed.

Investigation has determined that the initial problems with the winch originated from a partially failed splice being wrapped around the winch drum. The reactions of the winch operator to an unknown winch malfunction were immediate and consistent with procedures.

Faced with a power loss, the glider pilot initially raised the nose of the glider. This increased the rate of deceleration and by the time the pilot applied the correct procedure, the glider had stalled. The investigation revealed that the pilot had not received adequate winch power loss training.

Immediate actions were taken to address the training deficiencies, and further preventive measures have been recommended which will minimize the likelihood of a recurrence of this type of accident. ♦
