# FLIGHT COMMENT

ROYAL CANADIAN AIR FORCE

JANUARY • FEBRUARY • 1960

# SPINNING THE T-33

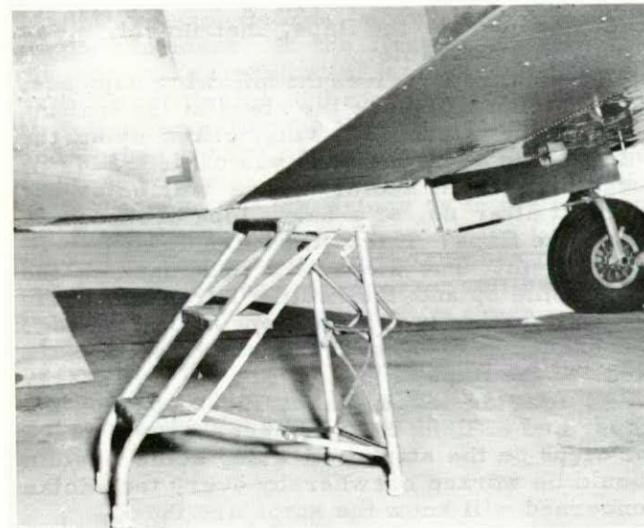
Settle into place and wait patiently...

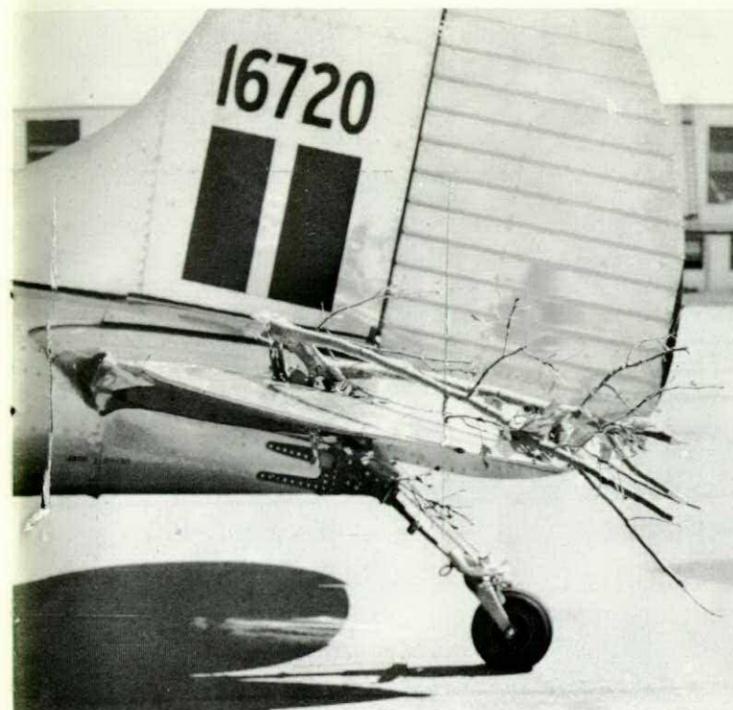
It's temperature, weight, and wind that separates the trees from the twigs.

According to EOs and Light Aircraft School there were several serious errors committed by the pilot: He did not make due allowance for a heavy takeoff. He did not fully appreciate the effects of temperature. He did not consider that the trees would shield him from the wind and, possibly, cause a downdraft. He failed to consider the implication of an up hill takeoff.
