# FLIGHT COMMENT

July • August • 1962

## FLIGHT SAFETY IN AMC

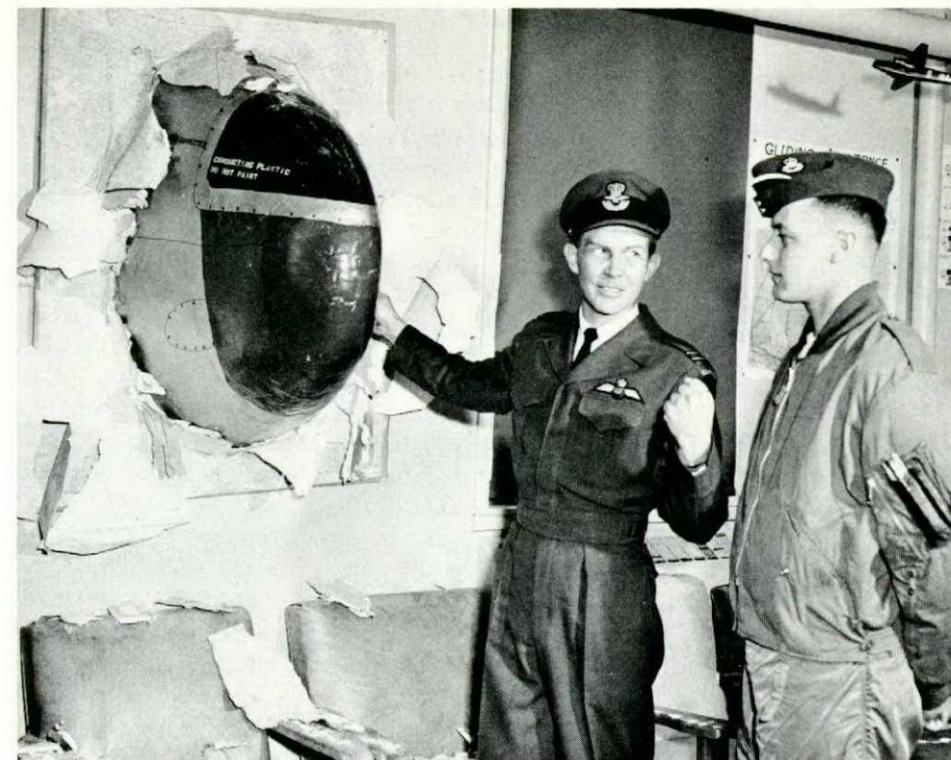
Students in B flight constructed a papier mâché mold of a T33 nose to emphasize taxi accident hazards. F/L R. M. O'Bryan (left), the SFSO, and F/C J. M. G. Nadon look on.
