WHITE vs RED  
INSTRUMENT IMPROVEMENT  
COLOURED COCKPIT INTERIORS

### CF104 FUEL PUMP DRIVE SPLINE FAILURE

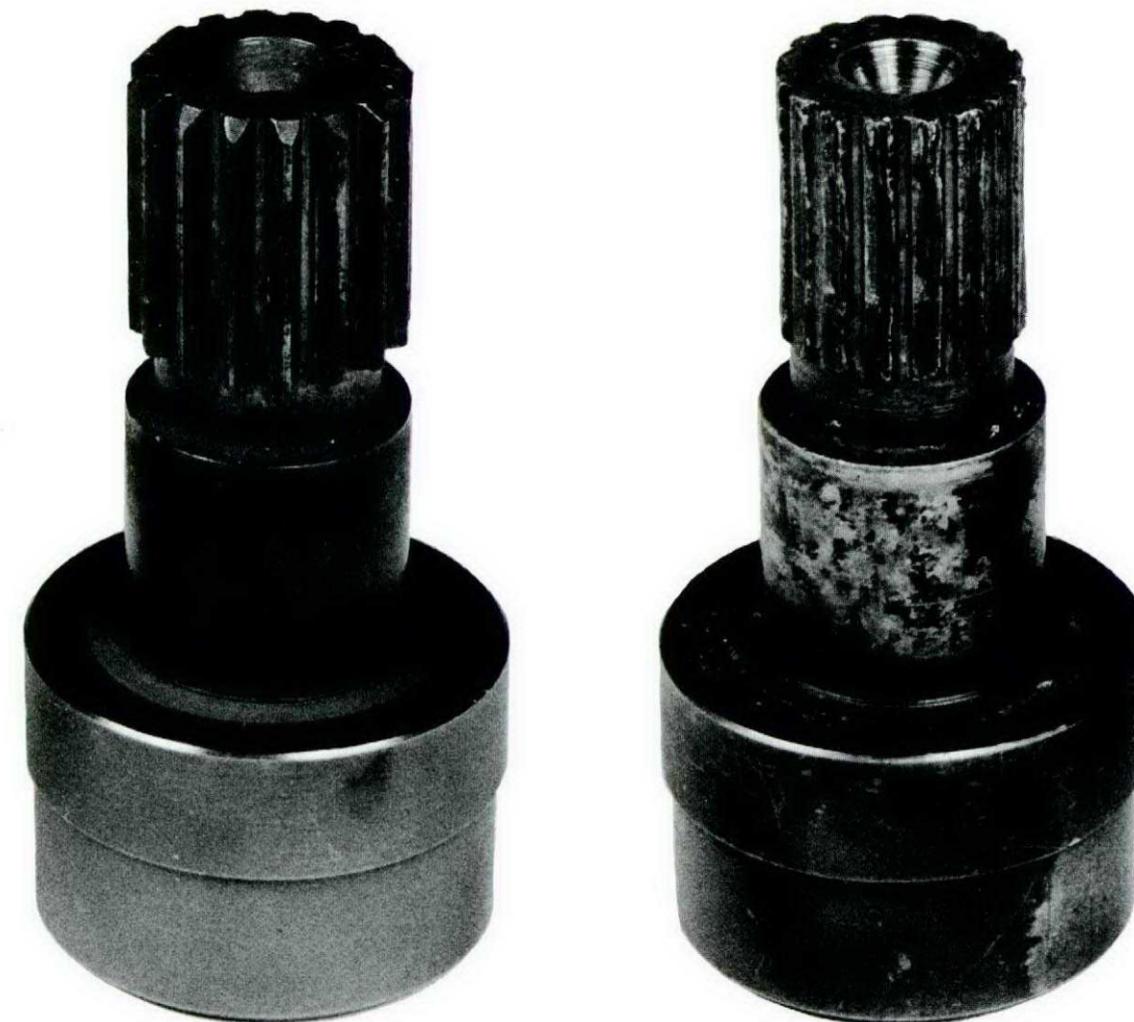
Two shafts, one showing spline failure.

In July we lost a CF104 from a fuel starvation flame-out. Both pilot and aircraft splashed into the Mediterranean following a successful ejection. The splines on the main fuel pump driveshaft had failed from excessive wear (see photo); the J79 engine has one fuel pump with one driveshaft, hence the flameout.

so the accompanying inspection, which probably would have revealed wear beyond limits, was not performed. Later, a fleet inspection uncovered numerous cases of wear.

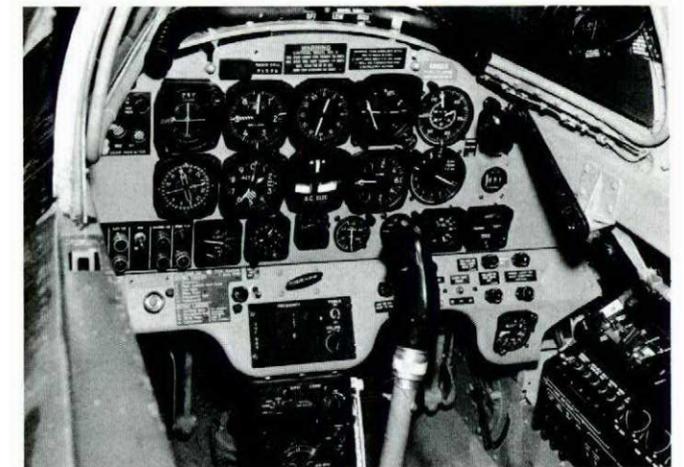
The grey cockpit interior of USAF T33.

The decision to employ white light sparked studies to determine the colour best suited for the cockpit. Researchers found the gray cockpit interior to have several advantages over the black:

- Visibility within the cockpit is poor under the "high altitude glare" of direct sunlight and the little or no atmospheric scattering of light. Gray interiors reflect light, making items in the darker recesses of the cockpit more discernible.
- Under ultra-violet light, many pilots experienced "floating" of the instrument marks during long night flights. The instrument marks - the only objects visible - would appear to move. This generally occurred under low lighting where the black panel was all but invisible. The gray panel provides a visible background or reference for the instrument markings.

The primary disadvantage of a gray cockpit interior is also that of white instrument lighting - it degrades night vision. It also increases the amount of light reflected from surfaces such as canopies (halo). However, these undesirable effects can be minimized by using a dark gray and by intelligently designed glare shields.

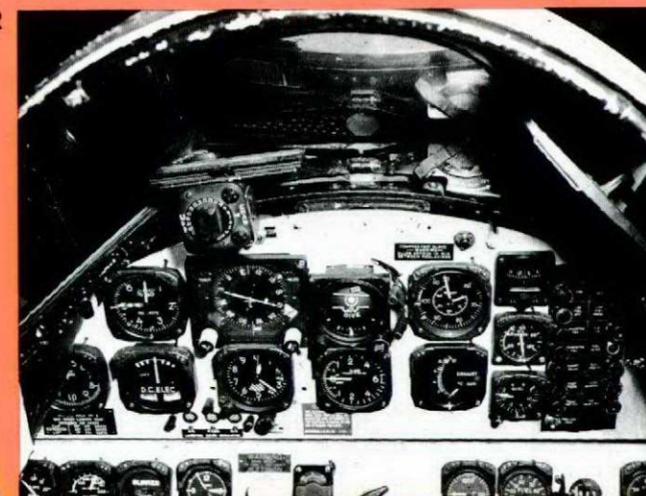
AFTER

The grey cockpit interior of RCAF T33 prototype.

The conversion from red to white instrument lighting and the associated abandonment of radioactive markings meant that instrument faces had to be repainted. The new "lustreless white" requires new silk screens to be manufactured for the repainting; this afforded us an excellent opportunity to redesign all instrument presentations at little or no extra cost.

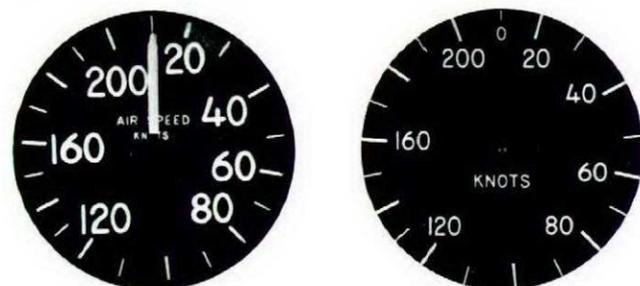
BEFORE AFTER

Instrument clean-up prototypes were checked and double-checked under both red and white lighting and reworked until the desired product was achieved. The program has been underway for over a year - many of the converted instruments are now in the field. Most instruments will be converted by the end of 1966. The standards established by this working group will be applied to future purchases of aircraft instruments.

At CFHQ, a working party of designers, operators, and a human factors specialist directs the instrument improvement program. The program aims at a "clean-up" of instrument displays:

- removing useless information, such as manufacturers' names,
- standardizing letters, numbers and markers,
- eliminating "hot spots".

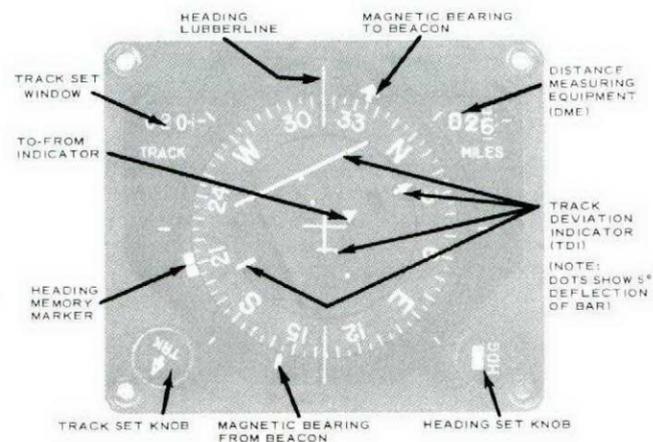
Let's examine the thinking behind the HSI design. The basic aim was to present to the pilot a picture as if he were looking directly down on his aircraft and could see both his aircraft and the desired track in relation to his position - the horizontal situation. The aircraft is depicted as a small symbol etched on the glass in the centre of the HSI. The desired track is shown by the track deviation indicator (TDI).

Depending on the equipment in your aircraft the HSI will give you all (or part) of this information:  
**Heading** Aircraft Heading is displayed conventionally on the lubberline at top of the dial.

**Heading Memory Marker** This may be employed as a reference only, or can be fed into the bank steering function of flight director and/or autopilot. The marker is set with the lower right-hand HDG knob. The heading memory marker may also be controlled by the tactical compartment in maritime aircraft and by data link on air defence aircraft.

The aircraft heading (350°) is shown on the lubberline; the intended flight is to intercept the 080° radial and fly toward the TACAN beacon. With the track knob, 260° is set in the track window; this will cause the TDI to point at 260° on the compass rose - in this case, on the left wingtip. The tail of the bearing pointer

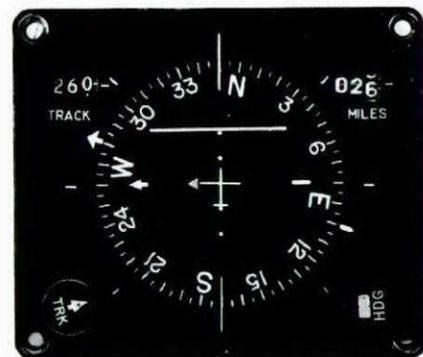
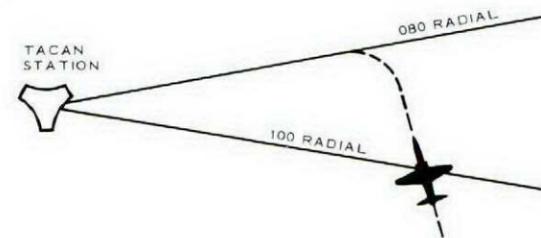
shows the aircraft to be on the 100° radial and thus south of the desired radial or track. By being fully displaced to the top of the instrument, the bar portion of the TDI also indicates the aircraft is south of the desired radial. Note that the TDI shows pictorially the intercept angle the aircraft is making with the desired track of 260° - in this case, 90°. The DME

indicates the aircraft is 26 nm from the TACAN beacon. (The heading memory marker has been deleted from the photos for simplicity).

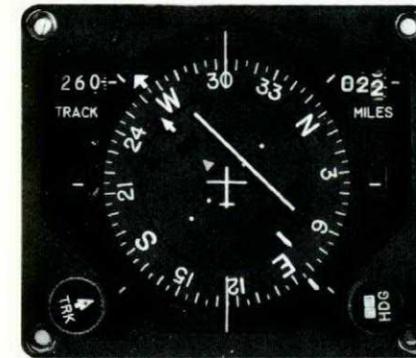
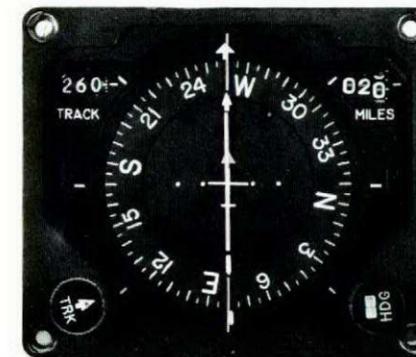
The aircraft is approaching the desired track of 260°, and the pilot has cut the intercept angle to 45°

by turning left; the heading has now changed to 305° on the lubberline. The tail of the bearing pointer indicates the aircraft is on the 085° radial - 5° from desired track of 260°; the bar of the TDI also indicates this by a displacement to the right of one dot, or 5°. Note the TDI is still pointing at the desired track (260°), and pictorially shows the track at 45° to the aircraft symbol.

The aircraft is now inbound on the 080° radial. The heading is 260°; the magnetic bearing to the station is 260°; the TDI remains at 260°. The bar of the TDI indicates no displacement from track by being centered directly under the aircraft symbol.

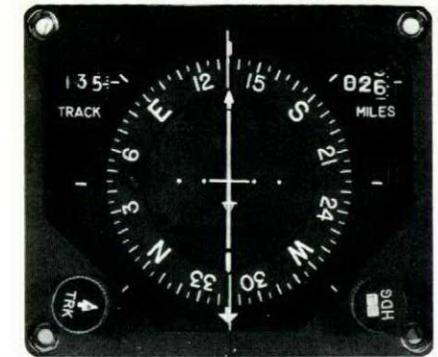
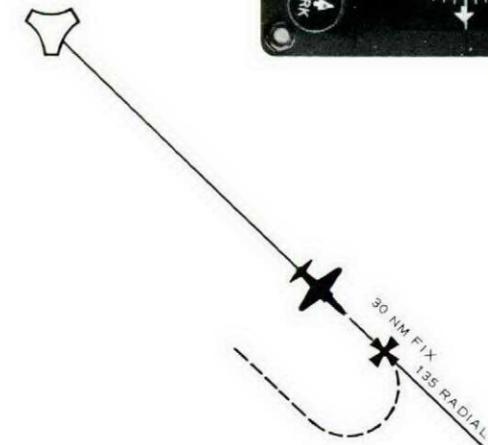
In this example the 10-mile long TACAN holding pattern uses right turns, and is to the NW of the holding fix at 30 nm on the 135° radial. The desired track is the 135° to the 30 nm holding fix. This is set into the window

with the track knob; as a result the TDI points to 135°. The bar of the TDI is centered indicating the aircraft is on track; in this instance, the pilot is holding a heading of 135° (under the lubberline) to maintain the desired track. The DME tells him he is 4 nm from the holding fix and the bearing pointer is indicating 315° magnetic, ie, the TACAN beacon is directly behind the aircraft.

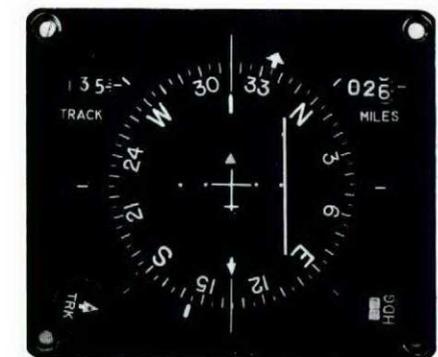
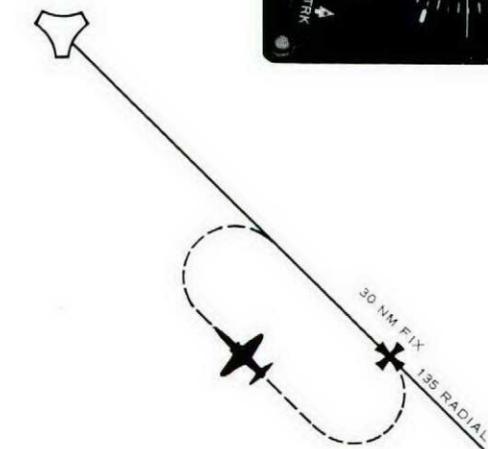
The aircraft has reached the holding fix, turned through 180° to the right, and is in the holding pattern. The heading is now 315°; the TDI and To-From indicator show pictorially that the inbound track to the fix is on the right, and 180° to the aircraft heading. When the DME indicates 20 nm the turn inbound will commence.

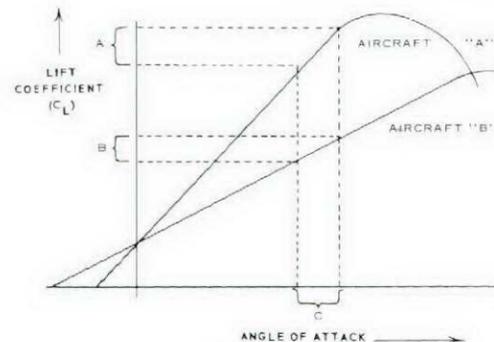
FIGURE 1

Referring to Figure 1, aircraft "A" has a high lift, low speed wing section. Aircraft "B" has a high speed supersonic section. Both aircraft are assumed to have the

First it is necessary to understand what causes an aircraft to roll when flying through the slipstream of another aircraft. Turbulence or slipstream is simply "pockets" of air that have been given a vertical motion. An aircraft flying through these vertical gusts will temporarily have the direction of the relative airflow, and therefore the angle of attack and lift will be changed. If both wings fly through the same gusts, then the aircraft is simply subjected to a bump. If, however, only one wing enters the gust, then this wing will temporarily have its lift increased if the gust is upwards or decreased if the gust is downwards. This will cause the aircraft to roll.
