# FLIGHT COMMENT

JULY • AUGUST 1973

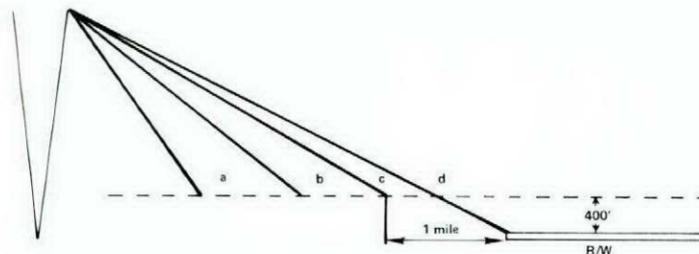
- M 5 ⊕ 3
  - M 8 ⊕ 1-1/2
  - M 9 ⊕ 3
  - M 8 ⊕ 3
5. Which of the four profiles for final descent, facility to field, do you consider the best? There is no glide path, you are doing a straight-in approach and the minimums are 400 feet and 1 mile.

- Rapid descent to minimums, then fly at minimums to field.
- Gradual descent so as to reach minimum altitude prior to minimum visibility mileage from the field.
- Gradual descent so as to reach minimum altitude at minimum visibility mileage from the field.
- Gradual descent calculated to provide a constant vertical speed from the FAF to threshold.

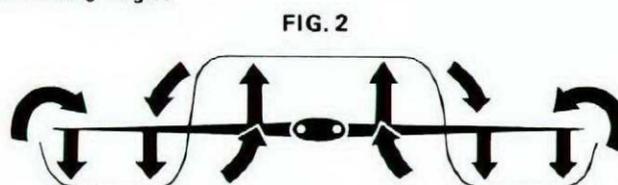
FIG. 2  
Induced Velocity distribution along blade span during VORTEX RING STATE

In plain language it means that **vortex ring state** is present to some degree during vertical descent; it is of small magnitude during a slow controlled descent and of serious consequence during a fast descent where most if not all the flow pattern is upwards (Fig. 2).

In Fig. 1 we see a typical induced air velocity distribution pattern across the rotor disc during hovering flight. If the total power available is insufficient to maintain the desired altitude, the helicopter begins to settle at a rate equal to the loss of lift created by the relative airflow. This may occur when the helicopter is at a low airspeed, out of ground effect, or in a descent with some power on.

FIG. 1  
Induced velocity distribution along blade span during hovering flight
