FLIGHT COMMENT

THE FLIGHT SAFETY DIGEST OF THE CANADIAN ARMED FORCES

EDITION 1 1979

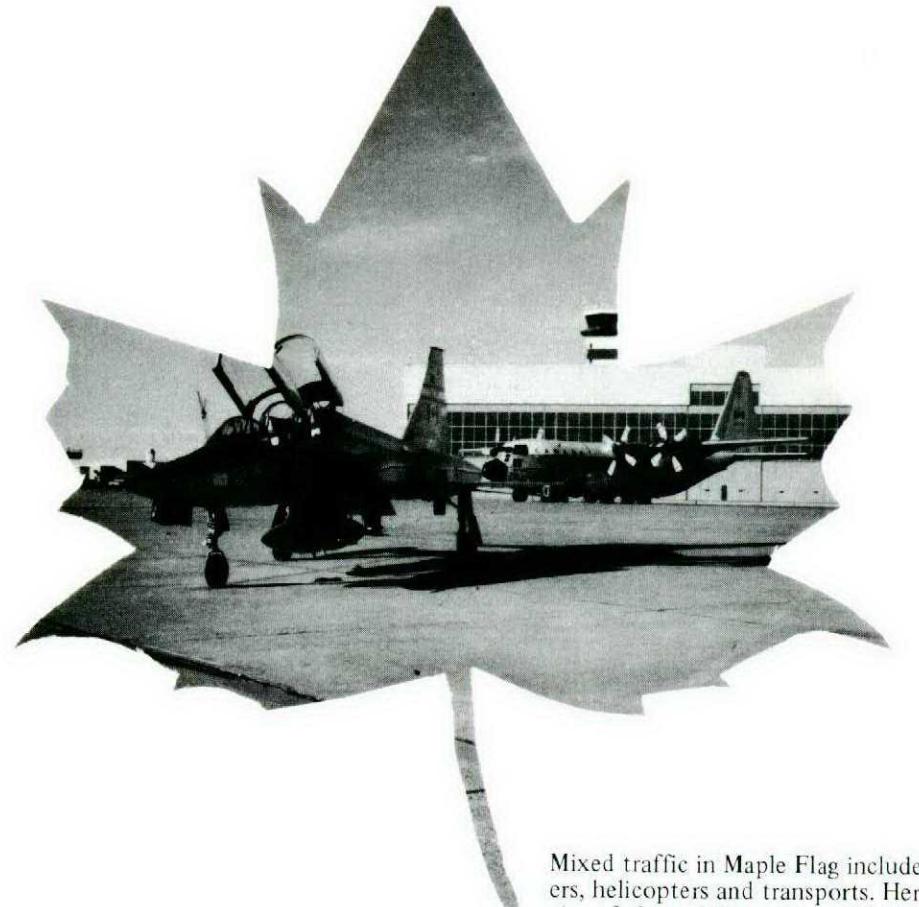
Mixed traffic in Maple Flag includes fighters, helicopters and transports. Hercules aircraft from 435 squadron, Namao, took part for the first time. The mixture demanded extra care from pilots and tower controllers.

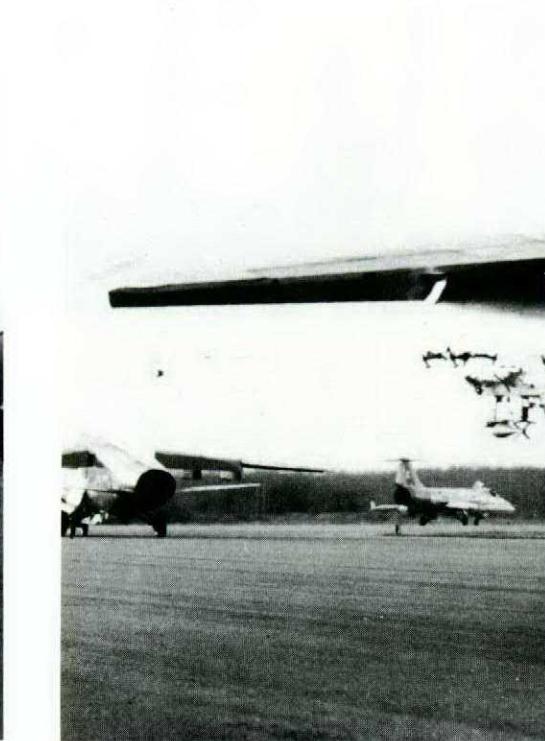
CF-104 and A7 aircraft arming. There are 2 Maple Flag launches and recoveries daily. Normally base flying training is scheduled around these periods when possible.

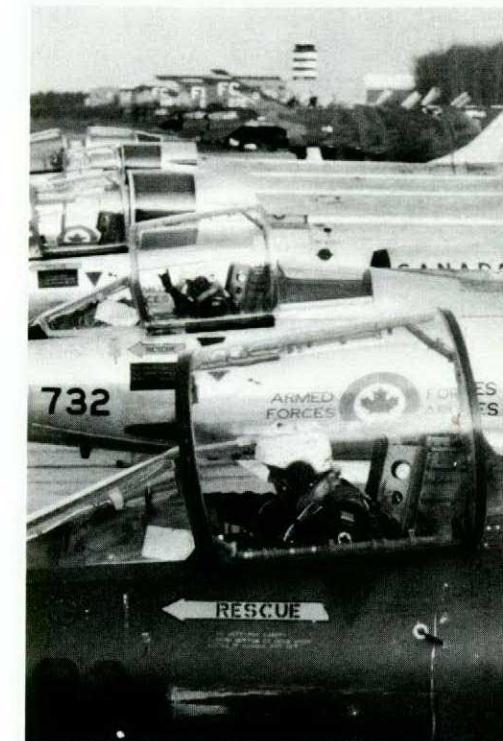
Most of the Maple Flag fighter aircraft shared 417 Squadron's ramp, a space which normally accommodates twenty CF 104s. Phantom, Harrier and Corsair aircraft more than doubled this number; extra ramp sweeping and FOD control was required.

With an additional 50 to 60 or so extra aircraft on the base, ramp space can be a problem. All participants would like to be in the same location, naturally, but care has to be taken to avoid not only overcrowding but incompatibility of operation. Departing helicopters are kept away from jets to avoid blowing FOD into intakes; armed aircraft have to be pointed in safe directions; and stringent control of tarmac vehicular traffic has to be practiced.

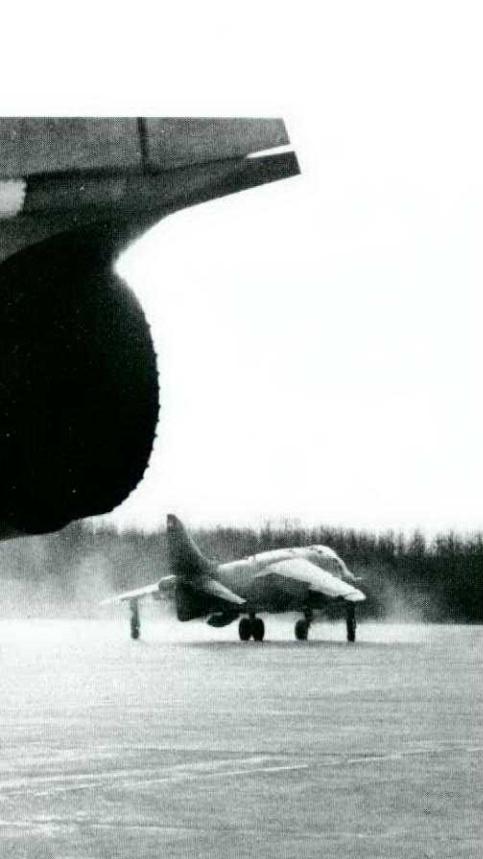
A US Marine corps AV-8 Harrier taxis out demonstrating why ramp FOD is unacceptable.
(McWilliams photo)

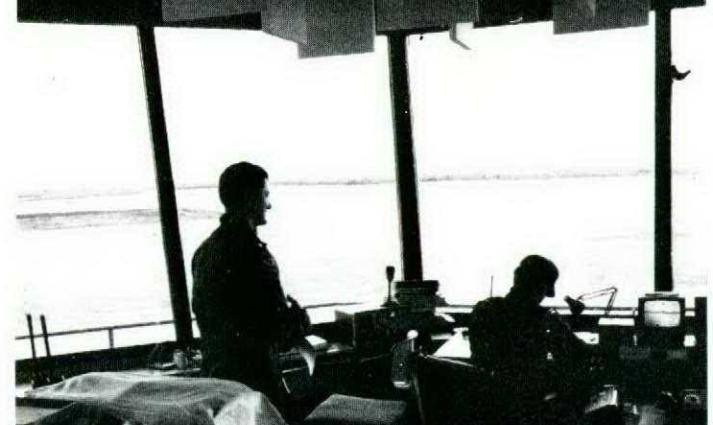
USAF practice is to have a Supervisor of Flying (SOF) in the tower during all flying. The SOF, a pilot from the "Principal Unit" deployed to Maple Flag is provided with checklists and AOIs. He has UHF communications to give assistance when required during emergencies.

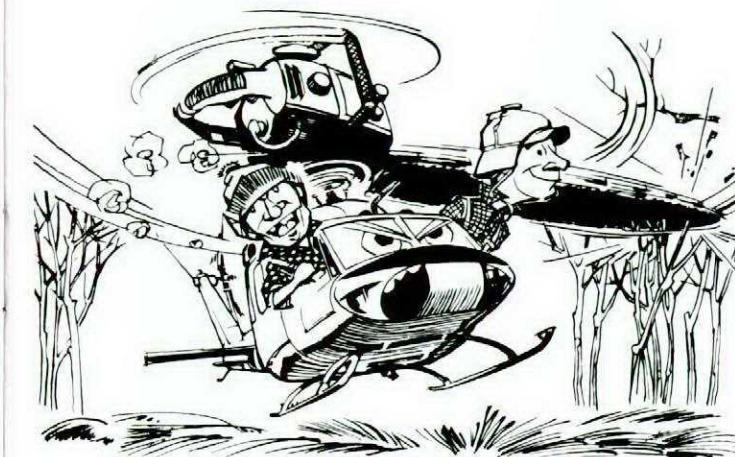
Here's a question for you helo drivers: How large a tree do you think your machine can fell without hurting the blades? If you played it safe and said that you wouldn't cut anything with a rotor blade, you'd be right! Recently, a Twin Huey SAR crew made a different decision with expensive results. As they let down into a confined area near a crash site, they discovered several small trees — up to one inch in diameter — inside the rotor disk. *The captain had heard somewhere that the Huey could negotiate foliage this size and continued the landing. How did it work? Fine — the trees were all cut. What did it cost? Two rotor blades — the trees had made several quarter inch grooves in the honeycomb material and they had to be returned to the contractor for repair. Remember that your blades are designed to displace nothing heavier than air; they'll harvest small trees for you, but only once.*

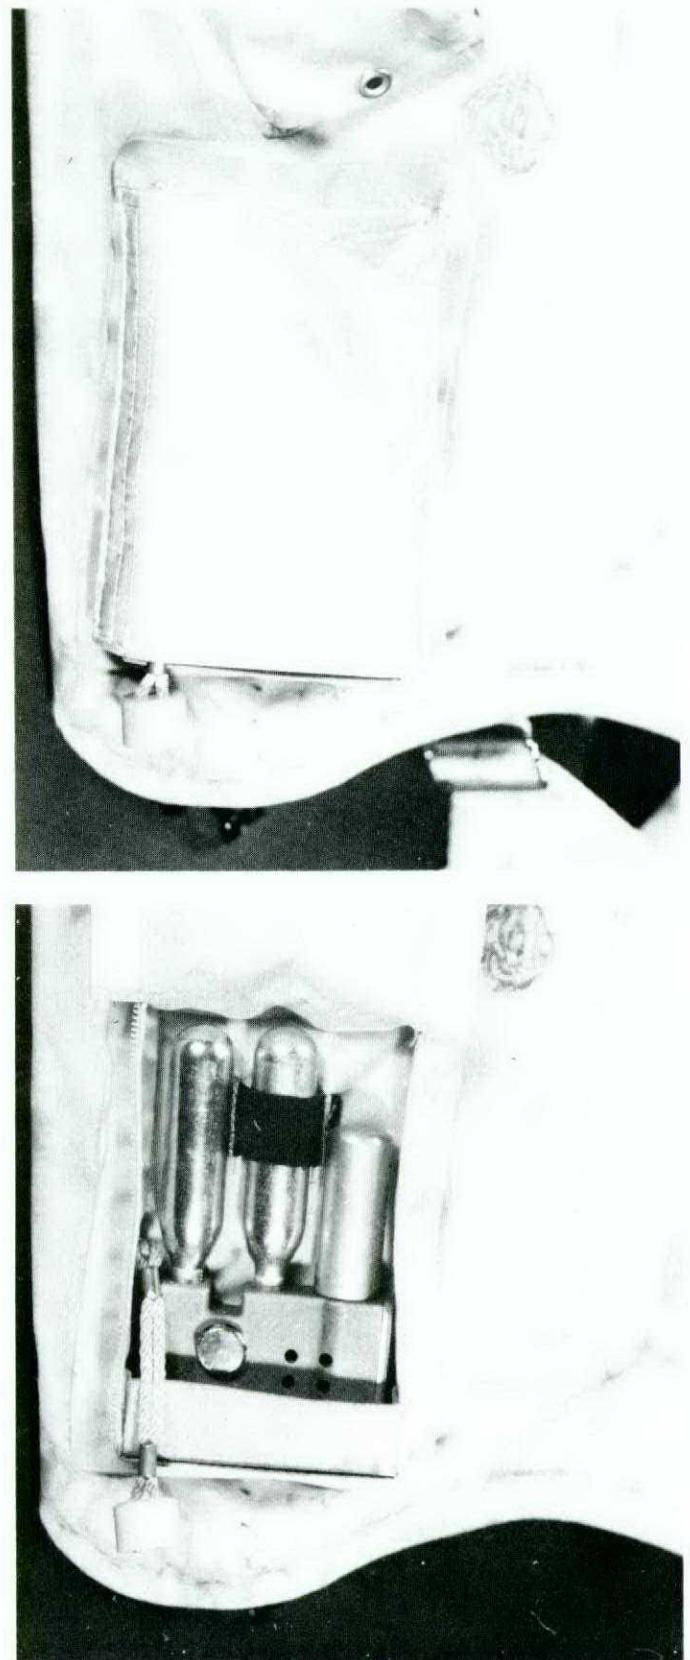
Investigation of the Mae West revealed that moisture had entered the water ports, triggering the automatic device, and that the 3G loading may have contributed, by forcing moisture into the electrical contacts. A modification project was initiated to deal with the problem.

He finally stabbed his Mae West with his rescue knife and felt immediate relief. Following a short period of "Composure readjustment", the crew returned to base with no further difficulties. Post flight inspection confirmed that the manual inflation lever was in place (witness wired). The pilot added that the Mae West had been exposed to heavy rain for 10 to 15 minutes prior to flight.

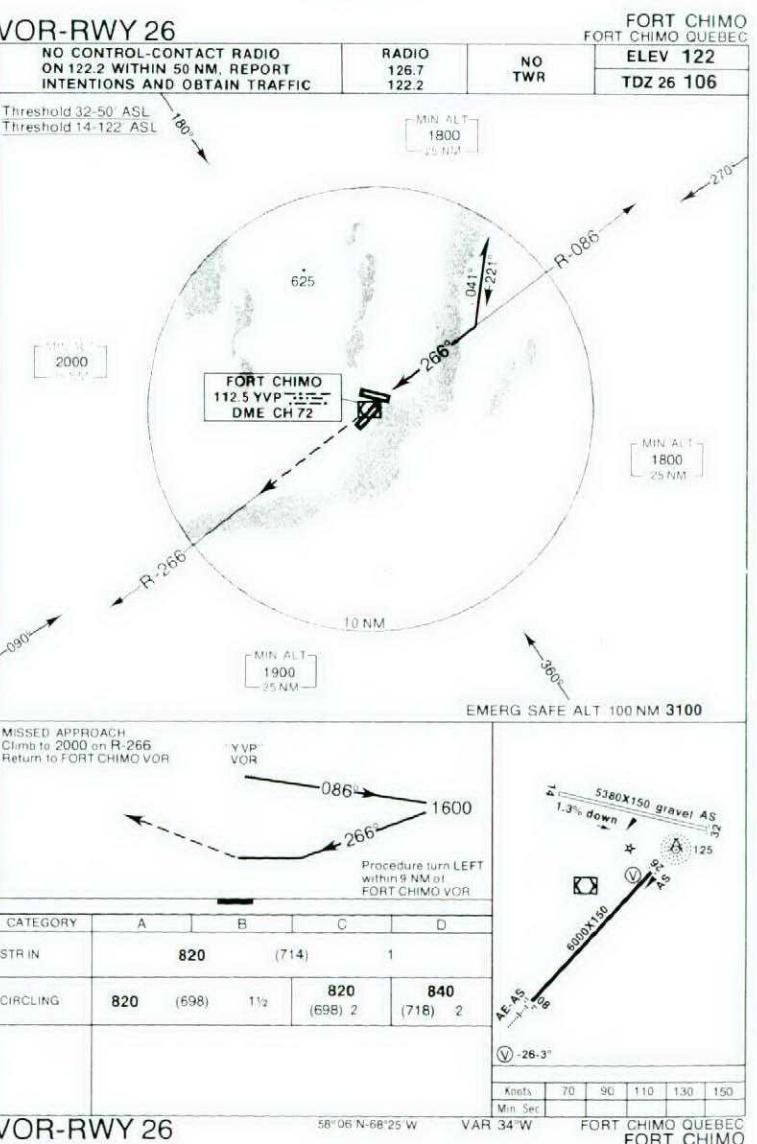
Figure 1

If we now examine Figure 1, it may be seen that it is a beacon-on-the-field VOR but *the procedure turn must be completed within 9 NM*. If the pilot allowed an extra minute outbound timing, assuming 165 KTAS and a 60K tailwind, he would fly 7.5 NM prior to commencing the procedure turn. He would then fly the procedure turn heading for an additional minute which would put him 10.75 NM from the VOR. His turn radius on the 180° procedure turn would add another 2 NM so as to put him 12.75 NM from the nav aid. Put another

The temperature correction charts in FLIPs are based on the aerodrome temperature for field elevations of zero (MSL) and do not allow for ISA temperature change as a result of increased field altitude. For example, let us assume the actual temperature at an airport 2,000 feet MSL is -30°C. Uncorrected the altimeter would have a relatively large error, however, the altimeter setting will correct for temperature (density) and the altimeter will read correctly on the ground at the altimeter setting source. The correction chart in FLIPs instructs us to use the aerodrome temperature (-30°C) and move across the chart to the HAT or HAA to find the correction. Let us assume an 800 feet HAA. The altimeter error from the chart is 140 feet which would be added to the MDA.

A more accurate method of calculating altimeter density error would be to first find what the ISA temperature is at 2,000 feet MSL, then calculate the difference between ISA and actual temperature. (The correct adjustment for this Example is 131.2 feet).
