SPRING 2005

Flight Comment

- *Metal Fatigue — It's Got a Bad Name*
- *Predators on Patrol*
- *Communications During Aircraft Ground Deicing Operations*

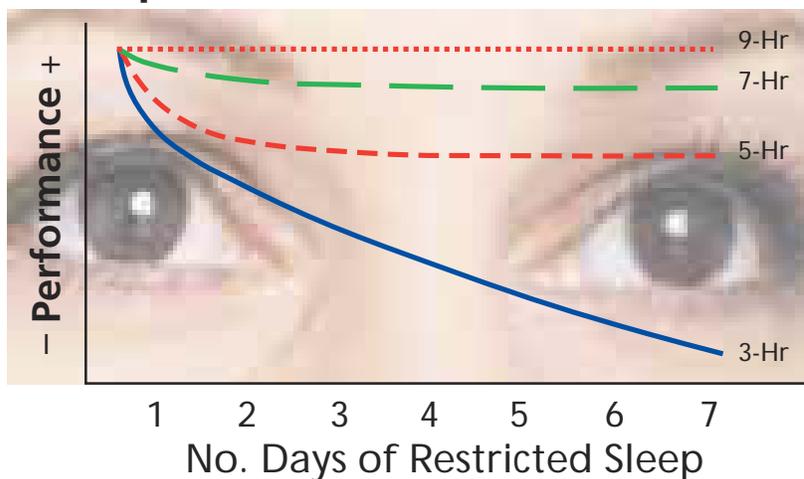
Sleep Restriction vs. Performance

Adapted from: "Patterns of performance degradation & restoration during sleep restriction and subsequent recovery: a sleep dose-response study" Belenky et al., J Sleep Res. Vol. 12:1 Mar 2003.

For individuals consistently running on 5 or 6 hours of sleep, take note: Recent studies indicate human performance drops off significantly, and then stabilizes at a lower level following mild (7-hour sleep period) and moderate (5-hour sleep period) sleep restriction. Experts caution that 5 hours of sleep per day is the absolute minimum and should not span more than 14 consecutive days ... or rule # 2 may kick in!

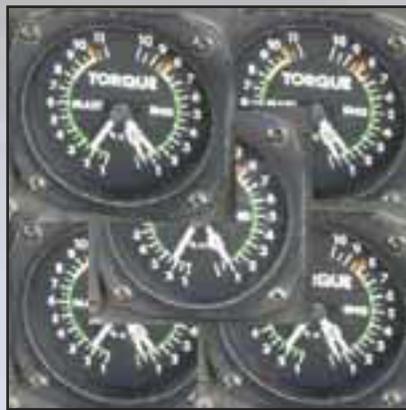
A collage of Griffon torque gauges showing “the split” — not exactly representative of flight conditions but you get the idea.

The *Griffon's* co-axial engine torque needles need to be carefully monitored to ensure that the engines stay on condition with each power change (the manually controlled engine about 5% below the automatic; commonly referred to as

“the split”). In the blink of an eye the two torque needles can overlap or even swap positions if there isn't a throttle reduction with every reduction in power to the main rotor.

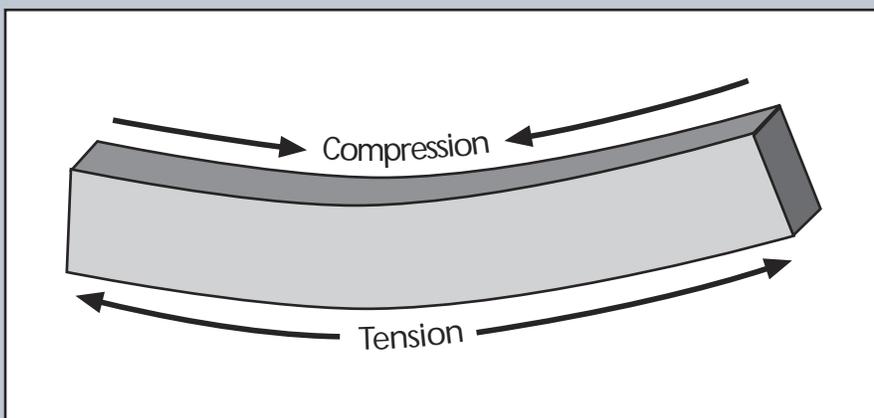
Bending the bar results in tension on the lower surface and compression on the upper surface.

As described above, in looking for loads that may lead to fatigue we are interested in repeated applications of tension on a component. An obvious case would be a part that is subjected to a pulling force that relaxes periodically. An example of this would be the pressurization of the fuselage. If one imagines a section of a fuselage to be a circular hoop which tends to expand like a balloon when pressurized the tensile loading is easily visualized. How about bending? As an object like a bar is bent, there will be tension on one surface of the bar and compression on the opposite surface, as shown on page 25. Fatigue crack growth will be possible on the tension side of the bar. This type of loading would be typical of a wing spar or a helicopter rotor blade.

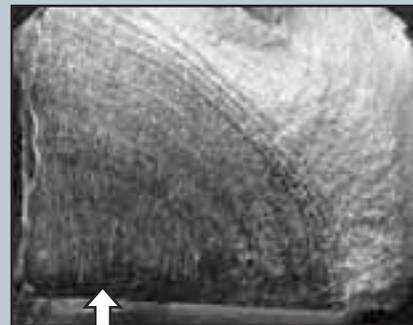
SEM Photograph of an example of a fatigue fracture on a CF-188 flap hinge. The arrow indicates the initiation site. The beach marks are clearly visible in the fatigue zone, while the lighter shaded area (upper right) shows the roughness indicative of the overload zone.

that displays a fracture face that has zones of differing appearance should be investigated further. Secondly, because of the progressive nature of fatigue crack growth the fatigue zone often shows a ring-like growth pattern, somewhat similar to the growth rings on a tree. These patterns are called “beach marks” since they are reminiscent of the effect of waves in the sand at the waters edge. Finally, a fatigue fracture surface tends to be much smoother and flatter than an overload failure, however this is not a very certain indication, since there are other failure modes that also result in a smooth fracture surface.

- Two distinct fracture zones;
- “Beach Marks” — they look like growth rings;
- A relatively smooth, flat fracture surface.
