SUMMER 2005

# Flight Comment

- *Transformation Project*
- *Flight Data Monitoring  
— A Proactive Approach to Safety*
- *Tail Rotor Half Hub*

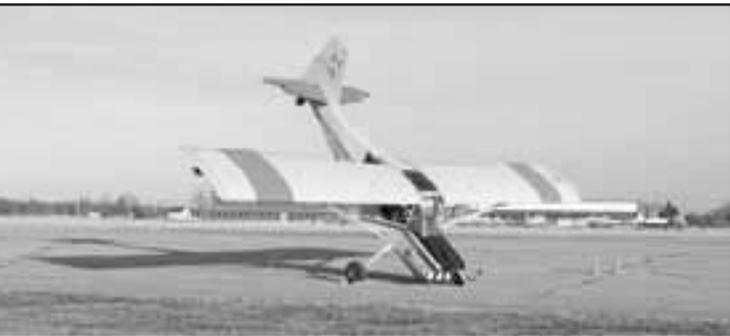
The aircraft struck the left hand wingtip and came to rest on its nose, damaging various propeller components. Damage sustained in the occurrence rated this as a "D" category incident.
