National
Defence

WINTER 2005

Flight Comment

THE CANADIAN FORCES FLIGHT SAFETY MAGAZINE

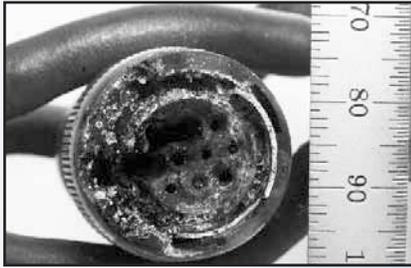
Connector showing damage to the three phase pins

On 18 February 2002, a fire onboard a *Labrador* helicopter CH113304 was initiated at an electrical connector. One possible cause identified by the Quality Engineering Test Establishment (QETE) was that the blank/empty pinholes in the connector possibly allowed pin movement and shorting. The connector was a ten pin connector but only five pins were used, neither the unused pins nor the blanking pins were installed.

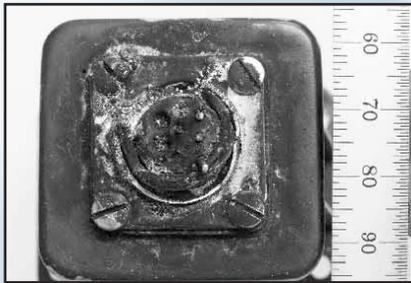
Relay end of the connector showing the damage to the three phase pins and the melted connector case.

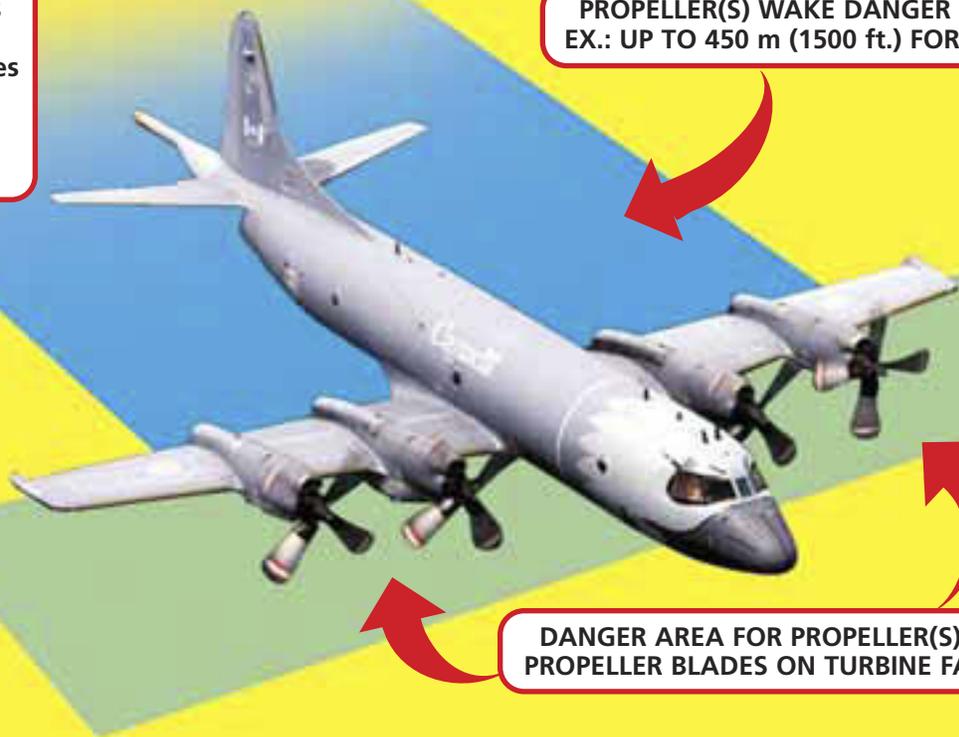
FIGURE 2: Major/typical danger areas for propeller-driven aircraft

AREA		THINGS TO WATCH FOR:
1	Propeller(s)	<ul style="list-style-type: none"> • Propeller(s) often hard to see when running • Propeller(s) blades failure
2	Propeller wake (Prop wash)	<ul style="list-style-type: none"> • Wind velocity behind aircraft can be very high, which causes people, AMSE, rocks, dust and other matter to be thrown far behind the aircraft (up to 450 m (1500 ft) for the CP140)
3	Auxiliary Power Unit (APU, GTC)	<ul style="list-style-type: none"> • Exhaust — high temperature • Intake — powerful suction on some aircraft
4	Turbine	<ul style="list-style-type: none"> • Disintegration of turbine could create shrapnel and other debris

- Weapons
 - bomb bay doors
 - externally jettisoned stores
 - pyrotechnics
- RF emission
- APU

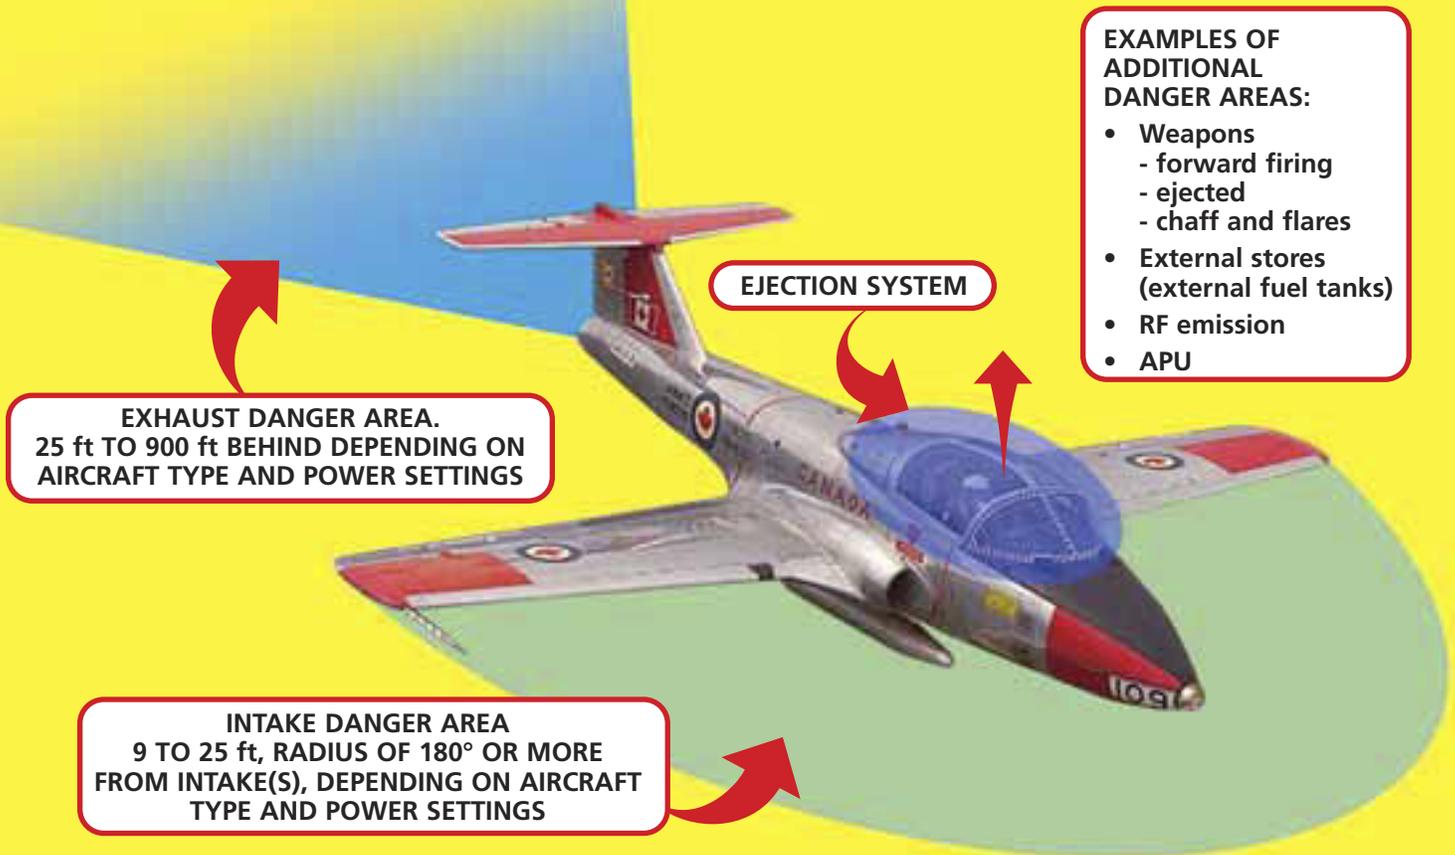
FIGURE 3: Major/typical danger areas for jet aircraft

AREA		THINGS TO WATCH FOR:
1	Jet engine(s) intakes	<ul style="list-style-type: none"> • Very powerful suction. Danger area starts from the intake(s) to approximately 3 m (9ft) and can extend up to 7.5 m (25 ft) or more in from of the engines, depending on power settings and aircraft type
2	Jet engine(s) exhaust	<ul style="list-style-type: none"> • Jet blast behind aircraft can be severe, which causes rocks, dust and other matter to be thrown far behind the aircraft (up to 275 m (900 ft) for the <i>Hornet</i> at maximum power) • At high power, people and AMSE can be thrown to the ground as well • High temperature — up to 538°C (1000°F) for the <i>Hornet</i> at maximum power
3	Auxiliary Power Unit (APU)	<ul style="list-style-type: none"> • Exhaust — high temperature • Intake — powerful suction on some aircraft
4	Ejection system	<ul style="list-style-type: none"> • Ejection of canopy and/or seat(s)

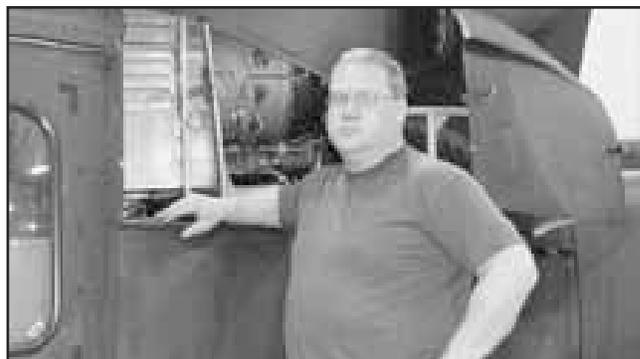
He specifically suggested that a thorough visual inspection of all areas that might introduce a contaminant into the system be carried out. As a result, it was discovered that pressurization of the fuel boost system was resulting in leakage from a fuel pressure sensor fitting, which was then running along the pressure line and pooling at the lowest point of the baffle. Fumes from this pooled fuel

were then being drawn into the system via the compressor inlet and eventually being introduced into the heating system via engine air. Rectification of the leak eliminated the odour problem and the aircraft was once again serviceable.

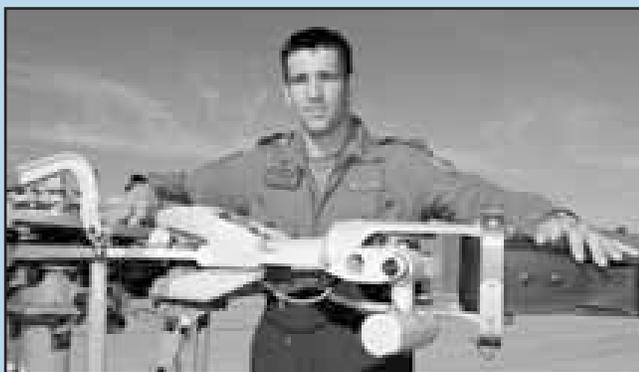
Captain Gautron was doing the pre-flight of *Griffon* 146426 on 7 July 2004. During his inspection of the main rotor hub, he noticed a gap in the elastomeric

bearing of one of the blades. On further inspection he noticed that the bearing had delaminated from the spindle, causing dust to build up on the spindle. He immediately reported the situation, which led to the grounding of the aircraft.
