ISSUE 2 2006

Flight Comment

- ✦ *NOTAMs: Do You Really Have Them All? (Part 2)*
- ✦ *Thumbs Up: A Lesson in Hoist Safety*
- ✦ *Helicopter Ground Resonance*

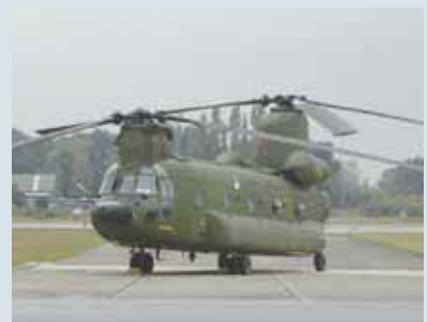
Figure 1

the blade to move up and down. This is known as “flapping”. Components within the pitch varying housing allow the blade to rotate about its span (the distance from end-to-end). This is known as “feathering”. A vertical hinge pin allows the blade to swing forward and aft with respect to rotor-head rotation. This is known as “leading and lagging” (hunting) . The vertical hinge pin has also been called the “drag hinge”. (see Figure 1)

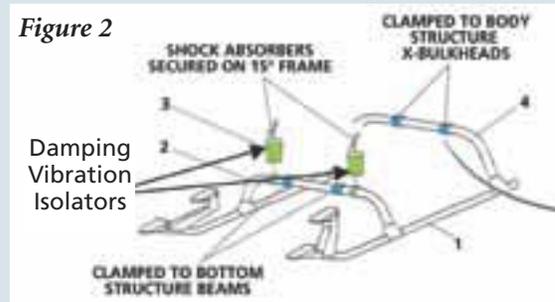
Figure 2

the solutions. One type of damper is described in the following quote from heli-chair.com. “Ground resonance is mitigated...by employing the use of damping vibration isolators to attach the landing gear to the airframe. The dampers are tuned to absorb energy at the proper frequencies of ground resonance and typically can prevent this destructive event.” Proper maintenance of dampers is critical for safe flight. (see Figure 2)

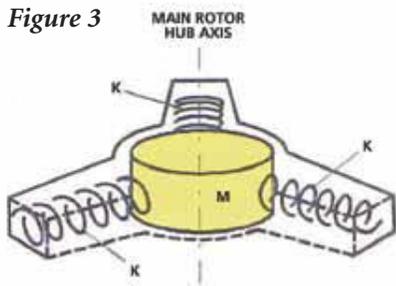
Figure 3

Various engineering arrangements are useful in intervening in the resonance scenario. For example a Rotor Hub Vibration Absorber may be used to counteract divergent excitation vibrations in the rotor mast. The resonator acts on excitation loads at their source. A weight is located on the rotor hub axis and is held in place by 3 springs allowing it to vibrate. The weight/springs system is excited

by the periodic cyclic loads on the rotor hub, and responds at the excitation frequency by counteracting the excitation load. (see Figure 3)

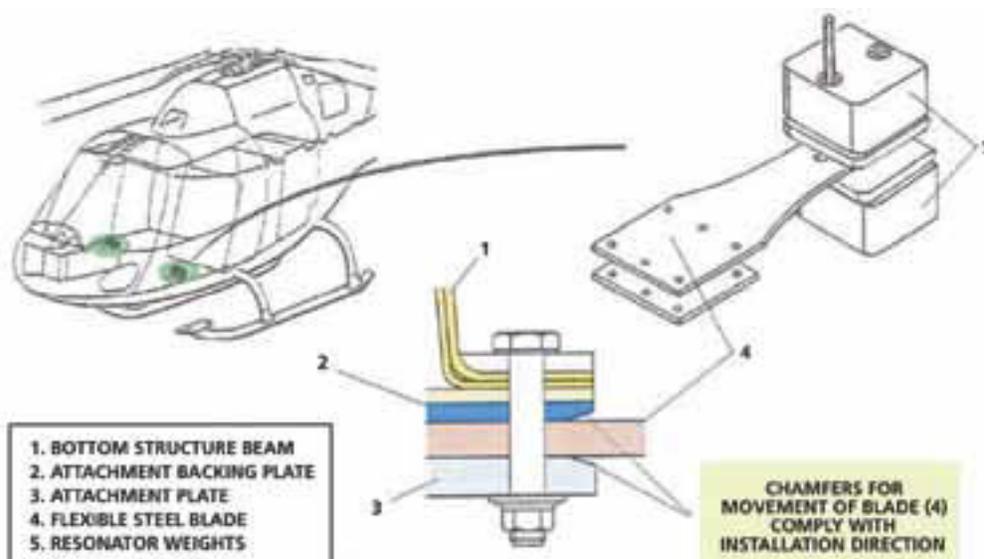
Figure 4

Another engineering intervention is a Cabin Resonators system, used to cancel out vibrations at the aircraft natural frequency, which is normally near three (3) Hertz . The cabin resonator acts on a principle of physics called the resonator principle. It acts by damping the aircraft vibration at the attachment point, thereby reducing the vibration level. (see Figure 4)

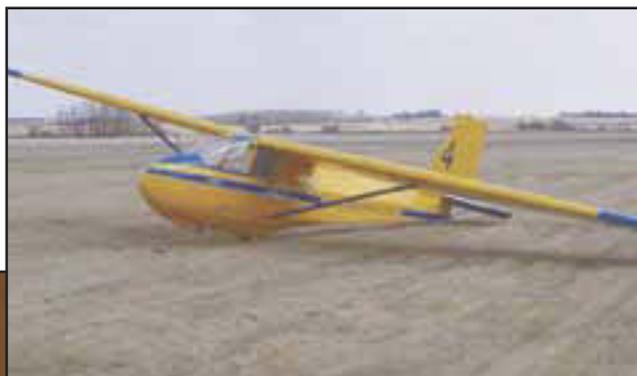
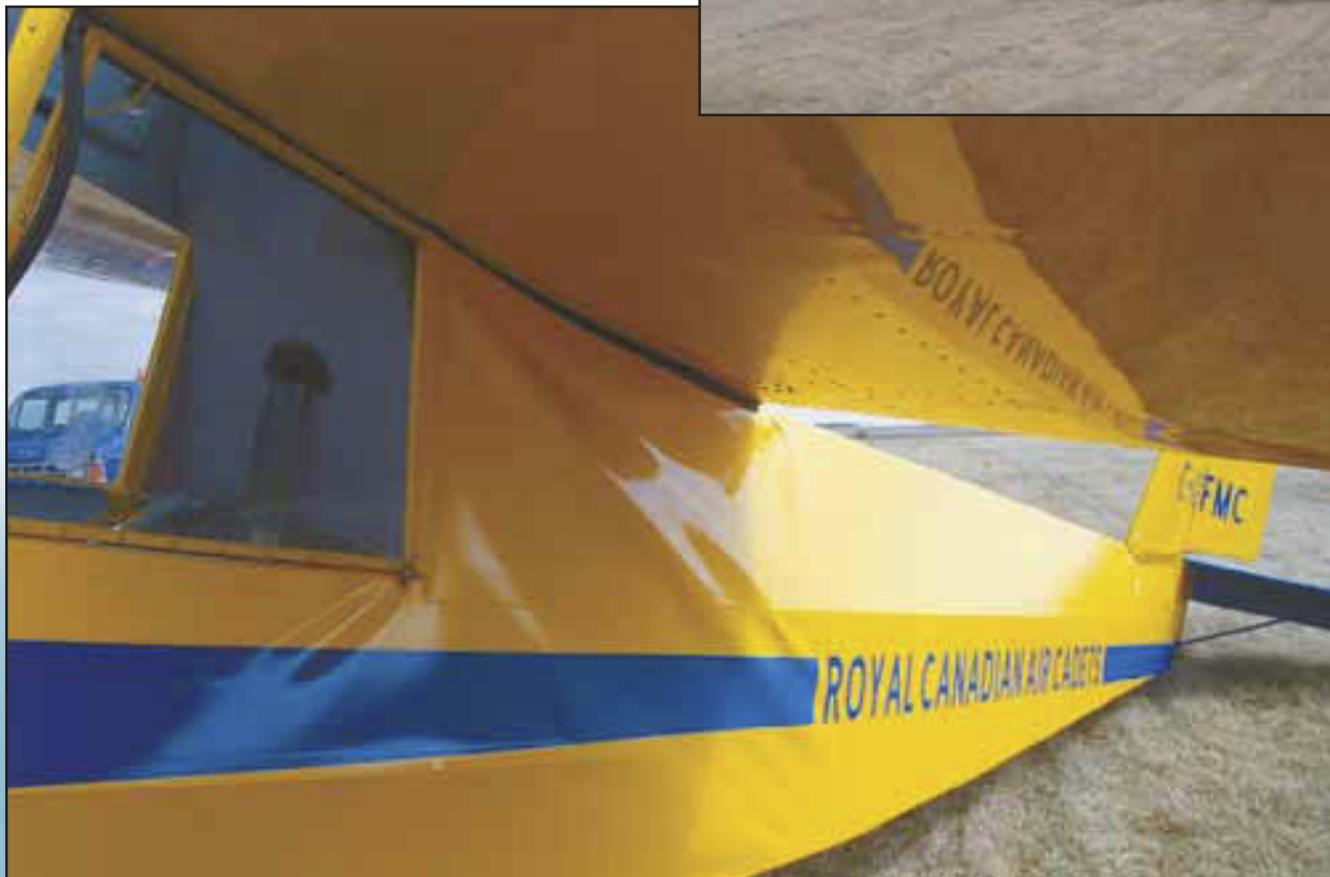
Investigation revealed that the winch had not been operating at optimum performance throughout the day. The spark plugs had become increasingly fouled due to a leaking power valve. The normal maintenance inspections did not pick-up this progressive breakdown. Discussion is on-going with respect to treating winch engines as 'airworthiness' assets.

The investigation also noted that after the momentary power loss the winch operator focussed his attention from the glider to the winch, then back to the glider. This delay in reducing the winch engine to idle and applying the cable brake was a contributing factor to this accident. A National Pilot Information File was issued which states, "At any time that a winch experiences a momentary power loss, the immediate action shall be to close the winch throttle and apply the cable brake." Recommendations also address winch operator training. ♦

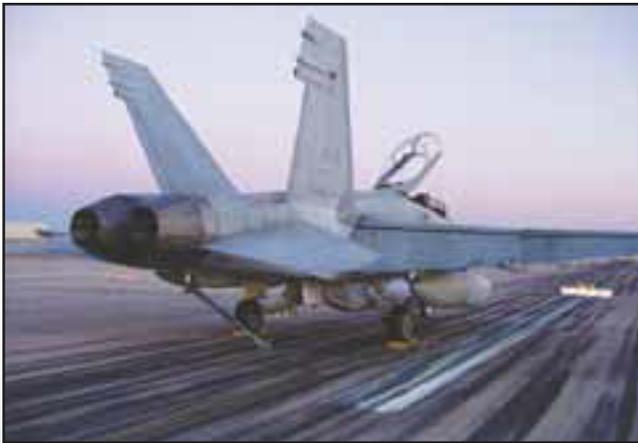
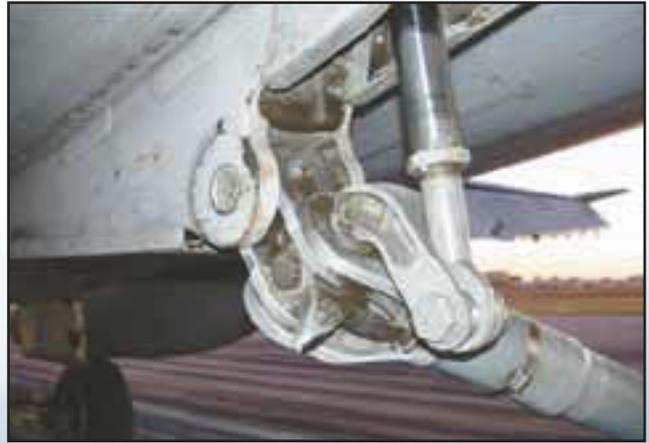
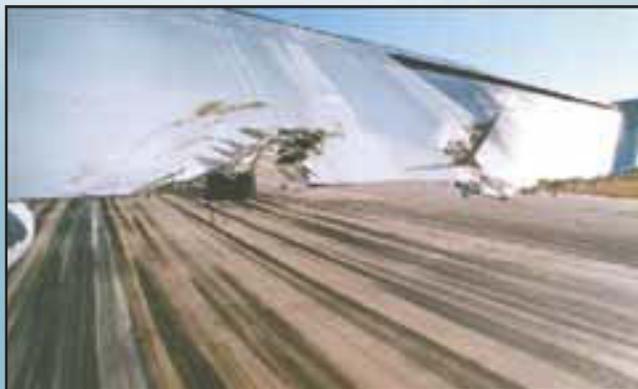
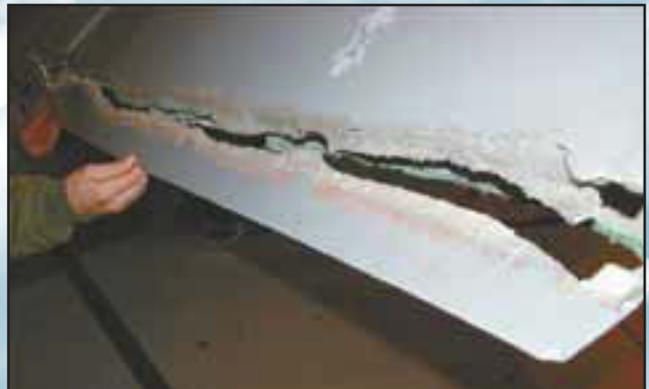
TYPE: CF188933 *Hornet*
LOCATION: Tinker AFB,
Oklahoma, USA
DATE: 13 January 2005

the E-5 arrestor gear in the undershoot area of runway 12, 70' before the threshold. The aircraft's main landing gear then touched down prior to the runway threshold. After encountering difficulty with directional control, the PIC used emergency braking to bring the aircraft to a halt on runway 12, 7500' from the threshold. After conducting a normal shutdown, both pilots egressed uninjured. The aircraft sustained "D" category damage; the E-5 arrestor cable and runway also sustained damage.

The Flight Safety Investigation revealed that the CF-188 crew were unaware that the tail-hook touchdown point can be over 500 feet prior to the intended aim-point (depending on variables such as glide path angle, and angle of attack). Recommendations include amending manuals to ensure aircrew are aware of the difference in touchdown points.

The engine oil pressure fluctuations were caused by a faulty connector which had failed due to a cracked oil pressure transmitter bracket. False oil pressure indications have resulted in approximately 15 single-engine landings over the past five years. Recommendations include a re-design of the transmitter bracket, and modifications to the inspection procedures. ♦

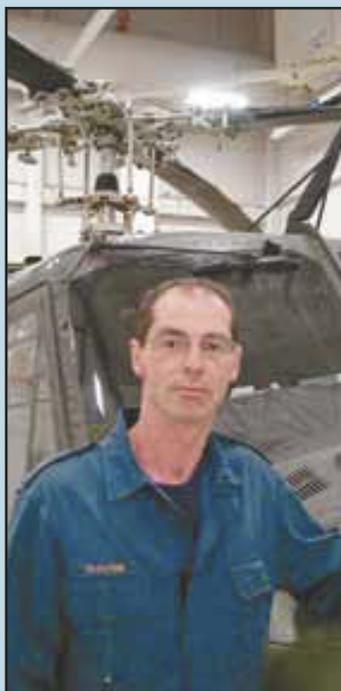
MASTER CORPORAL DENIS CLOUTIER

While conducting a 25-hour 30-day inspection on *Griffon* 146408, Master Corporal Cloutier was examining the main rotor head and flight controls system when he noticed that both drive links were just slightly out of position. Upon closer investigation, he observed that both drive link washers were actually missing. These washers align each of the drive links and prevent the drive link-bearing end from wearing into the swashplate.

In this case, due to the damage, one on the two drive links had to be completely replaced.

The ensuing investigation revealed that these washers had been missing since the completion of the 2500-hour inspection, 210 operating hours ago. During that time the aircraft had undergone two separate 100-hour inspections, many 25-hour/30-day inspections and untold pre-flights without the fault being detected. Because the drive links have a normal operating life of 5000 hours it is probable that the deterioration of the bearings would have progressed unnoticed for some time.

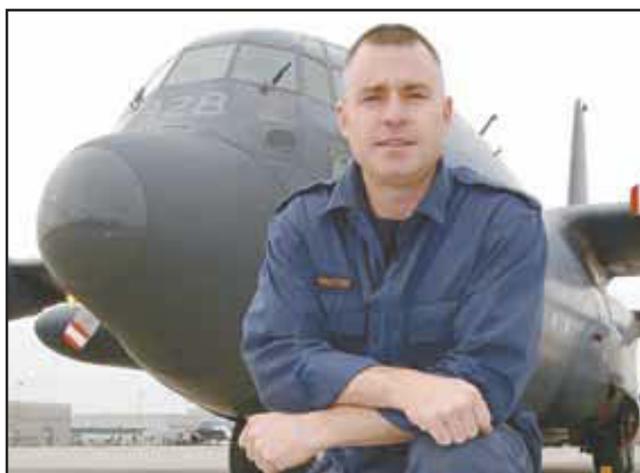
In October 2005, Private Walton, an Avionics Systems Technician was tasked to fix an unserviceable jump light on *Hercules* CC130305. While performing the repair, he observed that part of the ramp rail assembly was missing. Private Walton immediately alerted the Flight Engineer and his supervisors and the scheduled mission was cancelled.

The pursuant flight safety investigation revealed that the missing component had departed the aircraft due to a hung load during a heavy equipment drop conducted several days earlier. Private Walton's keen observation had been missed by several aircrew and by more experienced technicians during their checks. Private Walton got qualified as a journeyman only a few weeks before. Private Walton's unfamiliarity with the aircraft structure, the obscure location of the damage, and his relative inexperience makes his observation all the more remarkable.

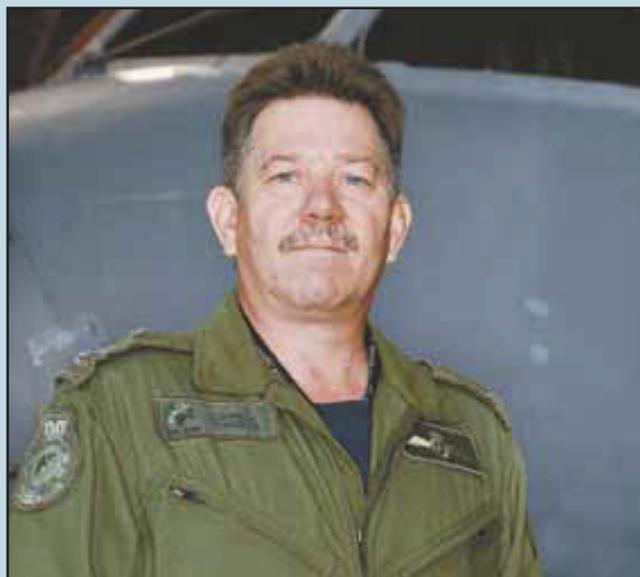
SERGEANT LOWELL O'KEEFE

In October 2005, Sergeant O'Keefe, a flight engineer (FE) on the CP-140 *Aurora*, was conducting an external pre-flight inspection when he noticed a crack on the nose wheel steering cylinder nut. The nose gear area had accumulated dust and dirt over time, masking this particular crack. Many technicians and FEs who had worked in and inspected this area had missed this defect. Although the FE external pre-flight inspection of the nose wheel area includes several steps, there is no mention to inspect the nose wheel cylinder.

Closer inspection revealed that the crack was 8 inches long. The nose wheel cylinder nut, normally installed with 800-1000 inch lbs of torque, required very minimal force to be removed indicating failure was likely imminent.

Following testing at the Quality Engineering Test Establishment, it was determined that the fault in the nut was a progressive fatigue crack that had been present for quite some time. In light of this incident, nose wheel steering cylinder nuts are now inspected for fatigue cracks at 3rd line overhaul.
