ISSUE 3 2007

Flight Comment

- ✦ **Maintainer's Corner**
Tampering with Torque (page 6)
- ✦ **From the Flight Surgeon**
Solving the Misery: Motion sickness in aviation (page 9)
- ✦ **178 Seconds to Live**
VFR into IMC (page 18)

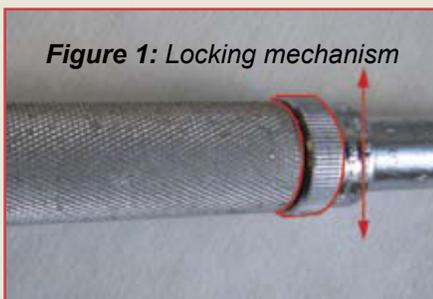
Figure 1: Locking mechanism

Proper torque values play an important role in day-to-day aircraft maintenance. Torque wrenches are precision instruments, calibrated to indicate the exact amount of force being applied to a nut or bolt. This is paramount in ensuring that aircraft components are precisely installed so that nuts and bolts don't become loose, which could permit excessive play, disconnections, and, ultimately, unexpected performance. Torque instruments must therefore be well maintained and regularly verified to guarantee accuracy. The role of the technician is to keep it clean and release the pressure and locks (*Figure 1*) and reset the torque value to its lowest setting after every use and before storing.

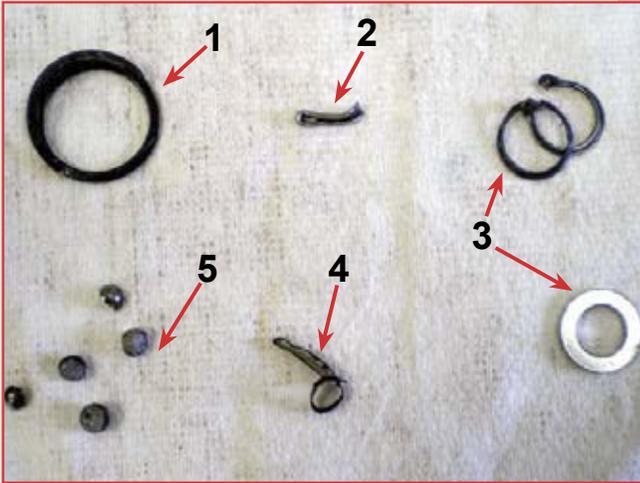
Figure 2: A sampling of the unsafe items found that revealed obvious tampering:

1. Ratchet seal, soldered, in place of the Cerro safe seal
2. Cotter pin found in load spring
3. Circlips and aircraft washers used as spacers
4. Metal shaving found inside torque wrench
5. Broken ball bearings in lock mechanism

A very disturbing trend is emerging, where a high percentage of torque wrenches that come to CFTCC for repair have been opened or altered in some way. It is not unusual to receive one with the handle covered in duct tape in an attempt to hold it all together. Are technicians really using tools in this condition? We hope not! A taped up wrench may be good enough for the garage, but it doesn't cut it for aircraft maintenance. And the things that are found inside torque wrenches are also very unsettling (*Figure 2*): spacers have been replaced with circlips or aircraft washers; parts are installed in the wrong order, or just plain missing; sometimes there are split pins, locking wire, and metal shavings in handles and spring tubes; and incorrect lubricants are found to have been used, clogging the internal mechanism or causing excessive

With the number of torque wrenches available in units, there is no need to take it upon yourself to make a wrench work and save the day. There is no reason to grind down pivot blocks, drill holes through ratchet tangs, or shave, grind or shorten load screws. But this all happens on a regular basis and it is compromising the integrity of torque wrenches. Based on the number of altered torque wrenches seen at CFTCC, it appears that there are many altered wrenches out there. This is worrisome because CFTCC only sees the wrenches that are actually sent for repair: it is possible that many altered wrenches out there are still considered serviceable.

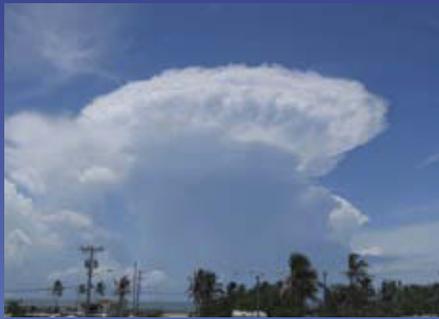
CUMULONIMBUS (CB)

Heavy, dense cloud. Lightning, thunder and hail occur and there may be moderate to heavy showers of rain, snow or hail. Turbulence may be severe both in and below cloud, very violent on entering or leaving. Risk of icing; clear ice likely above the freezing level.

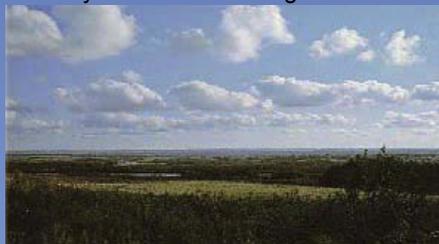
CUMULUS (CU)

Generally dense with sharp outlines and uniform bases. Light to moderate turbulence in fine weather. Large cumulus may generate moderate to severe turbulence both in and below cloud; strong turbulence on entering or leaving. Rain or snow may occur. Risk of icing; clear ice just above freezing height.

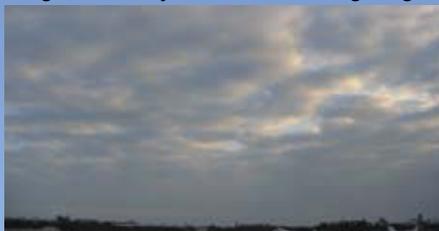
STRATOCUMULUS (SC)

Grey or whitish patch or sheet of cloud. Very light rain, drizzle or snow may occur. There may be light to moderate turbulence beneath and in cloud, and when passing through inversion at cloud top. Smooth above. Occasional rime icing if the freezing height is low enough. A change in air density through the inversion causes changes in aircraft performance.

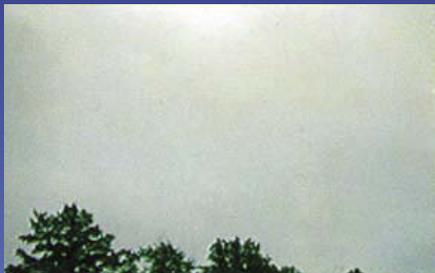
STRATUS (ST)

Generally a grey cloud layer with fairly uniform base, which may precipitate as drizzle. Light turbulence. There may be an inversion as with stratocumulus. Usually no icing. At takeoff you need to attain a good speed early in the climb and exercise care in descent.

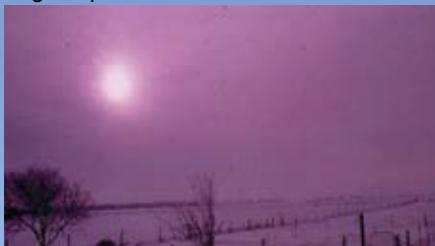
ALTOSTRATUS (AS)

Greyish or bluish cloud sheet. Rain or snow can occur. For thin altostratus there may be a little turbulence in the cloud. Some risk of icing and light rime. Clear ice is possible in lower levels of cloud. For thick altostratus, turbulence is generally light in cloud. Turbulence may be moderate to severe at fronts and over high landforms.

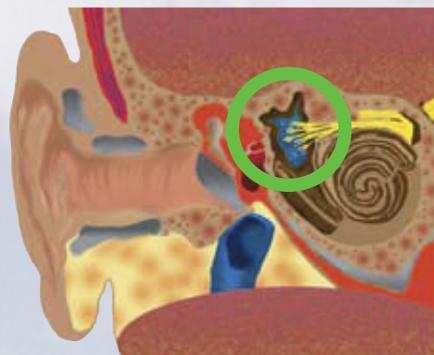
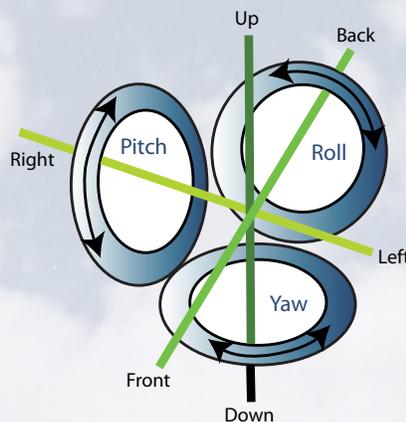
Each of the three canals in the inner ear is aligned along a different axis of rotation and contains a small tuft of sensory hairs (above circled). Orientation illusions can occur when these hairs are affected by acceleration.

Spatial illusions and disorientation are created when the fluid of the inner ear responds to acceleration, deceleration, pitch, roll and yaw.

Forces on the ear: Each of the three canals in the inner ear is aligned along a different axis of rotation and contains a small tuft of sensory hairs (circled above). Orientation illusions can occur when these hairs are affected by acceleration.

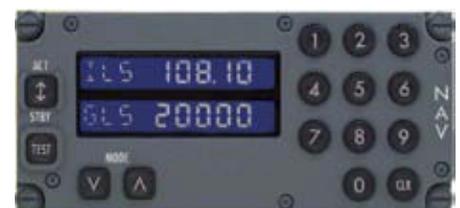
Figure 1: Gables G7501-01 GLS-capable navigation control panel (image courtesy of Boeing)

Landing System, providing both lateral and vertical guidance down to CAT III minimums. Recently, three ICP School staff had the opportunity to fly GLS approaches in a Boeing 737-800 Next Generation aircraft simulator (see in *Figure 1* for the navigation control panel used). It was very similar to ILS to both set up and fly.

GLS stands for GNSS landing system. This is the satellite-based equivalent to today’s Instrument

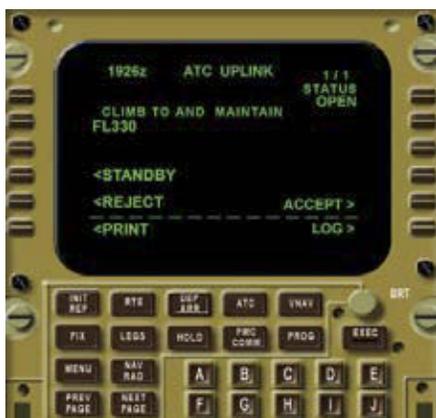
Figure 2: Boeing 747 FMS CPDLC page (image courtesy of Boeing)

CPDLC stands for controller-pilot data link communications. This system is intended to allow the communication of routine ATC instructions through data link vice voice radio. Many airlines and corporate operators are already receiving their initial IFR clearances through data link. The picture in *Figure 2* shows a Boeing 747 flight management system (FMS) CPDLC page with a clearance from ATC to “climb and maintain flight level 330.” Note some of the options available for the crew depending on which button they select: standby, reject or accept.

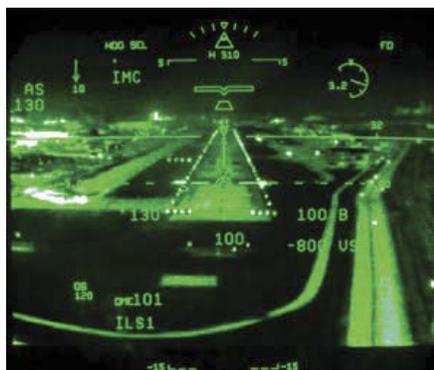
Figure 3: EVS night view

night vision goggles (NVGs) in that it is intended to provide a means to see through darkness and, unlike NVGs, through cloud as well. *Figure 3* is a night approach as seen with EVS through a head-up display (HUD).

EVS stands for enhanced vision system. This technology uses different methods, but is similar to

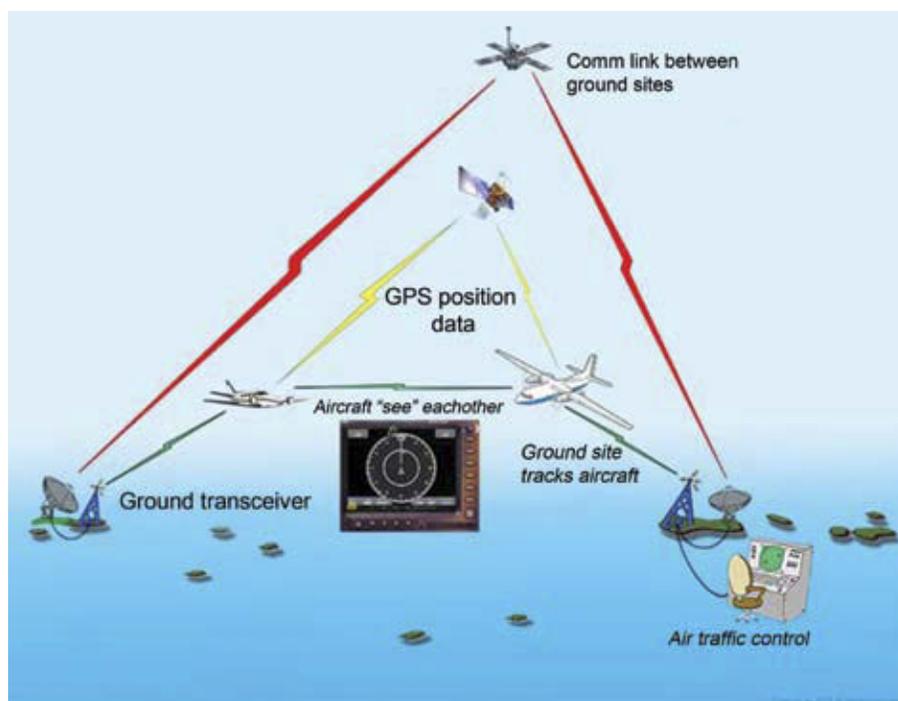
Figure 4: Basic ADS-B architecture (image courtesy of ADS-B)

ADS-B is the acronym for Automatic Dependent Surveillance-Broadcast. This system is designed to provide surveillance capability both between aircraft and ATC. The way it works is relatively simple. Aircraft use GNSS to derive their position. That position information plus other data is then transmitted via datalink to other appropriately equipped aircraft or ATC facilities. *Figure 4* outlines the basic ADS-B architecture.

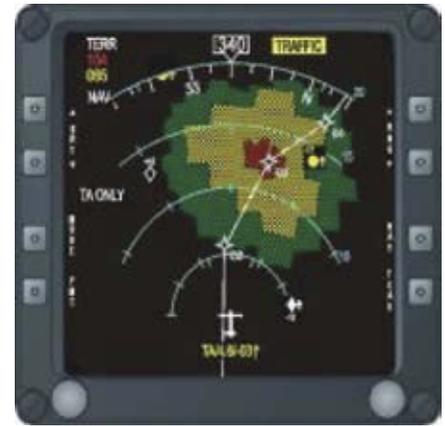
Figure 6: TAWS display

TAWS is the acronym for terrain awareness and warning system. This is the modern version of the ground proximity and warning system (GPWS). *Figure 6* shows a typical TAWS display. If you stay on the track depicted you will crash into a mountain peak!

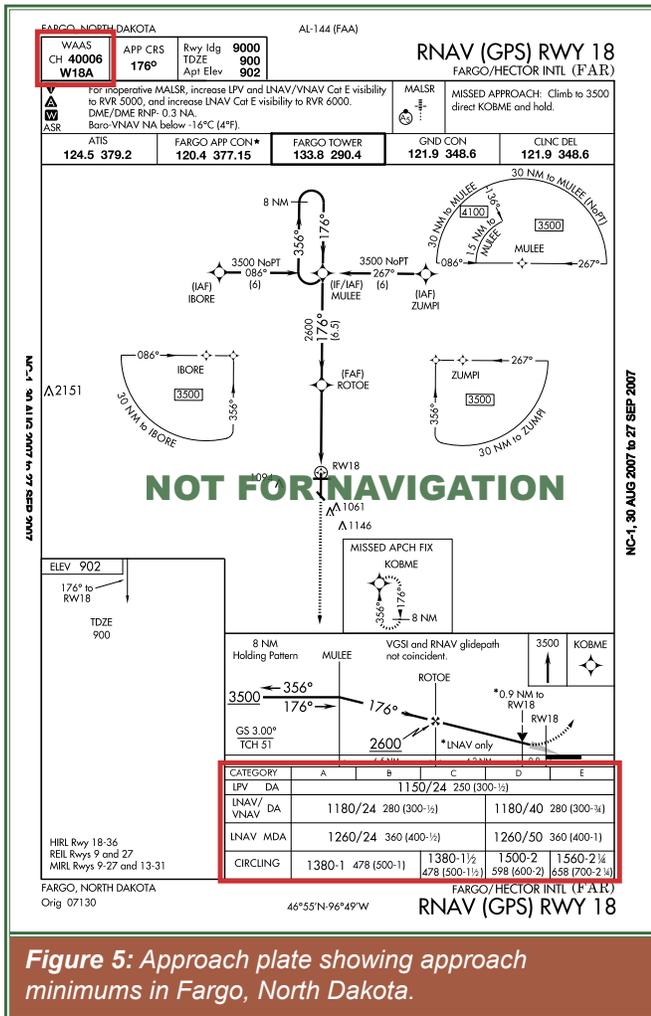
Figure 5: Approach plate showing approach minimums in Fargo, North Dakota.

RNAV stands for lateral navigation. RNAV approaches are space-based non-precision approaches. These approaches require GPS avionics. The approach plate in *Figure 5* has RNAV minimums. ♦

nearing ILS standards. A sample approach plate is shown in *Figure 5*.

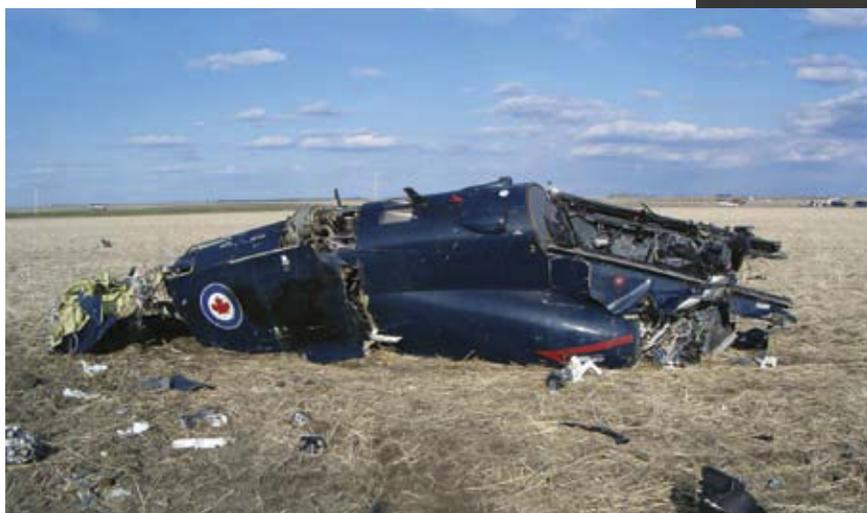
TYPE: *Hawk CT155202*
LOCATION: Moose Jaw, Saskatchewan
DATE: 14 May 2004

The crew of two had completed a low level navigation syllabus mission, and were utilizing their remaining time conducting proficiency flying in the traffic pattern at 15 Wing Moose Jaw. The instructor pilot (IP) had just taken over aircraft control, with the aircraft accelerating and positioned near the departure end of Runway 29 Right. At about 70 feet above ground level (AGL), 239 knots indicated airspeed (KIAS) with the landing gear up and combat flaps selected, a bird struck the left side of the aircraft. This was immediately followed by several engine warnings and very high engine temperature indications. The IP initiated a climb to trade airspeed for altitude, confirmed that the engine temperature remained high, and told the student pilot (SP) to prepare to abandon the aircraft. As the aircraft descended through 3000 feet mean sea level (MSL), (about 1000 AGL) and after confirming the student was ready, the IP initiated ejection. Both pilots survived the ejection, but the IP was seriously injured and the SP received minor injuries in the ejection. The aircraft crashed in a farmer's field about one mile north of 15 Wing and was destroyed. Investigation revealed a gull hit the angle of attack probe, then entered the left hand engine intake and was ingested by the engine, causing serious damage.

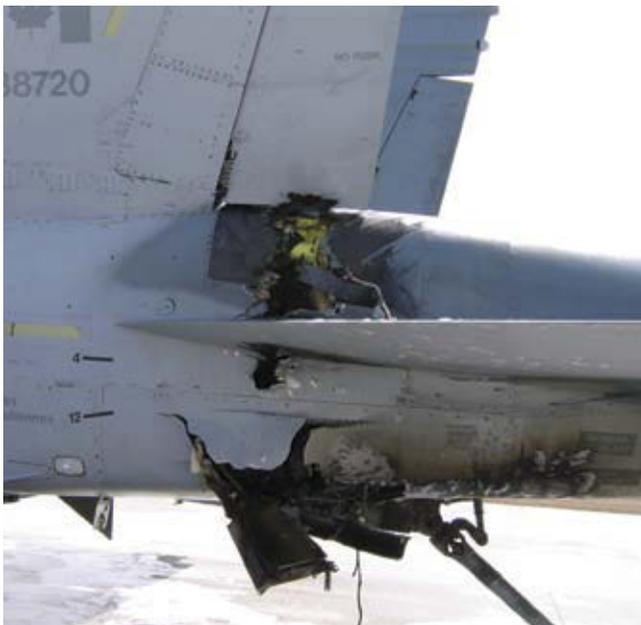
TYPE: *Hornet CF188720*
LOCATION: Bagotville, Quebec
DATE: 16 May 2007

Investigation revealed that the left-hand engine had suffered a catastrophic failure of the low-pressure turbine disk. The engine was found to be separated into two sections. Only a small portion of the low-pressure turbine (LPT) disk was recovered.

The inspection of the engine also revealed that the actuating ring attachment plate for the inlet guide vanes was missing 2 bolts and nuts at the 9 o'clock position with 4 inlet guide vane arms not connected to the actuating split ring. As a result of this finding, the F404 engine technical authority immediately directed field units' engine bays to conduct a sampling inspection to confirm the presence of all attachment hardware for the high-pressure compressor (HPC) variable guide vanes actuating split rings. All HPC modules were found with the appropriate hardware.

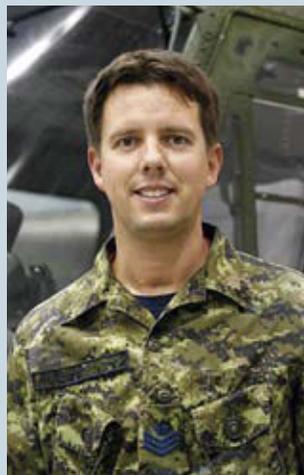
When the gearbox was uninstalled and thoroughly examined, it was observed that the mounting holes were severely elongated. The hole measurements indicated that two of the four were beyond the allowable limit, although the condition of the gearbox shims was normal.

Sgt Rancourt repeated the gearbox installation procedure in order to find out what went wrong. He had to put one more washer under each bolt head, as authorized by the Canadian Forces Technical

Order (CFTO), so the assembly would not move after applying initial torque. Adding extra washers made the assembly very secure after final torque was applied. It is clear that an additional washer under each bolt head would have been needed on the initial installation. Unfortunately, this fault allowed the gearbox to move, which caused the

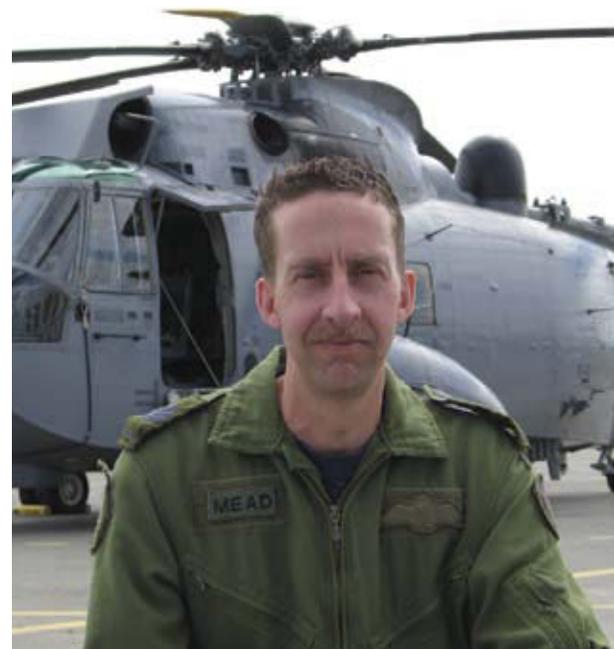
The investigation revealed that the bolts were installed opposite to the direction of rotation contrary to the Canadian Forces Technical Order (CFTO). If the nuts had loosened, the centrifugal force may have expelled the bolts causing a catastrophic tail rotor failure and the possible loss of the helicopter and crew.

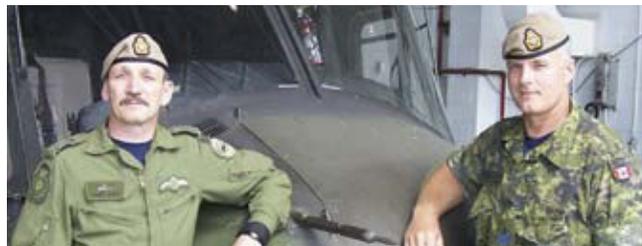
On 8 March 2007, during a CH146 *Griffon* helicopter pre-flight inspection, Master Warrant Officer Dodd found a roll pin and screw head on the cabin floor behind the pilot seat. This type of hardware is not typically used on helicopters and it makes common sense to suspect that it could have fallen off from a passenger's equipment.

MWO Dodd wasn't satisfied with this reasoning and he requested technical assistance to confirm that the hardware found wasn't from the helicopter. The maintenance crew chief, Sergeant Charbonneau, further investigated the provenance of the hardware and found that these items were used to hold the fire suppression system activation fire handles to the fire handle arm. Should an emergency have occurred, requiring the activation of the fire suppression system, the aircrew would have pulled the fire handle and it would have separated from its arm without activating the system. Sgt Charbonneau immediately inspected the fire handles on other aircraft to confirm

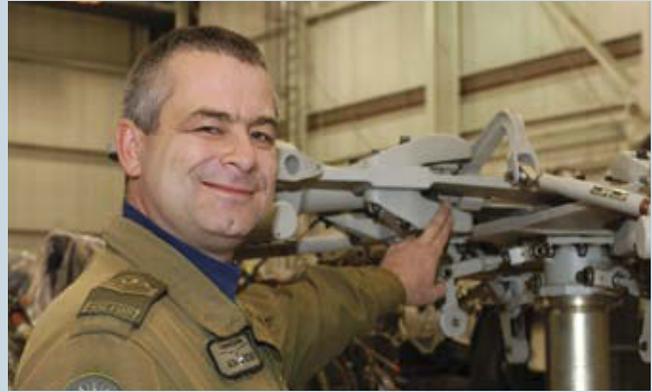
Maintenance personnel had installed the four bridge damper sets the previous day. The work was signed off and the aircraft was certified serviceable after the test flight. The dampers are difficult to inspect so an improper installation is easy to miss. Only an outstanding attention to detail allowed MCpl Smith to catch the error.

MCpl Smith has been a flight engineer for only 3 years. His uncommon awareness enabled him to visually detect the incorrect installation of a key component of the main rotor head in a very confined and hard to see area; even though it is not normally

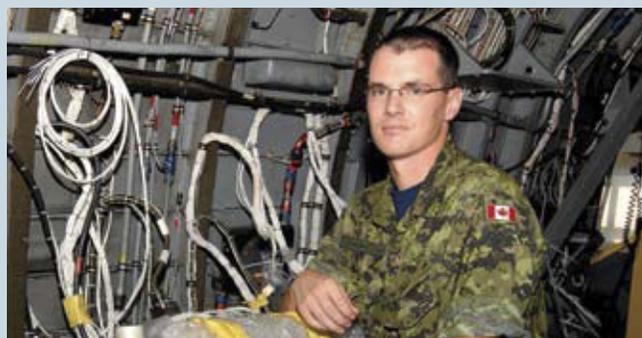
During this process, Pte Rossignol was tasked to support wire bundles to lessen the tension on a clamp that required removal. At this point Pte Rossignol who wanted to be actively involved in the de-snagging process, took the initiative to inspect the wire bundle and discovered a charred wire. He immediately informed his supervisor who investigated further and found that a number of wires were affected including one that had completely burned through.

The nature of this un-serviceability was such that, had it gone undetected, it could easily have led to an electrical fire. The energized damaged wire was exposed to the atmosphere in an area that is not visible during any regular servicing checks.
