Flight Comment

ISSUE 2, 2008

Riding the Rocket Seat

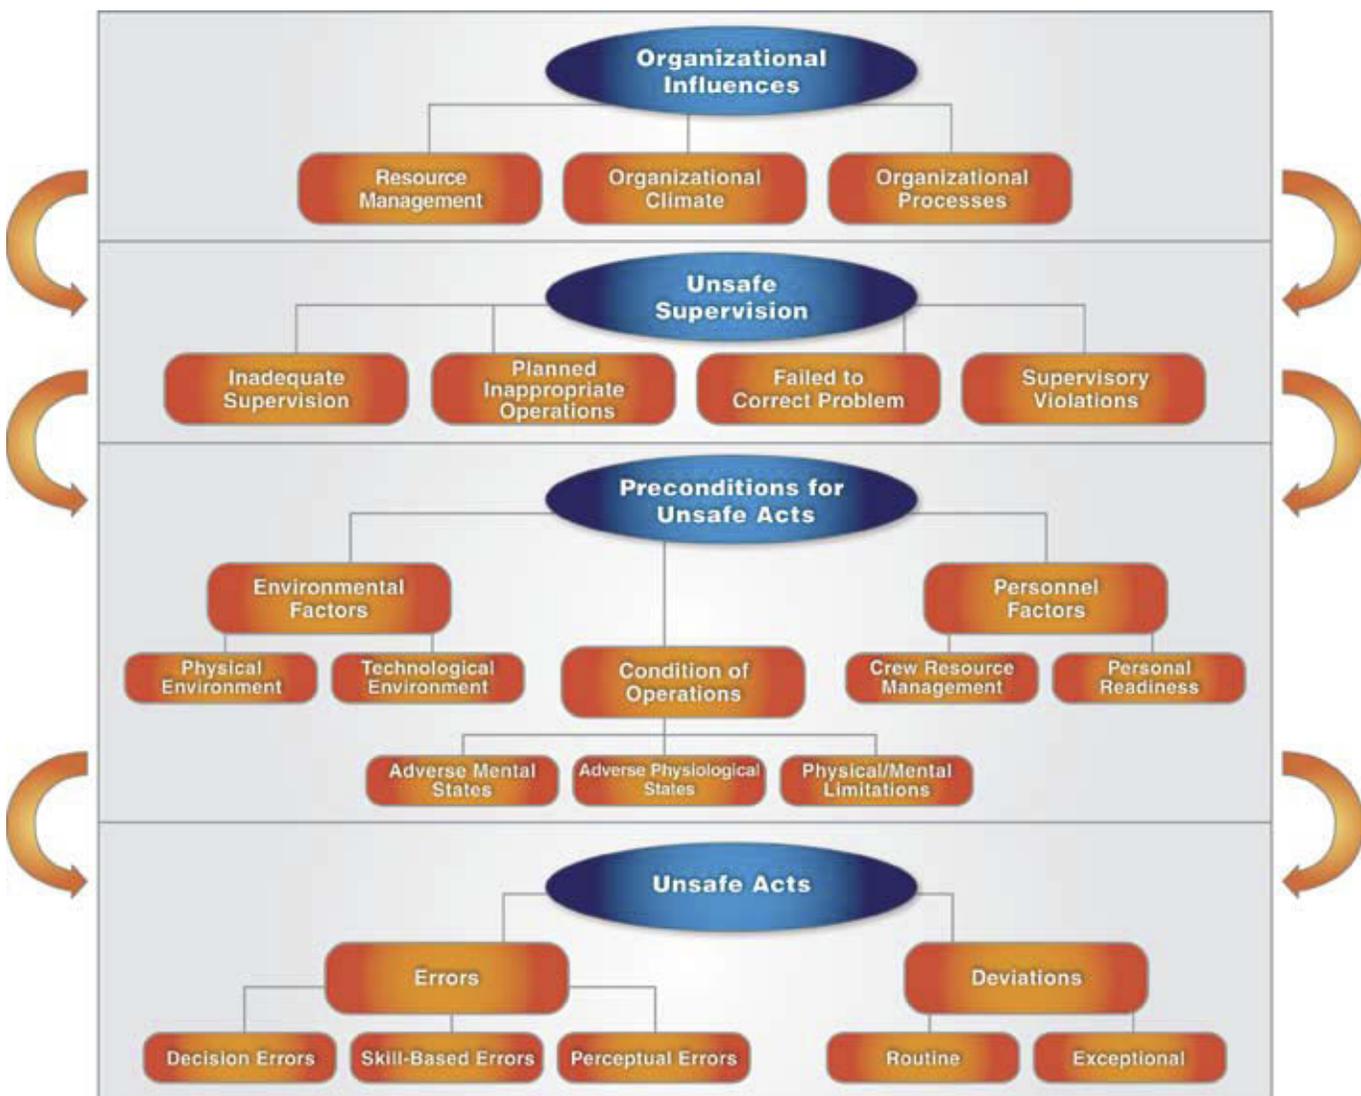
Figure 1. HFACS framework as developed by Drs. Scott Shappell and Doug Wiegmann

The first iteration of CF-HFACS (figure 2) was a modification from the original framework (figure 1). It was introduced to FS investigators at the end of 2003 and used from 2004 as such until recently. Despite having been presented at an annual FS seminar back in those years, having been incorporated in the training syllabus on both the basic and advanced flight safety courses, and having been used quite extensively throughout the recent years, some

difficulties in utilizing the model were highlighted by investigators at different levels of the FS organization. Key issues had to do with its relative complexity, quantitatively and qualitatively. As illustrated in figure 2, it contained more categories, or “bins”, than the original framework in figure 1. With regard to the supporting text, i.e. chapter 10 of the A-GA-135-001/AA-001, Flight Safety for the Canadian Forces (henceforth referred to as A-GA-135), FS personnel

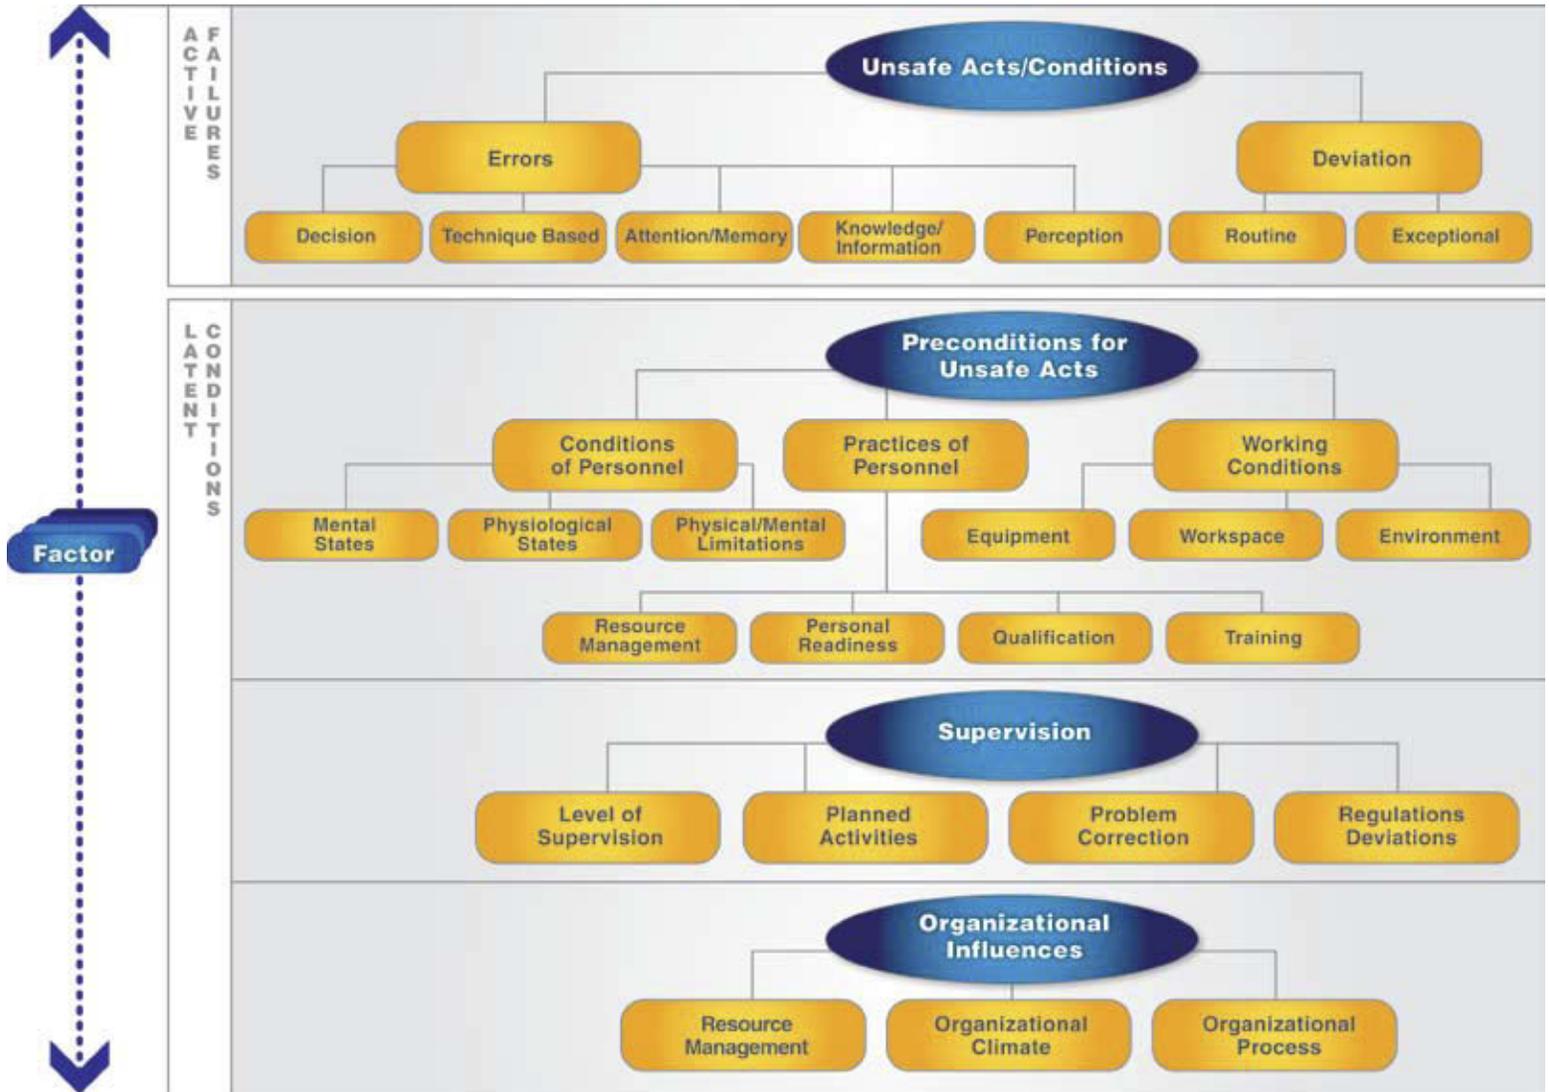
Figure 2. First version of CF-HFACS, adopted in 2004

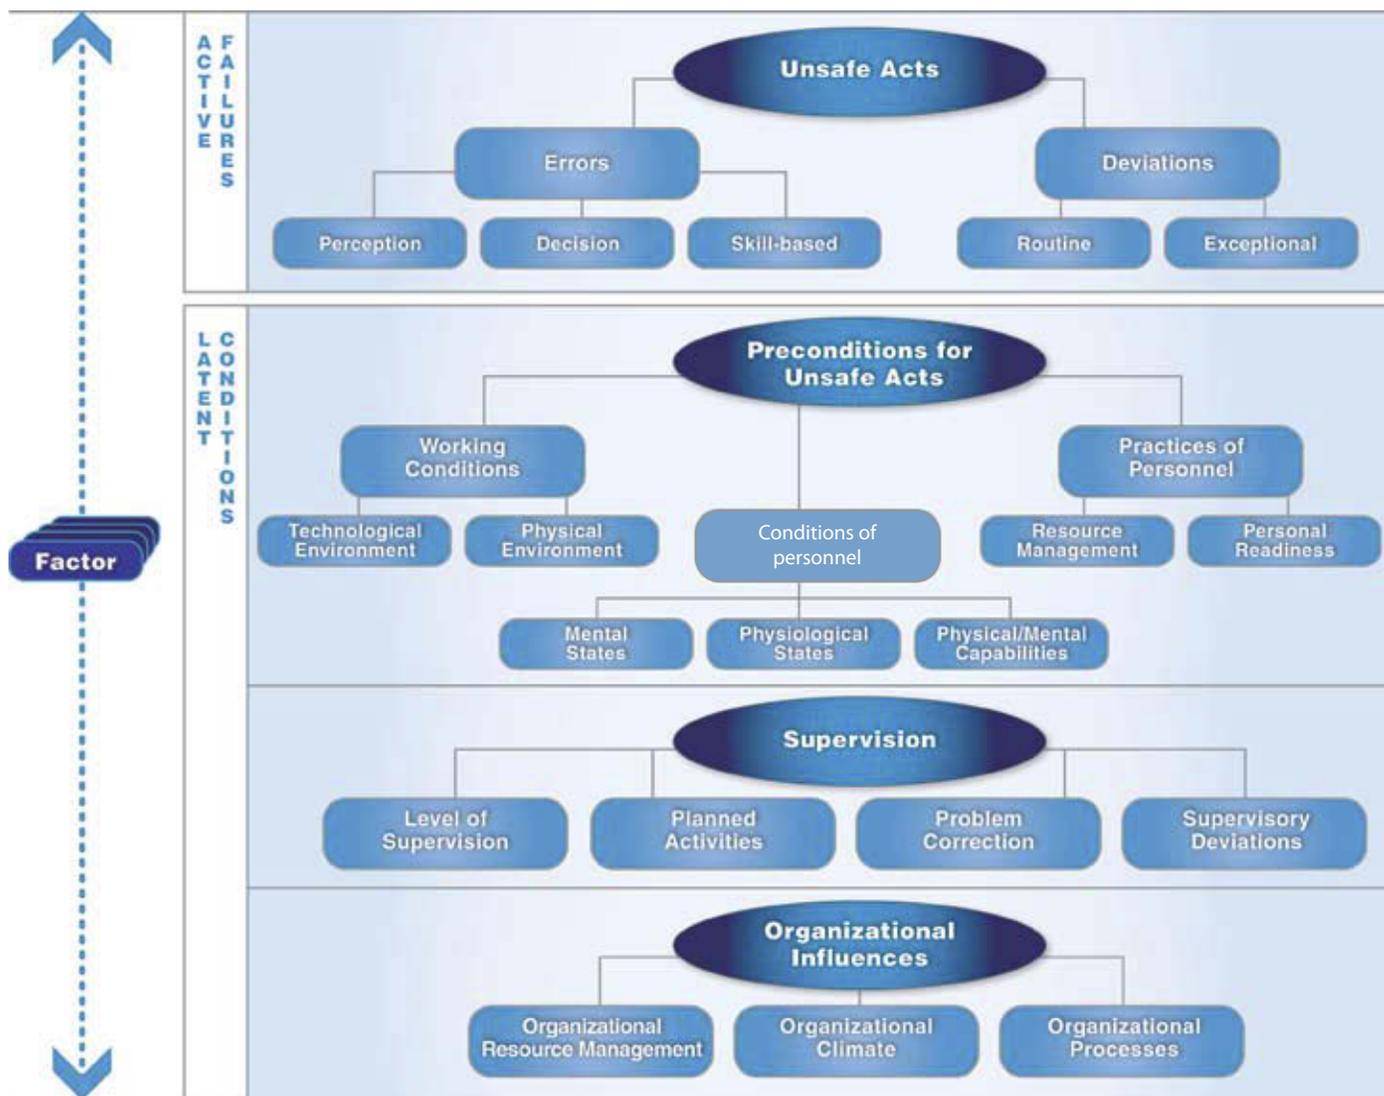
Figure 3. Amended CF-HFACS, version 2008

GA-135. As illustrated in figure 3, the CF-HFACS framework was re-designed. Most importantly, the text was entirely amended, concepts better explained, numerous examples introduced, categories and possible “selections” arranged in a step-by-step flow, and the selection “others”, appearing in just about all the “bins”, removed. Those changes are now available since April 2008 in the amendment # 1 of the A-GA-135, dated March 2007.

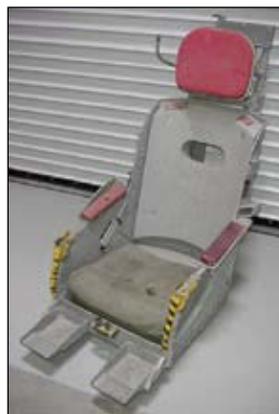
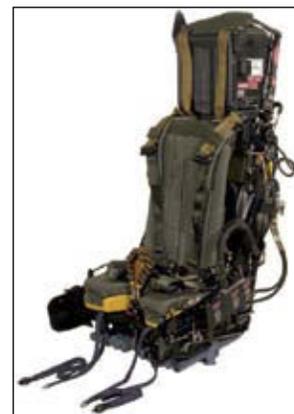
Figure 1. F86 Sabre (left) versus CF188 NACES (right)

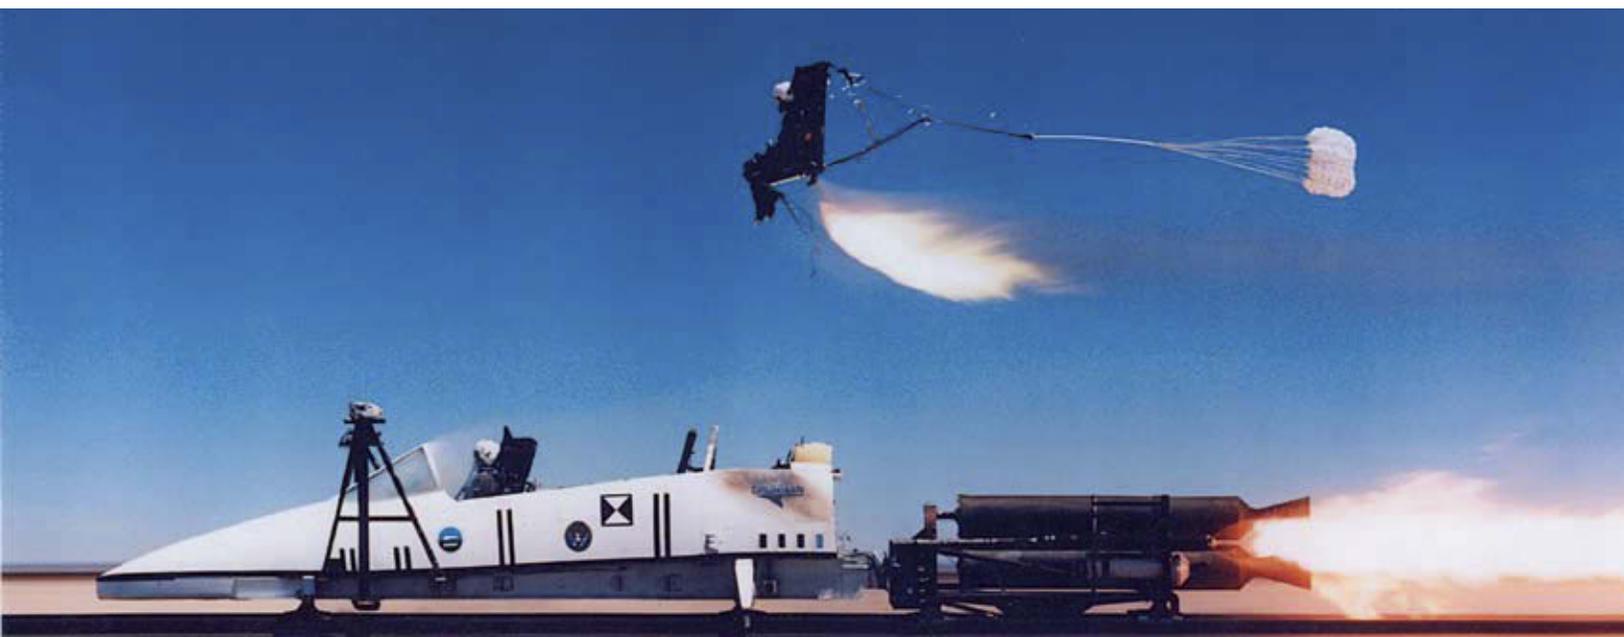
Figure 1a. NACES ejection test showing the multi-point attachment drogue chute

digital electronic sequencer along with airspeed sensors and electrically-fired systems on the seat to allow for five separate modes of operation depending on the sensed conditions at ejection. The pilot's legs are automatically reeled in and held in place, and the seat harness automatically retracts and locks the pilot firmly in place. The seat is pushed out of the aircraft via a multi-stage catapult system, followed by a powerful underseat rocket. Immediately upon leaving the aircraft, the seat deploys a rocket propelled multi-point attachment drogue chute which slows the seat down prior to the main parachute deployment and keeps it stabilized in the airflow (see figure 1a, next page). Needless to say, the main parachute (also rocket-deployed) opens automatically, along with seat-man separation. The NACES' ejection envelope goes from zero airspeed and zero altitude, all the way to 600 knots and 50,000 feet.

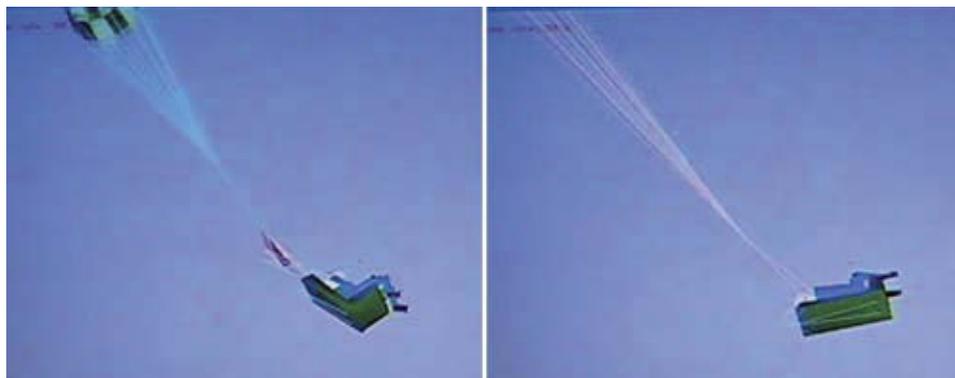
Figure 2. Extraction of main parachute by drogue chute; approximation of misalignment of seat/pilot with main chute axis on inflation

The SJU 9/10 seat (otherwise known as Martin-Baker Mk 10L) which was used in this ejection uses a single point drogue chute for initial seat aerodynamic stabilization, deceleration and to extract the main parachute from the headbox. However, at low altitudes (below 7500' ASL), this drogue chute will only be in action for about 1 second prior to extracting the main parachute. Thus, during a low level, high speed ejection, a large deceleration force will be imparted to the pilot during the main parachute opening phase. In this case, it was estimated at approximately 25 G's. This large force was applied sideways because the seat was not properly aligned with the airflow at the time of main parachute opening (see figure 2).

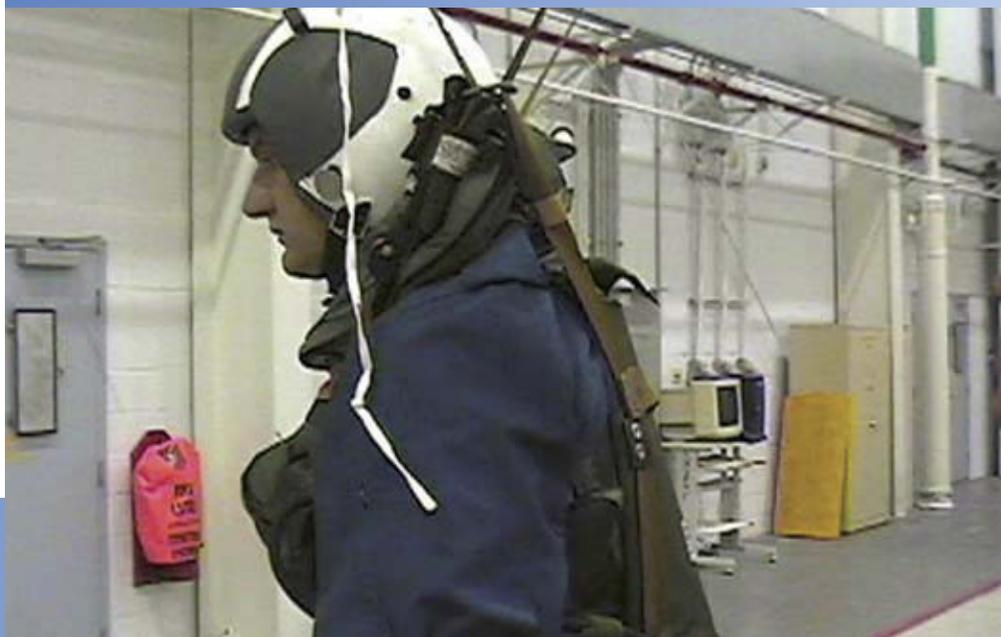
Figure 3. Suspension test showing excessive triangular void above the shoulders

This accident again highlighted the importance of following the proper strap-in procedure as per the AOI's. The IP had, here again, an excessive triangular void due to an improperly tightened harness, which

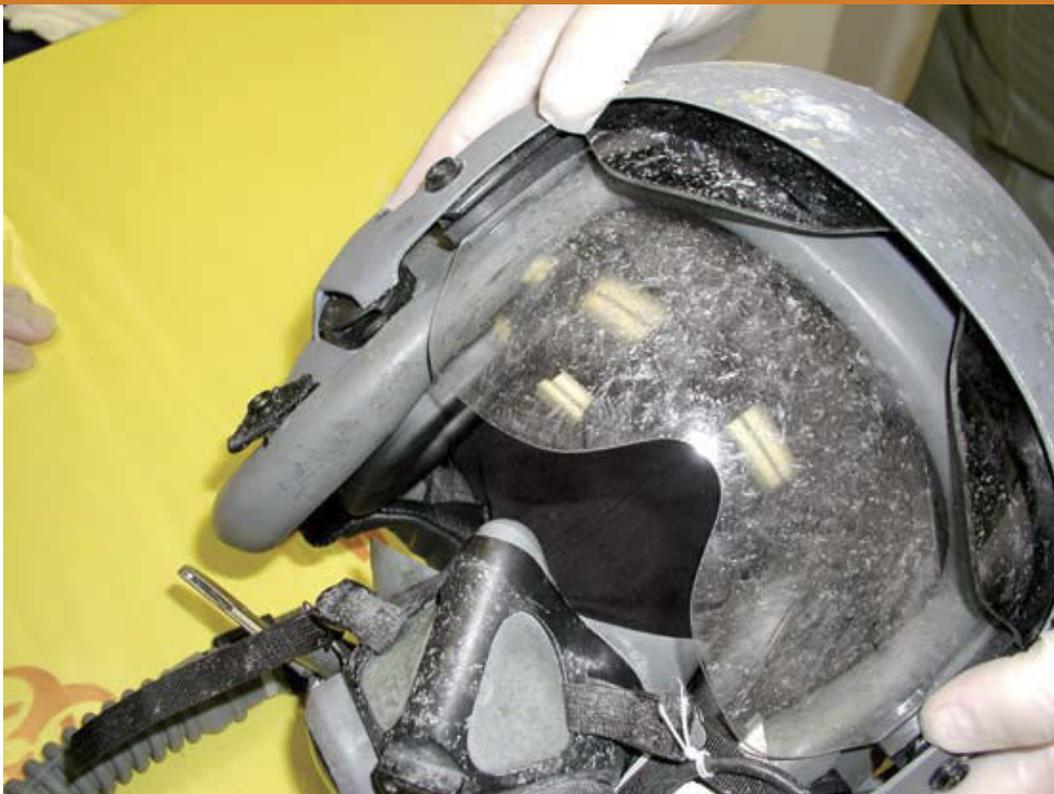
Figure 4. Helmet, visor and mask damage due to MDC and canopy material

Both pilots suffered burns from contact with molten MDC material during the ejection. Both helmets and visors showed signs of pitting, scratches and residue deposits (figure 4). As well, the blast cover of one Beaufort Mk30LC LPSV was perforated rendering the floatation bladder, stored within the carrier, unserviceable. The investigation

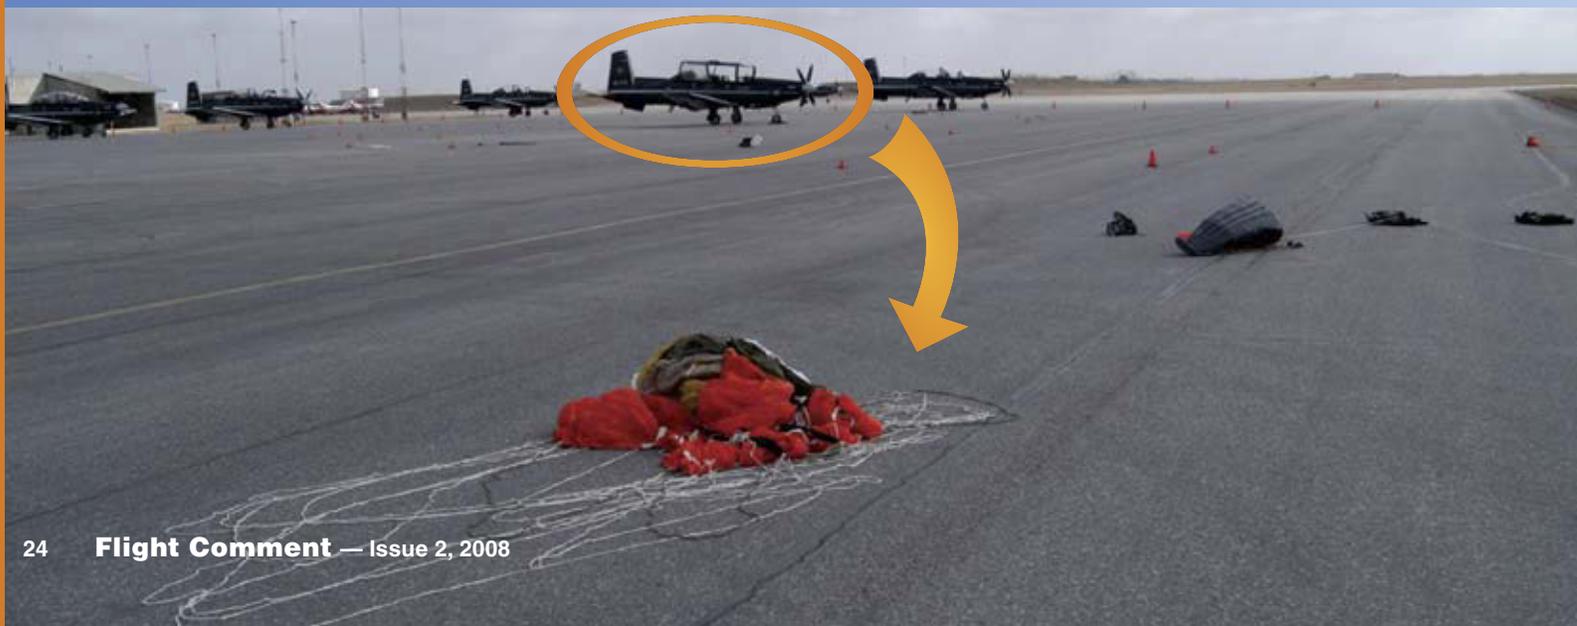
CT156 Harvard, 156112, April 4th, 2007

- A survey of CT156 aircraft in Moose Jaw revealed several differing lengths of communications lines on oxygen hoses.
- One of the two seat initiator cartridges did not fire, resulting in the non-activation of the harness powered retraction unit (HPRU), which forcefully restrains the pilot in the seat

and helps in adopting the proper posture. This was likely due to an improper stowing of the leg restraint lines by the pilot under the seat.

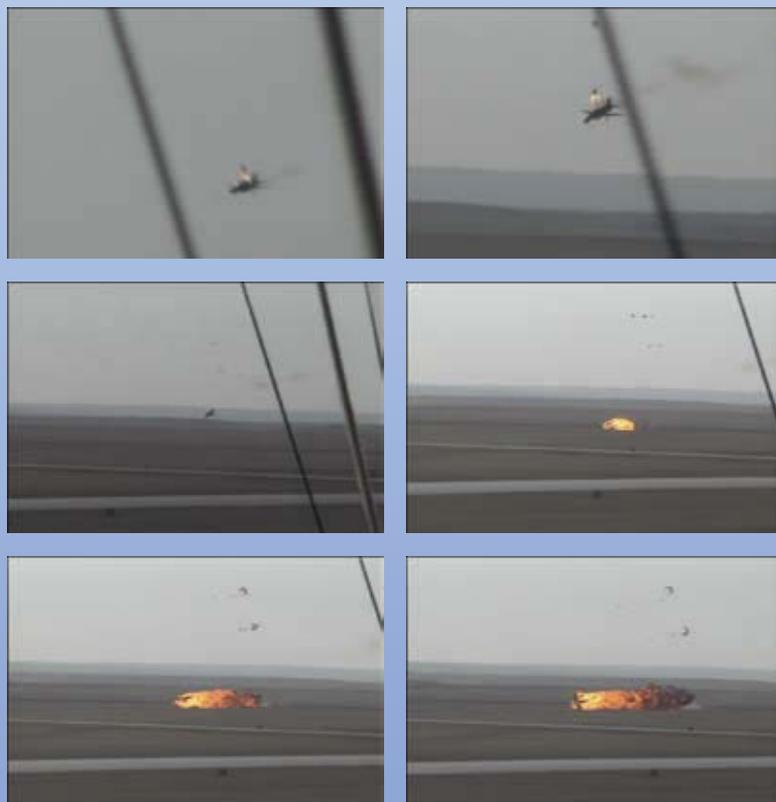
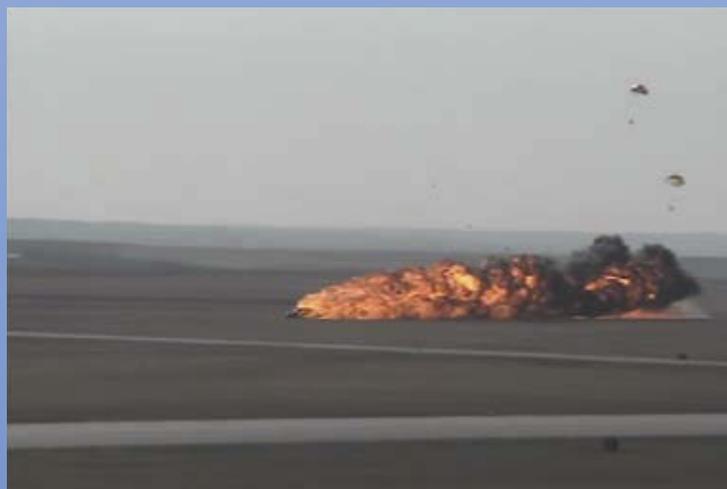
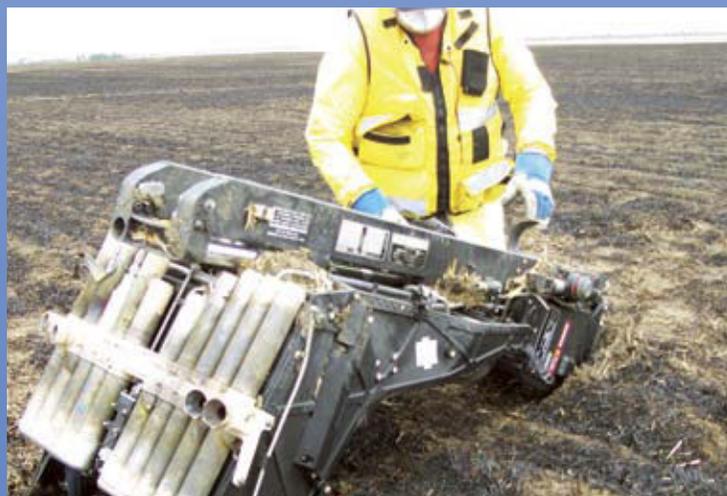
CT155 Hawk, 155215, Apr 18th, 2008

Following the initial takeoff and climbing through 10,000 feet, the occurrence aircraft, manned by a SP in the front seat and an IP in the back seat, experienced an engine malfunction, which resulted in an engine failure. The crew attempted to perform a forced landing profile in an effort to land back at the departure airfield. However, about 1 mile back from the runway, the IP realized that they would not make the runway, and informed the SP of the imminent ejection. The IP then command ejected both pilots from the rear seat. Both pilots ejected at an estimated altitude of 200 ft to 300 ft above the ground, 1.6 seconds before the aircraft struck the ground and exploded, setting a stubble field on fire in the process (See actual photo sequence, right). Both pilots landed in the burning field, and the IP had to help the SP unhook his survival kit and untangle it from the harness. The SP's parachute was, at this point, already on fire. The two pilots then moved away from the encroaching fire, and were met by the local crash fire rescue personnel.

- Both IP and SP suffered serious injuries. The IP's injuries are consistent with loads imparted during the catapult phase, where contact with the aircraft canopy plexiglas, prior to it being ballistically removed, likely contributed to the injuries. The SP's injuries are consistent with loads experienced during the ejection and landing phase sequence. Based on these injuries, both ejections were classified as unsuccessful/survivable.

- The IP's helmet and mask showed significant damage, and parts of his visor were recovered with the aircraft canopy debris.
- The IP did not attempt to steer his parachute or release the Personal Survival Pack (PSP), and landed with the PSP under the right side of his body. The student did not attempt to steer his parachute but did repeatedly attempt to deploy his PSP, unsuccessfully. He landed while still trying to deploy it.

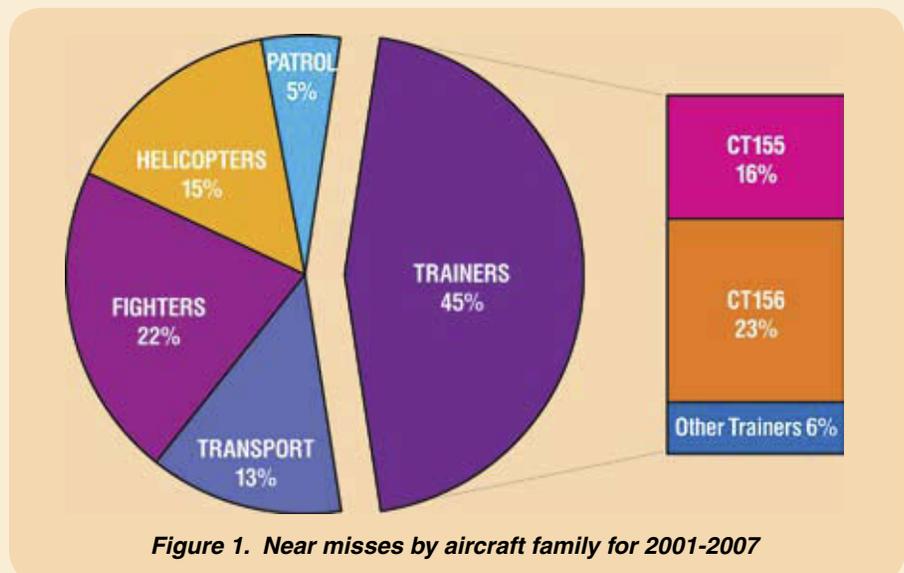
Figure 1. Near misses by aircraft family for 2001-2007

Overall there were 191 reported near miss occurrences in the CF from 1 January 2001 to 31 December 2007. Most near misses occurred under visual flight rules (VFR). Instrument flight rules (IFR) near miss events can generally only be perceived by the crew through traffic collision avoidance systems (TCAS), also known as airborne collision avoidance system (ACAS). Such equipment can be found on some CF fleets, such as CC130 Hercules, CC144 Challenger, CC150 Airbus, Upgraded CP140 Aurora and C17 Globemaster.

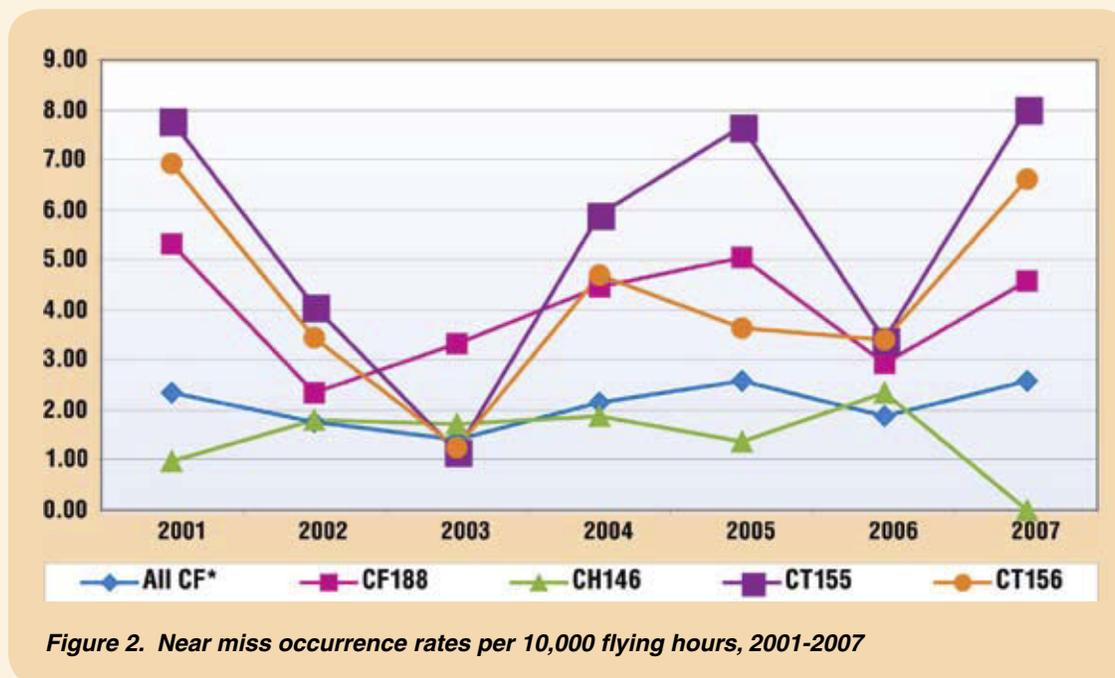
Figure 2. Near miss occurrence rates per 10,000 flying hours, 2001-2007

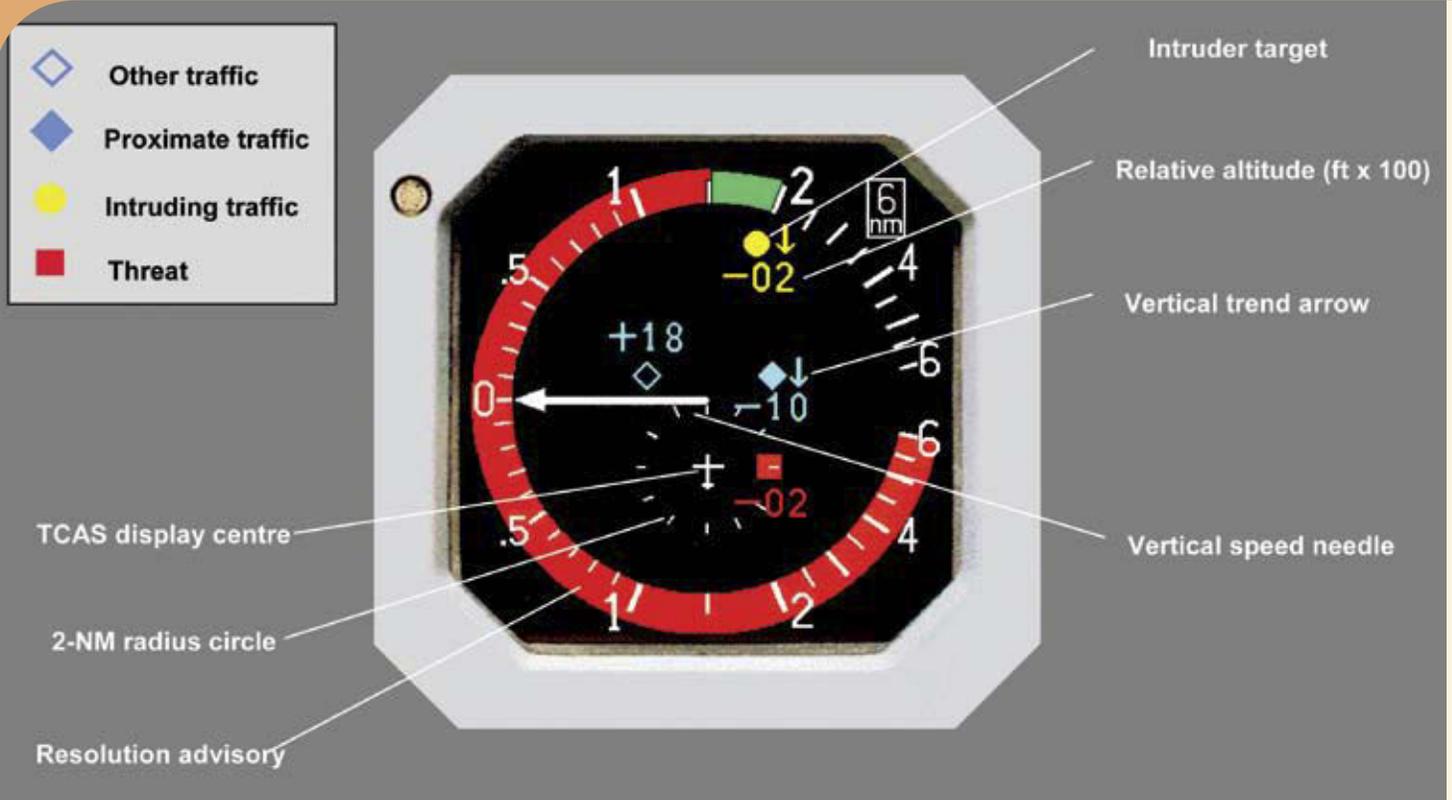
Figure 3. TCAS display on a vertical speed indicator

Technology such as TCAS/ACAS has proven to be a great mid air collision prevention tool. TCAS was developed in the USA by the Federal Aviation Administration (FAA), while ACAS is the name applied by the International Civilian Aviation Organization (ICAO) for similar systems. The use of TCAS/ACAS has been mandated in the USA and has been agreed upon and adopted by the ICAO member states, including Canada. Before regulation in Canadian civilian aviation, there were 13 mid air collisions with over 20 fatalities between 1990 and 2003. Since TCAS implementation in 2003, there have been 3 mid air collisions with 3 fatalities and 3 aircraft lost. None of those aircraft were required to be equipped with TCAS³. Since TCAS regulation over Canadian airspace in 2003, there have been 10 reported TCAS resolution advisory (RA) incidents, which one could take as accidents that TCAS avoided. See figures 3 and 4 for examples of common TCAS cockpit displays.

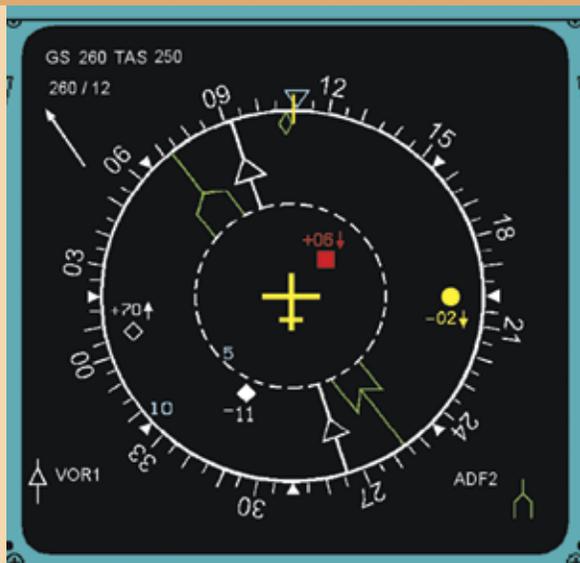
Figure 4. TCAS display on a horizontal situation indicator

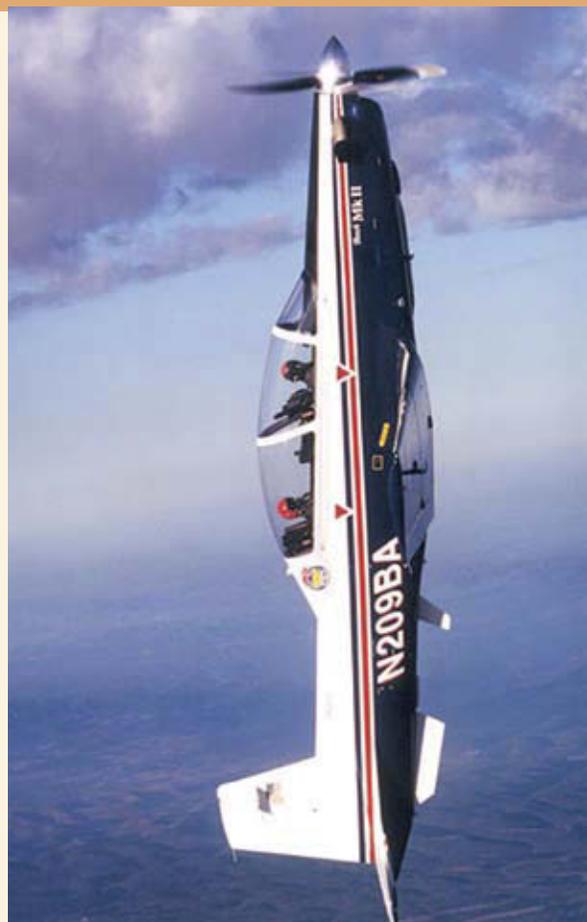
Figure 5. Recommended paint scheme for the CT156 Harvard. Shown here on an American aircraft

Many studies on paint scheme were done to determine the best paint for conspicuity. Research conducted by the Defence Research and Development Centre (DRDC) in Toronto⁴ on aircraft conspicuity concluded that a more reflective colour is easier to see against a darker background in daylight and also determined that the paint scheme, if conspicuity is important, must be a patterned colour scheme, which would have a darker bottom (easily seen against the sky) and a reflective colour

top to improve aircraft visibility when looked at from the top down. Thus, a recommendation to change the color of training aircraft was made in the same ESR mentioned above. See figure 5 for an example of the paint scheme recommended.

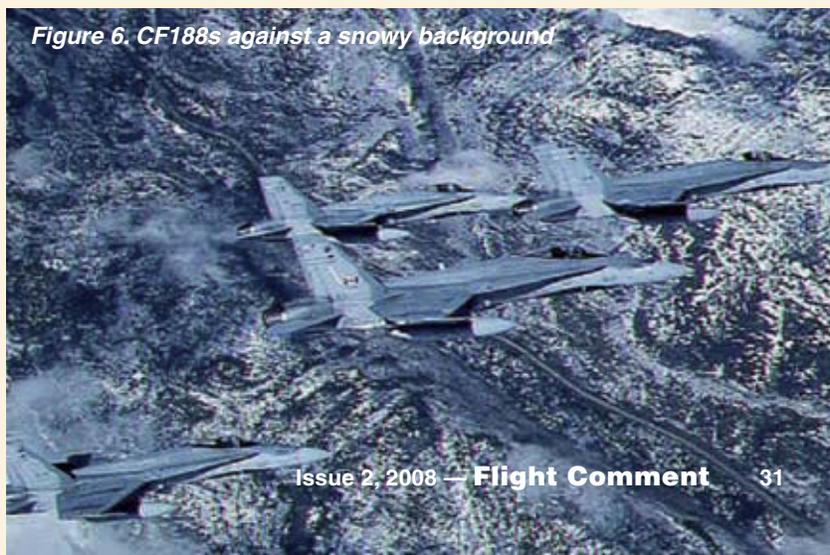
Figure 6. CF188s against a snowy background

Now, compare this with the CF188 Hornet formation depicted in figure 6 below, flying against a snowy

Canadian background. The light gray colour of the Hornets make them rather difficult to see in certain background and lighting conditions. This is obviously a purposeful characteristic of fighter aircraft, which nonetheless makes a good lookout and communication discipline vitally important for the fighter community.

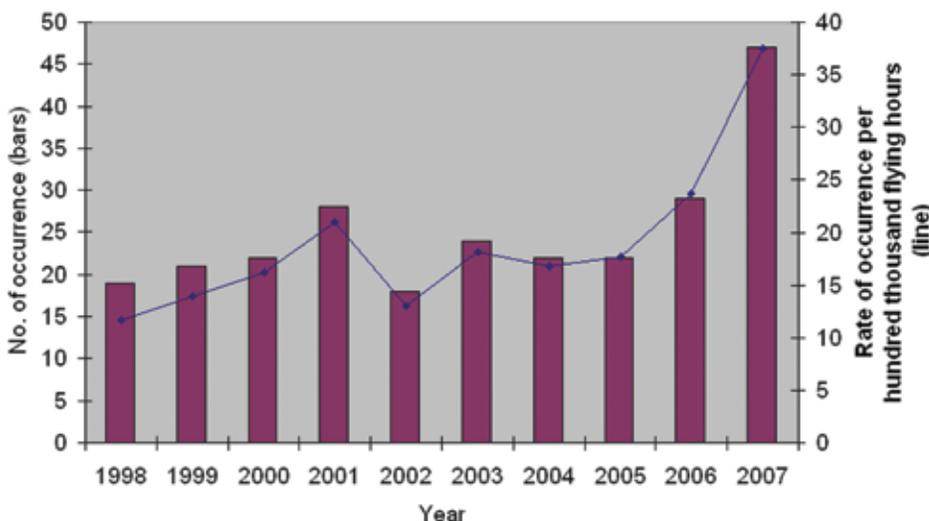
Figure 1. Number of occurrences related to Tool Control in the past 10 years in the CF.
