Flight Comment

ISSUE 2, 2009

IN THIS ISSUE:

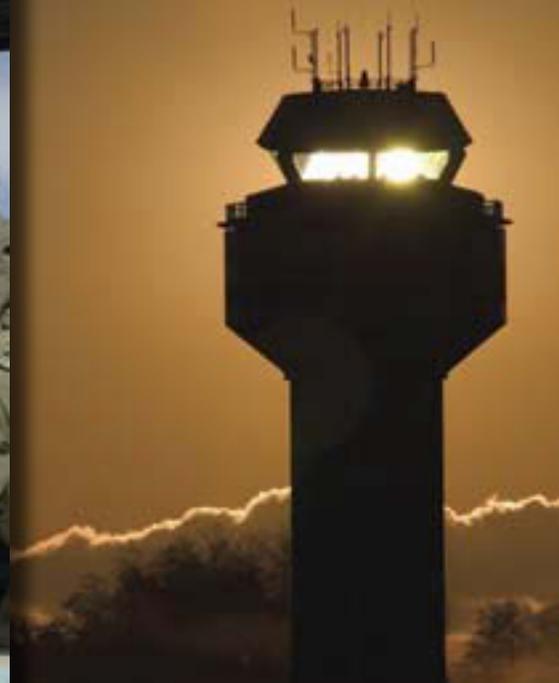
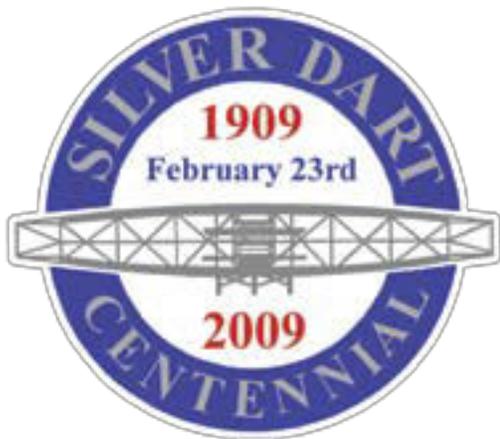
The Silver Dart

Flight Safety consideration	1909 Silver Dart	2009 Silver Dart replica
Ailerons	Aircraft roll was considered to be an adverse condition rather than beneficial for turning the aircraft. As such they devised a shoulder yoke for the pilot which was connected to the ailerons. The theory was that if a gust of wind caused the aircraft to start a roll, the pilot would instinctively lean in the opposite direction. This action would move the shoulder yoke which in turn would move the ailerons to correct the roll. This is fine in theory but totally foreign to a modern day pilot.	The ailerons are controlled by rotating the control wheel, as per modern aircraft practise. This change was made to lessen considerably the learning curve required by the pilot in controlling the aircraft.
Braking	No braking system.	Master brake cylinders were installed which were connected to disc brake callipers on the rear wheels. This proved to be a wise decision due to the limited steering angle on the nose wheel resulting in a rather large turning radius. The brakes came in handy during the early taxi tests when the aircraft manoeuvred into tight areas that the pilot could not steer out of.

Flight Safety consideration	1909 Silver Dart	2009 Silver Dart replica
Safety harness	The pilot sat on a plank of wood with NO seat belt or shoulder harness!	The biggest safety consideration would be the installation of a proper 5 G capable pilot's seat and a four point attachment seat belt with shoulder harness.
Fuselage structure	A bamboo structure that was subjected to buckling due to high compression loads while in flight.	Extra stiffening was added to the two longitudinal bamboo struts above the pilot in order to prevent buckling of the forward fuselage structure.
Tension cables	Limited to 200lbs maximum tension.	Increased the tension in the critical high stressed areas in the wing roots and central fuselage area up to 580 – 880 lbs maximum tension.
Cable tensioning turnbuckles	Constructed using a motorcycle spoke design.	90 percent of the turnbuckles are of original design except in 20 critical areas where they used modern aircraft turnbuckles in order to maintain proper tensioning in the wing root area.

Load capability	550 lb test cable was used through out the aircraft.	880 lb test cable was used in the first inboard wing bays to add extra margin for lifting loads.
Instrument panel	No instrument panel.	A small instrument panel was added for the pilot. It contained a tachometer, engine oil pressure and temperature gauges and an air speed indicator. In addition, a slip indicator ribbon was added to the nose structure and a vertical graduated stick behind the elevator so the pilot could read the elevator angle of attack.

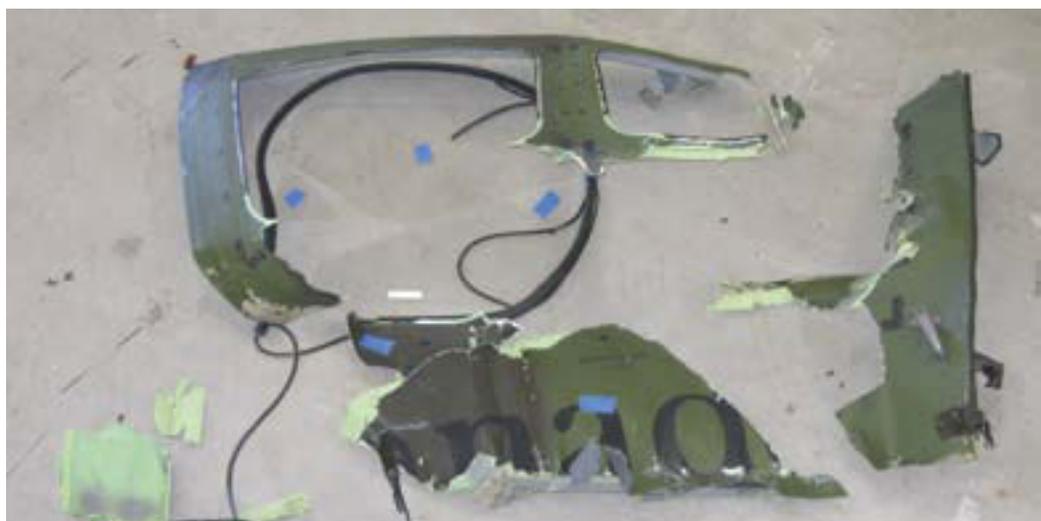
The occurrence took place at the end of the training day when a *Griffon* helicopter was flown from Camp Pendleton to Palomar Airport for refuelling. After the aircrew received their clearance to land, the aircraft lost its right-hand (RH) cargo door. The aircrew heard a loud “bang” but, at the time, they were unaware that the cargo door had departed the aircraft. Both pilots immediately referred to their instruments and assessed controllability. Confident that the aircraft could be flown to the airport, an emergency was declared and the aircraft landed short of the runway. At the time of the occurrence, the aircrew believed that the cargo door was in a fully pinned open configuration, consequently, they flew at approximately 100 knots indicated airspeed (KIAS). The evidence collected during the investigation showed that the cargo door was not secured in the open and pinned position. As a result, the aircraft was exceeding the maximum allowable airspeed for cargo doors in the in-transit configuration by 20 knots. With the aircraft in a RH turn and descent, the resultant airflow on the right hand passenger door generated sufficient lift and drag to cause the front J channel on the bottom of the cargo door to disconnect from the fuselage bottom track. Once disengaged, the additional drag on the cargo door completely tore it from the fuselage tracks. Laboratory work was conducted to determine the condition of the latching mechanism used to secure the cargo door in the open position. It confirmed that the pit-pin used to secure the door’s keeper to the latch assembly was unserviceable. The condition

of the pit-pin was not detected during the pre-flight inspection and is deemed to be a contributor to the occurrence. Further, the investigation revealed that the verification of the door security done prior to the last flight relied on a “pull-test” and did not include a visual and/or tactile check of the pit-pin. The act of pulling on the cargo doors to test for security may lead to the false assumption that the door is fully secured, whereas the visual and/or tactile check would allow the Flight Engineer (FE) to detect when the pit-pin is partially inserted and/or the pin locking mechanism is unserviceable/not fully engaged. Preventive measures range from revision of the training standards to ensure all FEs are taught a procedure that requires them to confirm the pit-pin is down and locked to the requirement for a new design of the front bracket holding the bottom of the cargo door to the fuselage track. ♦

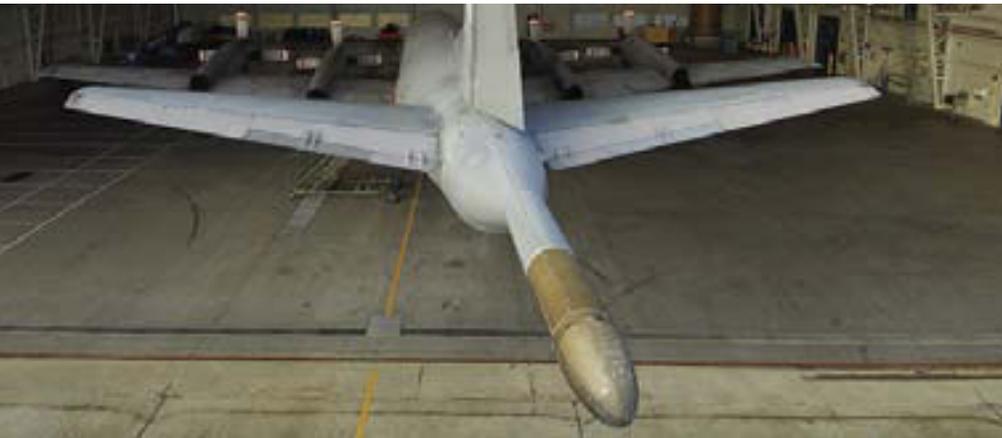
TYPE: CP140 *Arcturus* (140120)

The incident occurred during the early morning hours as a tow crew of five personnel was towing an *Arcturus* aircraft out of 12 Hangar at 19 Wing Comox. The tow crew supervisor positioned himself adjacent to the tow bar on the right-hand side of the mule. There was no tail-walker assigned and the option of using one of the available personnel to cover the rear of the aircraft was not discussed.

As the aircraft began to move backward it also began to drift left and the drift went undetected. The mule driver could not see the vertical stabilizer from the driver's seat and wing-walkers did not perceive that the vertical stabilizer was moving toward the side of the "doggy door" opening. The tow crew supervisor also did not notice that the aircraft was drifting off the centreline and had positioned himself in such a way that he was too close to the aircraft and could not see the vertical stabilizer. As the aircraft moved

rearward, the rudder and vertical stabilizer struck the top of the hangar door opening adjacent to the "doggy door", extensively damaging the rudder and vertical stabilizer tip cap and causing minor non-structural damage to the vertical stabilizer. The Squadron normally operates out of 7 Hangar but on the day of the occurrence the incident aircraft was parked in 12 Hangar which, unlike Hangar 7, requires a "doggy door" above the main door to provide clearance for the vertical stabilizer of the CP-140. Tow crews are generally less familiar with towing aircraft in and out of 12 Hangar and are not necessarily aware that it is critical to have a tail-walker specifically tasked to ensure clearance between the vertical stabilizer and the "doggy door". The tow crew members were all qualified, highly experienced and authorized for the task. The tow crew supervisor; however, had only recently been authorized to perform his duties and had only towed an aircraft from 12 Hangar once before.
