An Accident Waiting to Happen

This Skyjack maintenance platform was tampered with to override critical safety features. The tampering allowed the unit to be driven at high speed with the platform extended.

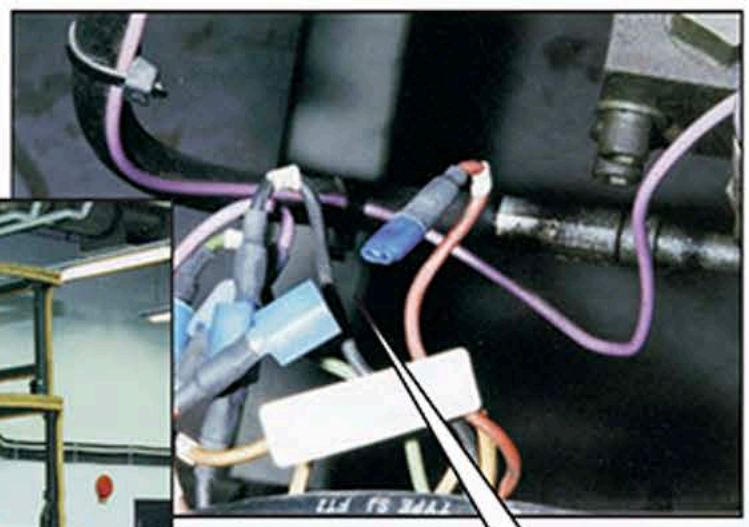
Wiring disconnected

Safety must never be jeopardized for the sake of expedience. Safety Devices are there for **YOUR** protection.

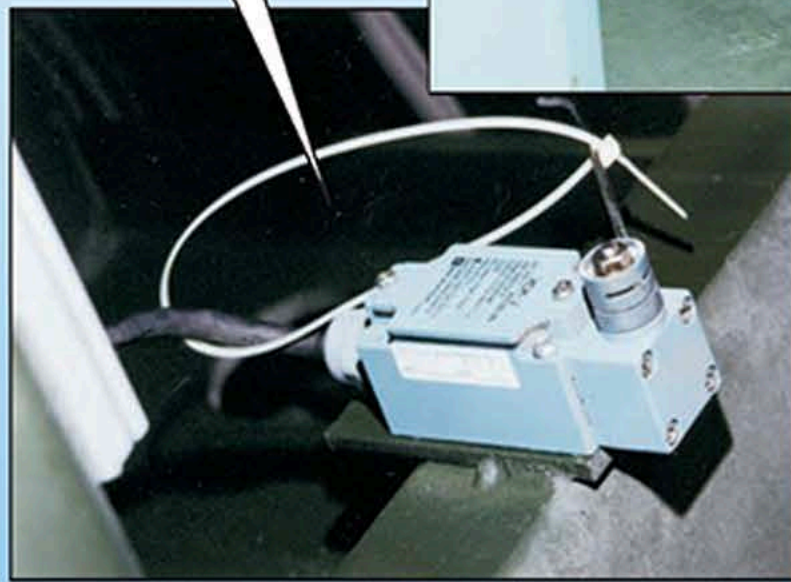
Plastic tie found around switch arm
